# Inspection Report

## EXISTING-HOME BUYER INSPECTION

**PASADENA, TEXAS**

Brad Leland  
Professional Real Estate Inspector  
T.R.E.C. License #5229  
Office 281-794-9102

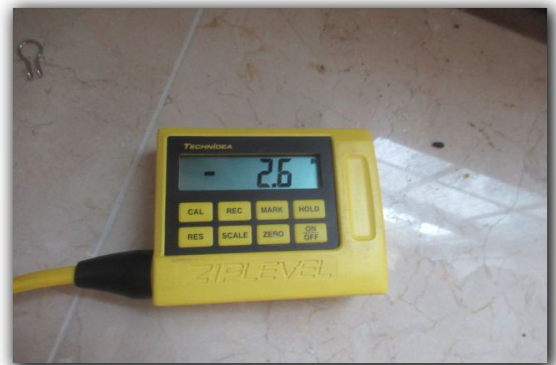
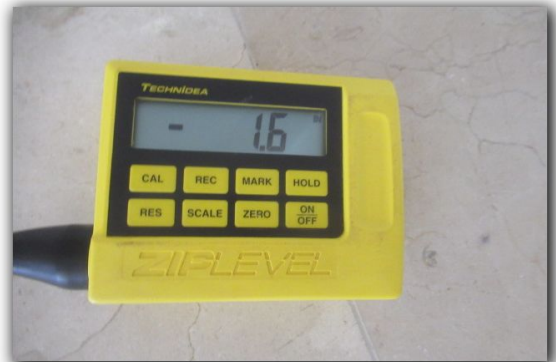
**Comments:** There are signs of more than normal past movement/settlement in the structure such as cracks in the interior sheetrock, cracks in the exterior bricks, doors that are not operating properly and when measured the west side and front of the home were approximately 1.6" to 2.6" low. As discussed, these conditions indicate that the foundation may require a permanent remedy to stabilize the structure in some areas. The best course to follow for foundation settlement is to consult a professional (structural) engineer so that a course of corrective procedures can be evaluated. This can consist of a certification that the foundation is functioning as intended at this time, or alternately, a plan may be designed for underpinning.

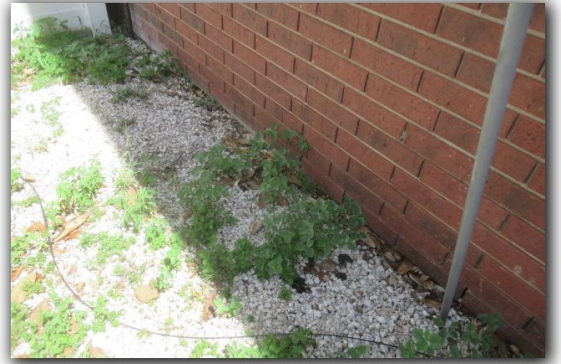
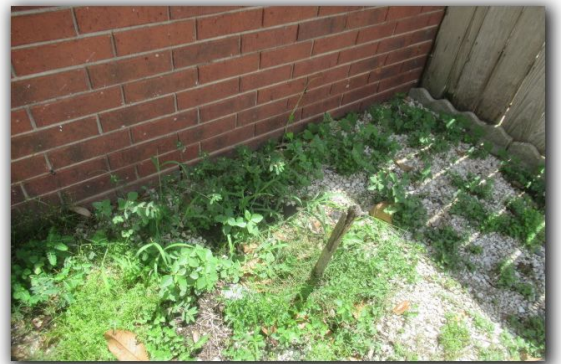
**Comments:** The rock/soil levels are high in relationship with the interior at the front and west side of the home. When soil levels are high against the face of the foundation it promotes water penetration of the structure and insect infestation. This item should be corrected so there is some exposure of the foundation face without creating reverse drainage. It is generally accepted that in an ideal situation, a brick veneer house should have about 4-6 inches of clearance. Wood siding houses should have more clearance.

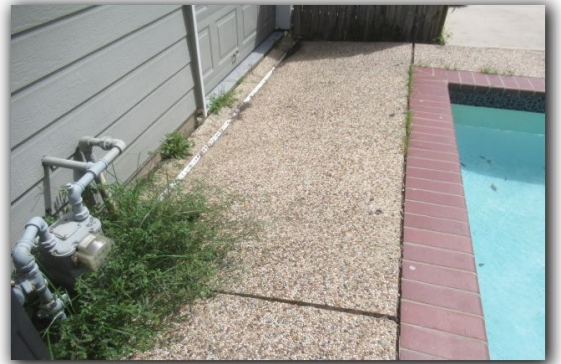
The foundation does not appear to have positive grading as the back patio/pool decking slopes towards the home. The drainage strategy of the yard as it relates to the foundation is important. Expansive soils can be destructive to the foundation if the moisture content of the perimeter varies.

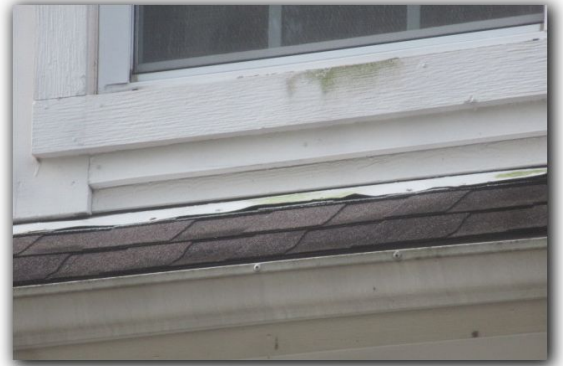
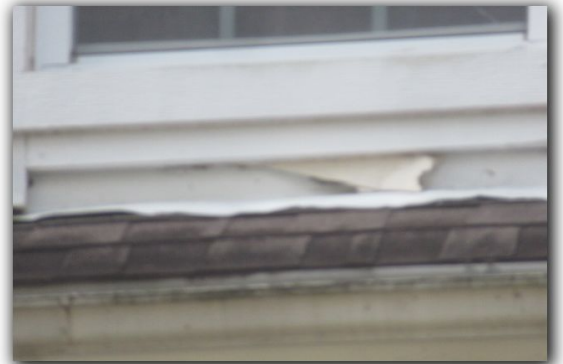
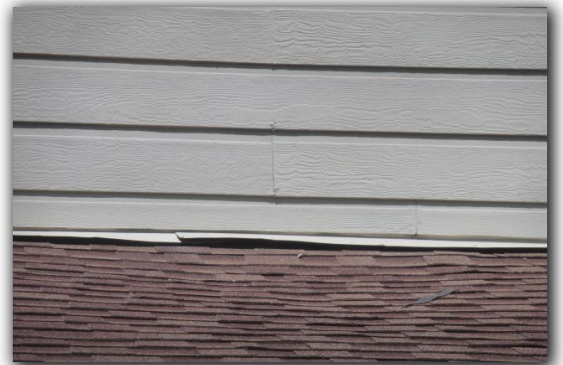
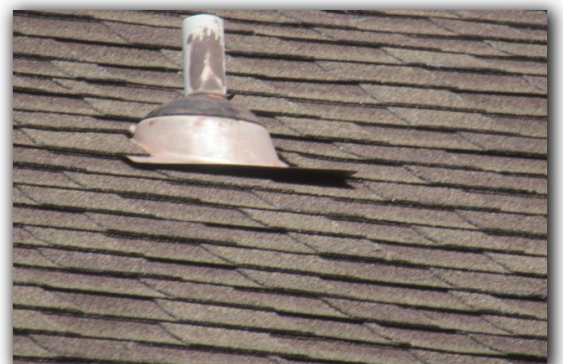
**Comments:** The flashing has lifted above the plane of the roof line in several areas. This condition is considered a conducive condition for water penetration and can be uplifted in high winds. Sealing and securing the flashing is recommended.

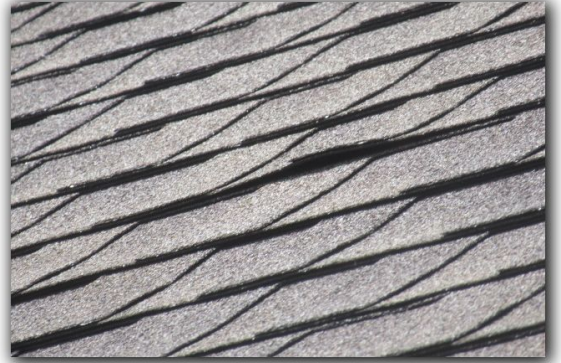
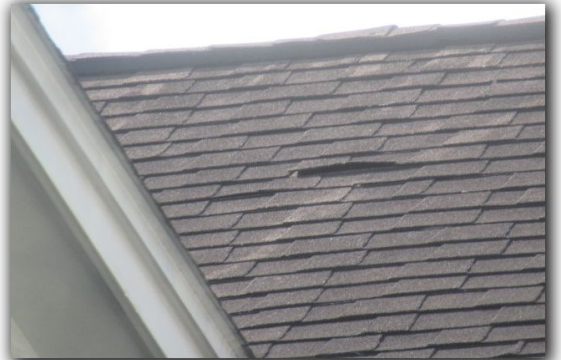
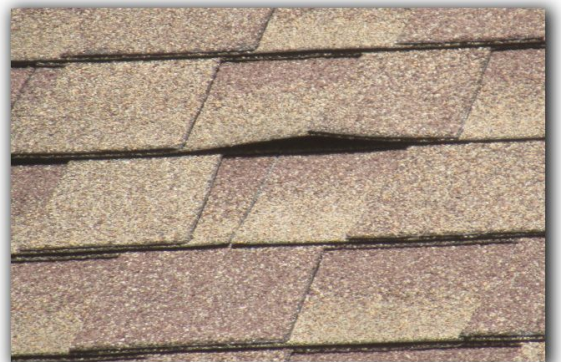
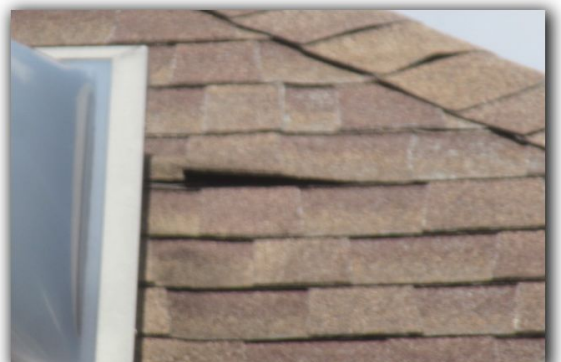
There are several lifted shingles that may be caused by nails backing out. A qualified roofing

contractor should be consulted regarding this condition.

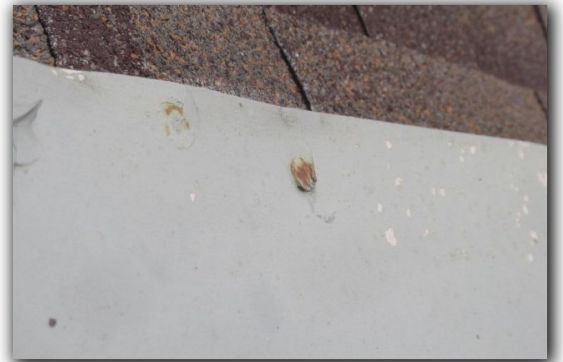
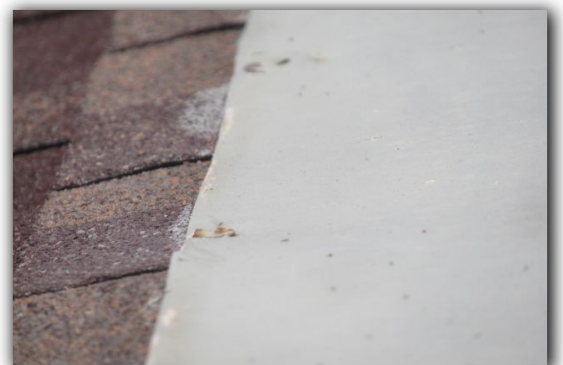
There are exposed nail heads. Exposed nail heads at either the vent and roof flashing or at the composition shingles can allow water to penetrate past the roof covering given enough time. As the exposed portion of the nail rusts more space will become available between the nail and the roofing material for water to penetrate. This condition can usually be remedied by sealing or caulking affected area.

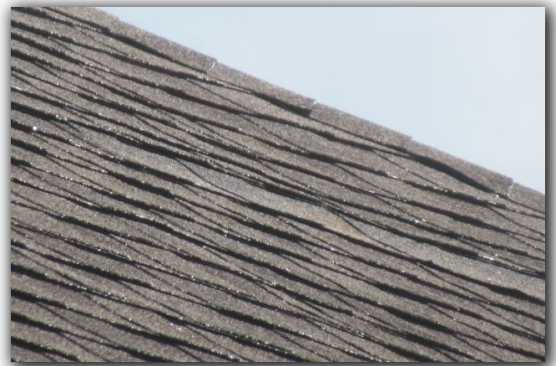
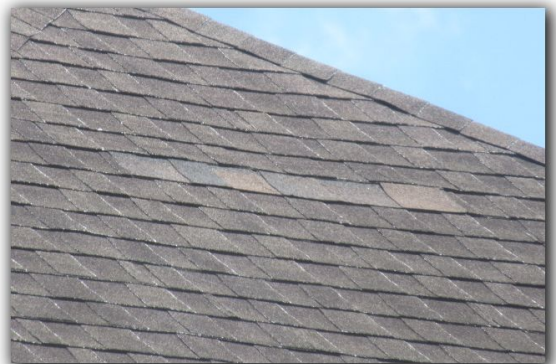
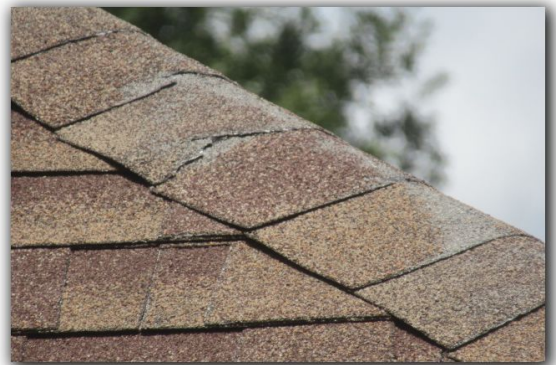
There are some damaged shingles and some repairs to the roof.

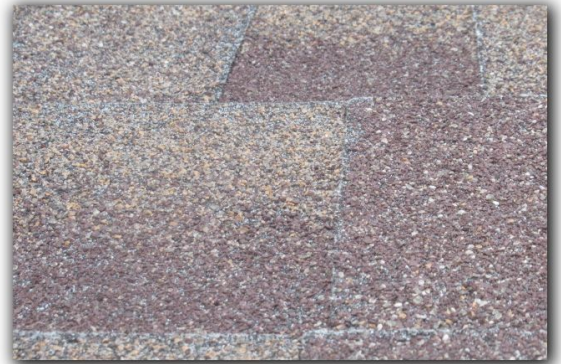
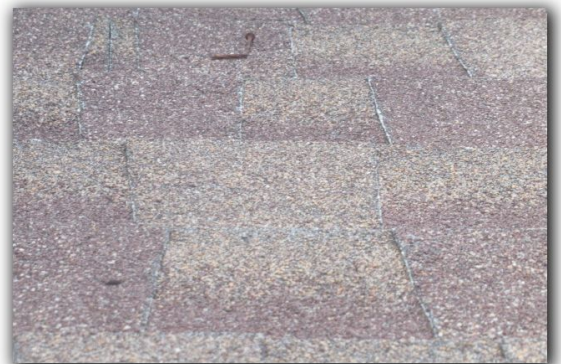
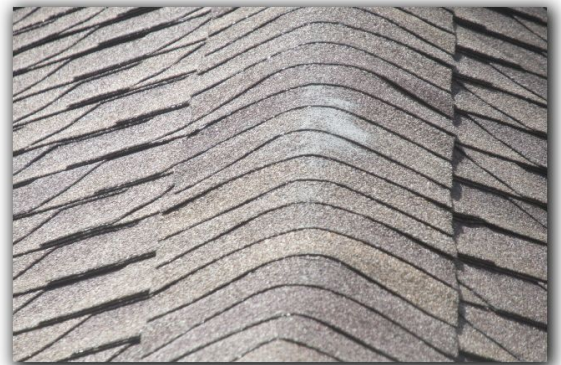
The surface of the roof is worn/loss of aggregate in several areas which is an indication that the shingles may need to be replaced in the near future.

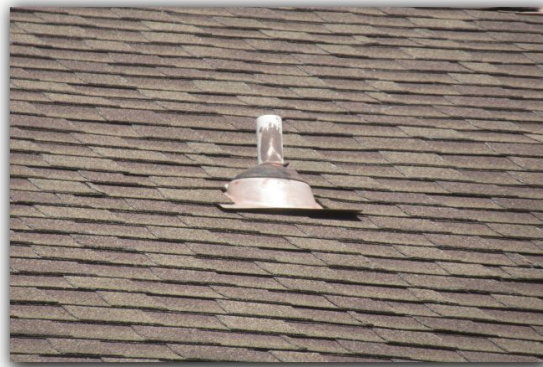
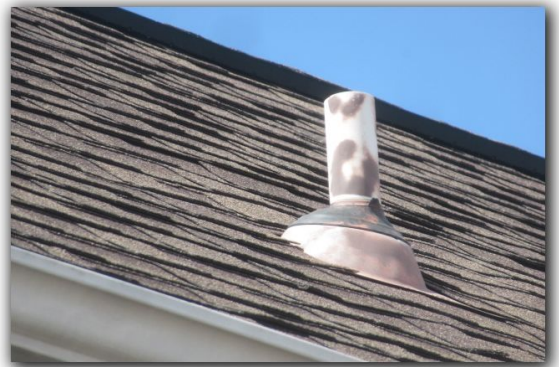
The plumbing drain vent pipes should be re-sealed and painted to protect them from the weather.

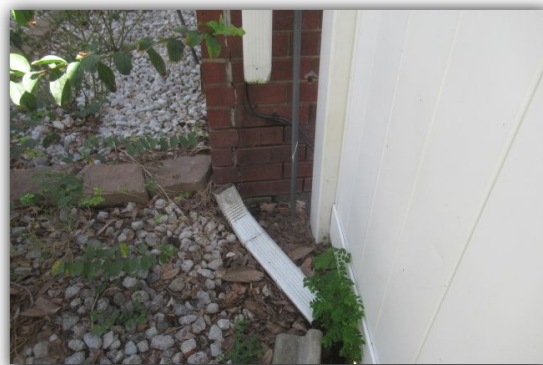
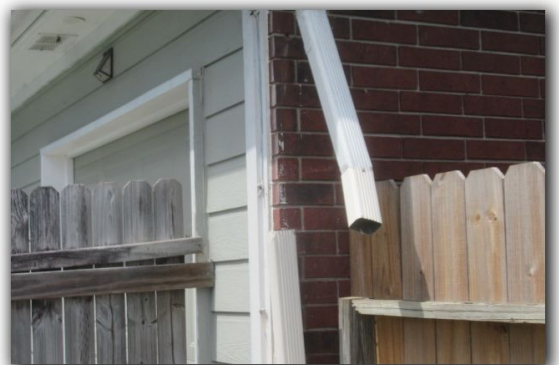
The water heater and furnace flue pipes are not completely sealed at the rain collars on the roof as daylight can be seen around these pipes in the attic area.

The gutter down spouts have come apart at the rear southeast and the front northwest corners of the home.

A qualified roofing contractor should be consulted regarding the repair of the above items as well as check the entire roof covering for any other possible defects.

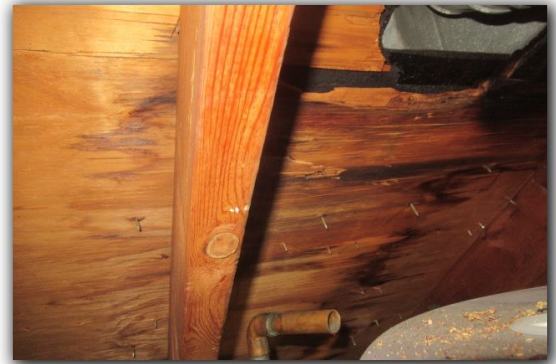
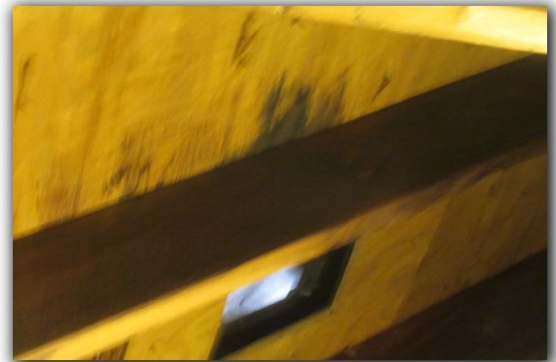
**Comments:** There were water stains/water damage on the roof decking in several areas. These areas appear dry at this time. This condition is an indication of previous water penetration. The areas should be monitored during heavy rain to determine if the leaks are active.

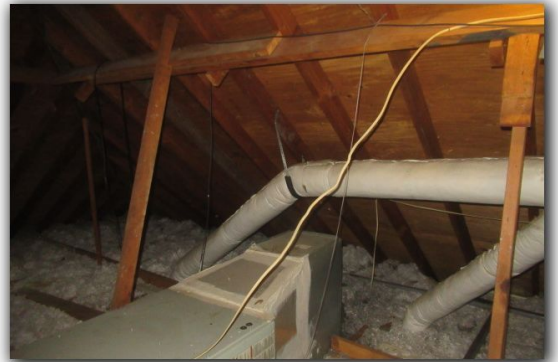
The mid span rafter supports have not been installed for the roof structure every four feet as would now be required.

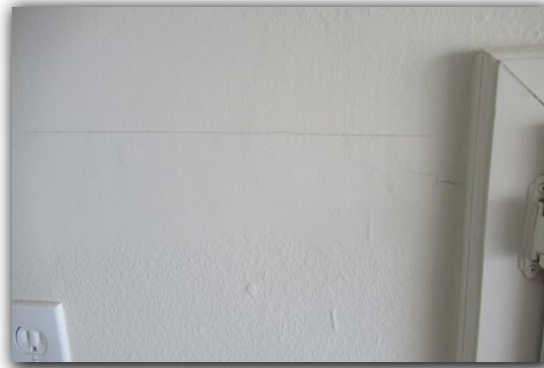
**Comments:** There were cracks in the interior sheetrock in the breakfast area and in the garage. Cracks in the sheetrock are usually indications that there is some degree of movement occurring in the structure. The severity of the cracks can be an indication of the amount of movement in a structure.

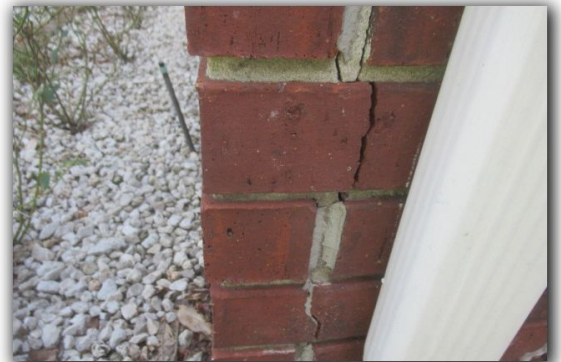
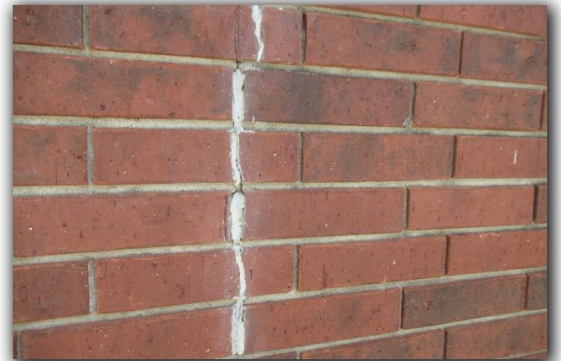
There were cracks in the exterior brick on the west side of the home. Cracks in the bricks are usually indications that there is some degree of movement occurring in the structure. The severity of the cracks can be an indication of the amount of movement in a structure.

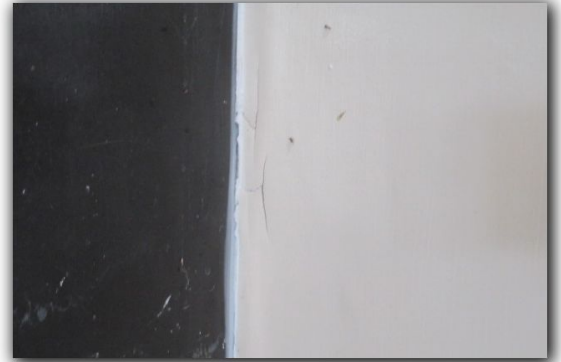
There are water stains on the sheetrock on the west wall of the living room. This area was dry at the time of the inspection. This condition is an indication of previous water penetration in this area. This area should be monitored for additional signs of water penetration. Hidden damage is a possibility.

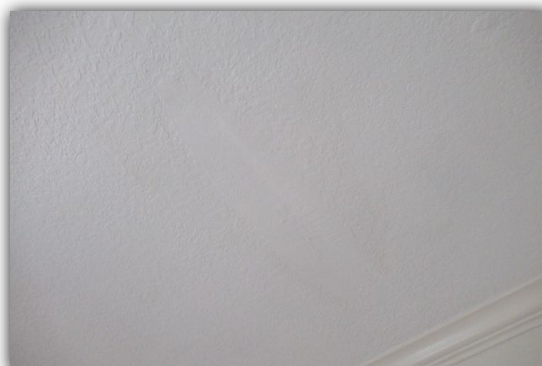
**Comments:** There was evidence of water penetration (water stains) on the ceiling in the living room. This area was dry when tested. Leaks can cause hidden or concealed damage. All damaged elements should be repaired or replaced. The reason for the water penetration is unknown. The area should be monitored, especially during heavy rain, to determine if the leaks are active.

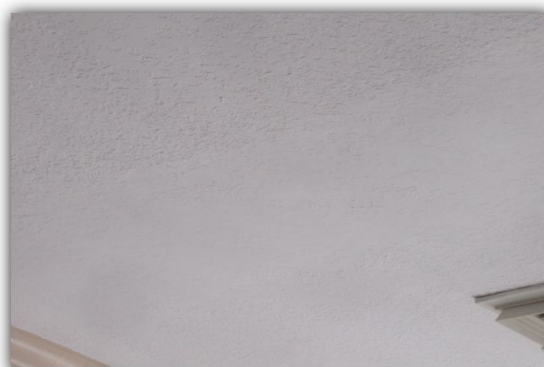
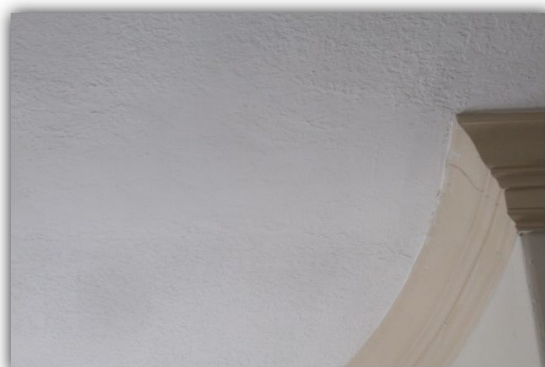
There were previous repairs to the ceiling in the living room and upstairs hallway. It is recommended that the current homeowner be consulted regarding the reason for these repairs.

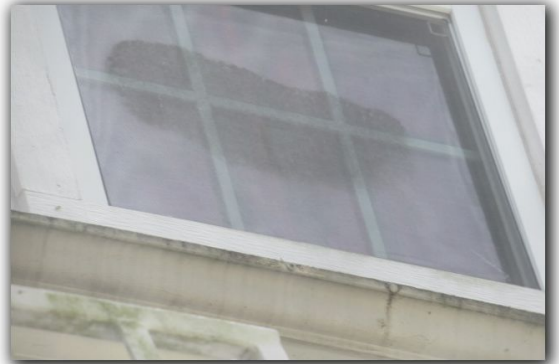
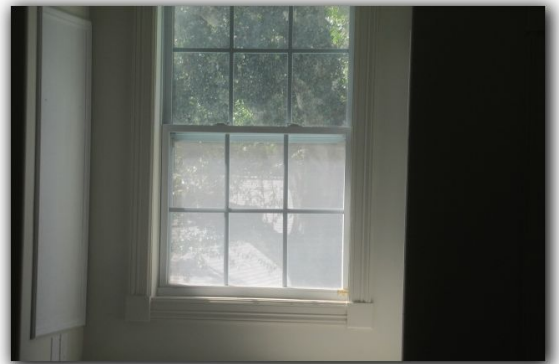
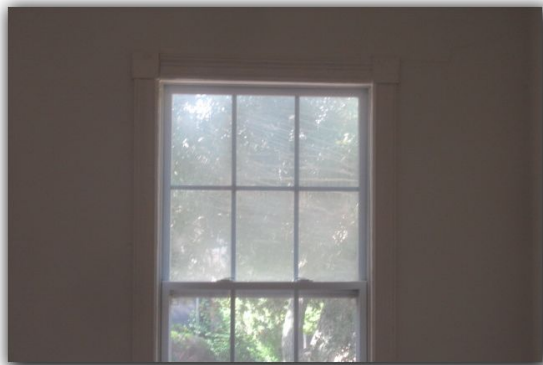
**Comments:** The upstairs rear middle bedroom window screen was missing. Screens are mentioned in this part of the report as they are a specific item in the T.R.E.C. Guidelines. All windows that have channels for screens should have them installed.

It was noted that the some of the windows in the breakfast area did not operate properly.

Several of the thermo pane windows may have lost their seal as there is notable discoloration. It is recommended that these windows be cleaned and rechecked.

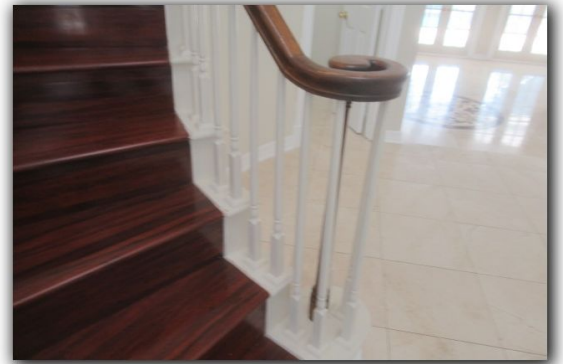
**Comments:** The stair case handrails were loose at the top and bottom of the stairs. It is recommended that all banisters and handrails be able to withstand 800 pounds of pressure to ensure the safety of the occupants.

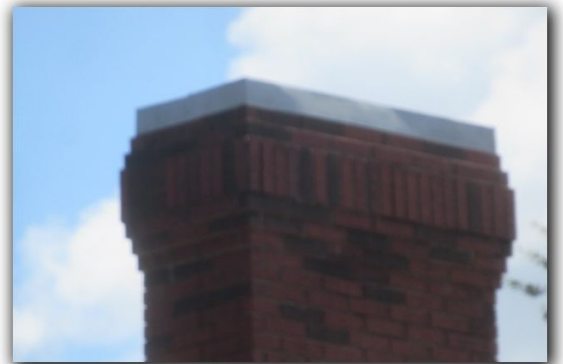
**Comments:** The chimney cap was missing. The cap should keep water out of the flue and fireplace. The screen keeps out birds, animals, and insects. The screen also has spark arresting properties.

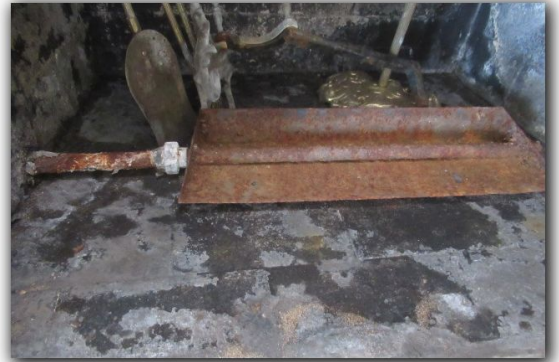
There was corrosion on the damper assembly and it would not open. This condition is an indication of possible moisture penetration.

The igniter tube is heavily corroded therefore the gas feature was not performance tested.

It is recommended that a chimney sweep be consulted regarding these conditions as well as check the entire fireplace/chimney system for any other possible defects.

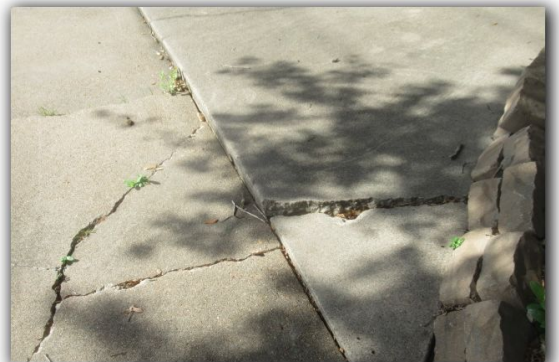
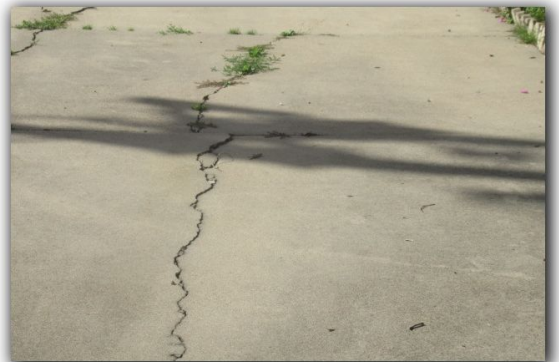
☒ ☐ ☐ ☒      **L. Other**  
**Comments:** Driveway sections have cracked and lifted/settled unevenly.

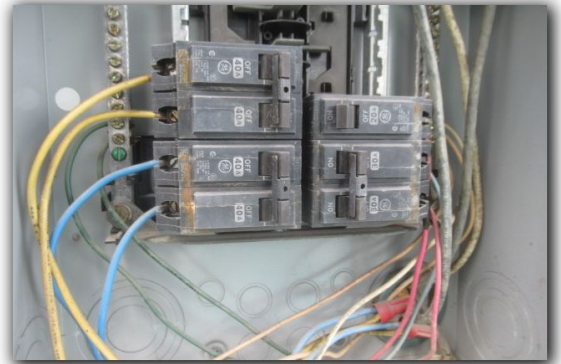
**Comments:** A 30 amp breaker in the sub panel was in the off position at the time of the inspection.

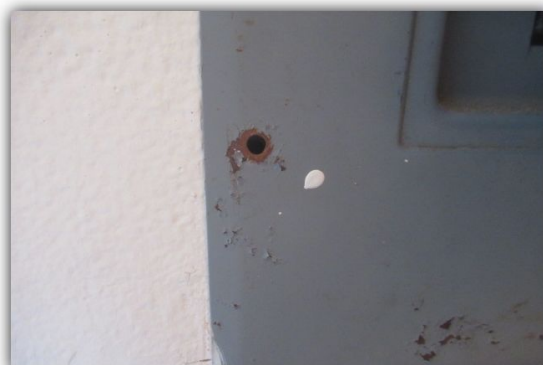
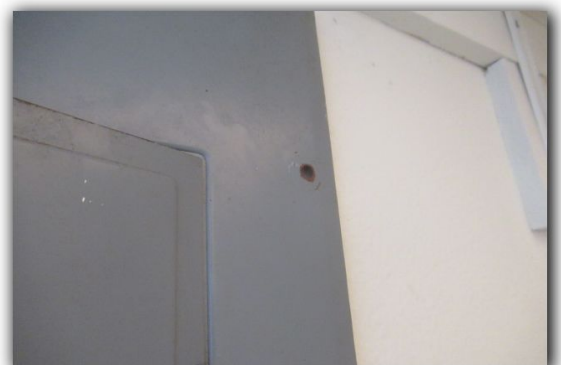
Two of the dead front panel securing screws for the main breaker box were missing.

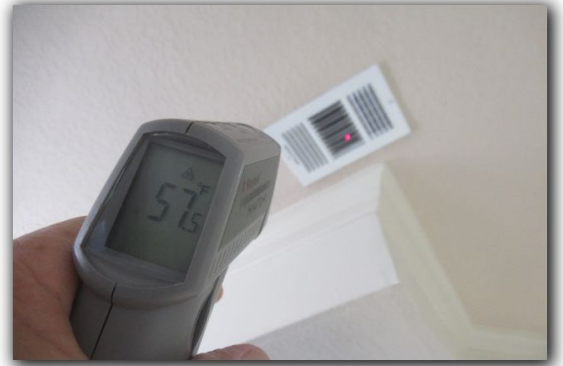
**Comments:** The downstairs zone system did not operate within the allowable tolerances. The air coming out of the vents should be 14 to 21 degrees cooler than where it goes into the cold air return. It is recommended that a qualified contractor be consulted regarding this matter.

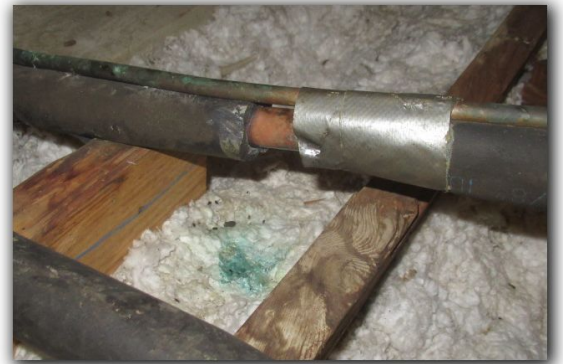
The refrigerant lines were not fully insulated to the 4 ton exterior compressor and both of the coil boxes. This condition causes the line to sweat and slightly degrades the performance of the system and may also cause water damage if they are located in the attic area. Applying foam tubes and taping them will remedy this condition.

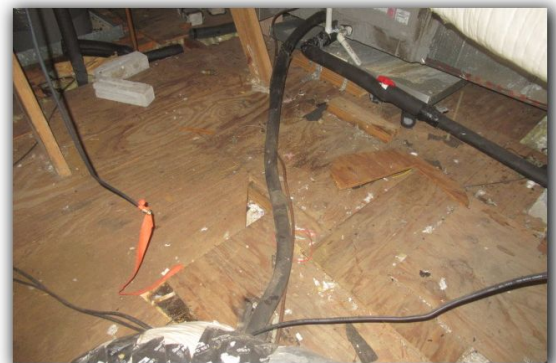
The AC refrigerant lines are not strapped up off of the attic floor as they should be in order to prevent possible damage to these lines.

A qualified HVAC technician should be consulted regarding the repair of the above items as well as check the entire cooling system for any other possible defects.

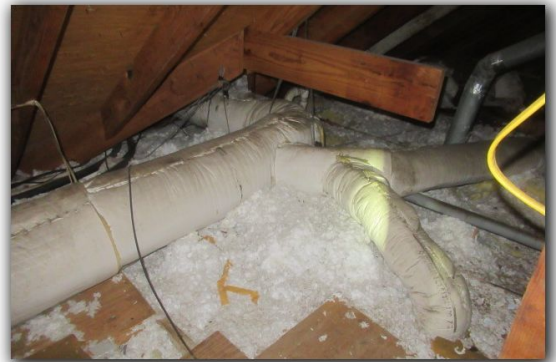
Duct work was not strapped up off of the attic floor as it should be in order to provide maximum air flow and also to prevent damage to the ducts.

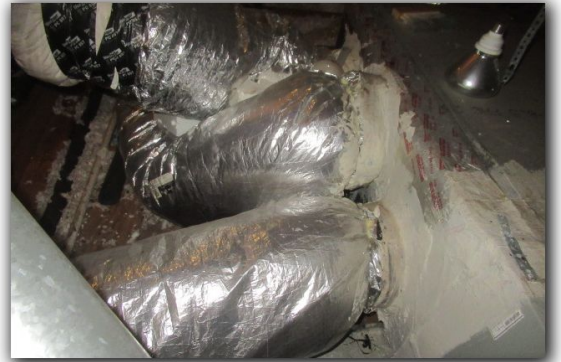
The ductwork coating is torn on some of the ducts in the attic area. It is recommended that the coating and insulation be complete for energy efficiency of the HVAC system.

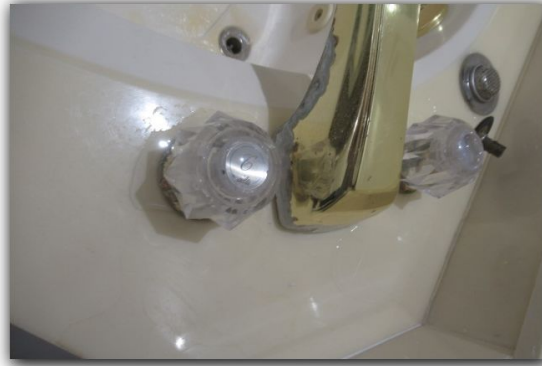
**Comments:** Water leaks from the handles for the whirlpool bathtub in the master bathroom.

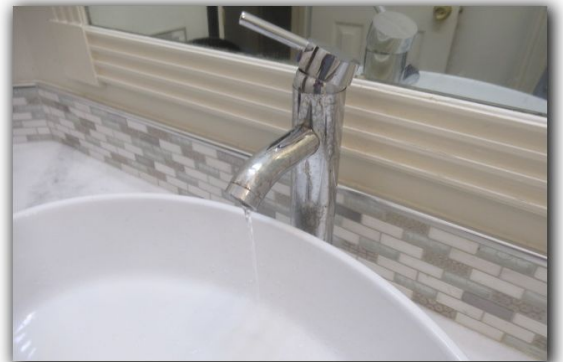
The water pressure was low at the half bathroom sink faucet and at the hot water for the rear sink in the jack and jill bathroom sink. There is no guideline for flow rates. If the water pressure appears to be very low, it is mentioned in this report. As there are several causes for low water pressure, a licensed plumber should service the utility.

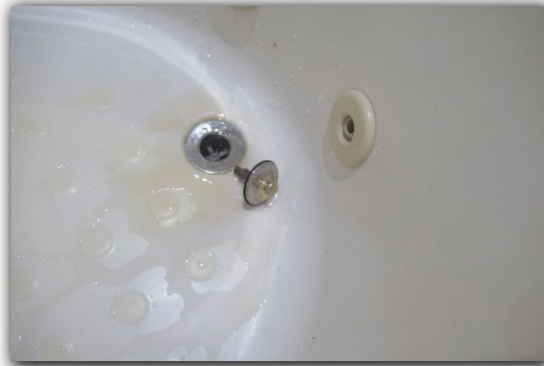
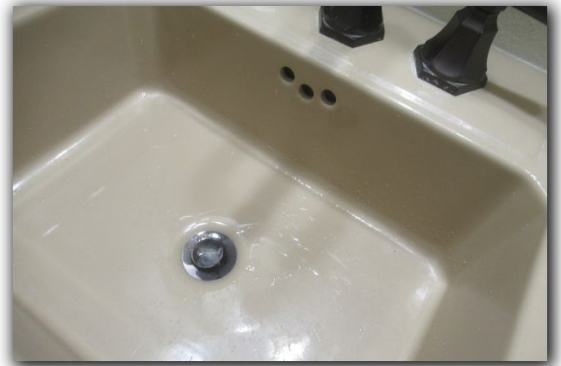
**Comments:** The drain stops in the master bathtub and the half bathroom sink are not operating properly. Sometimes a drain stop can be adjusted or it may need to be replaced.

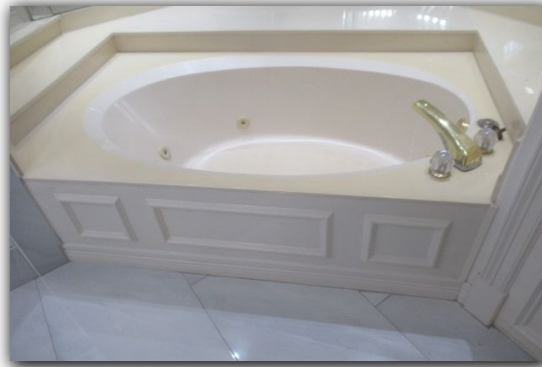
**Comments:** A G.F.C.I. breaker for the pump motor was not located.

The pump motor did not operate when tested.

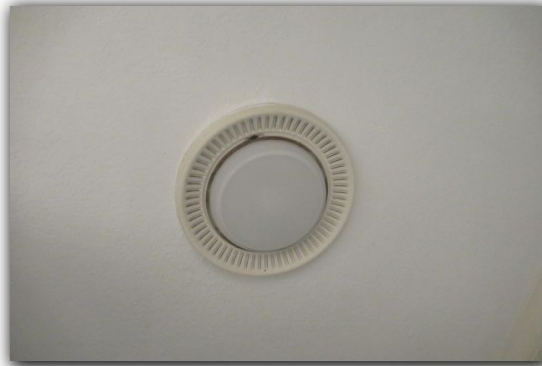
**Comments:** The jack and jill bathroom exhaust fan was loud and vibrated excessively when it was operated. All damaged elements should be repaired or replaced.
