**SAMPLE INSPECTION REPORT**

# **Foundation Pre-Pour**

Pearland, Texas

## **Pre-Pour Foundation Inspection**

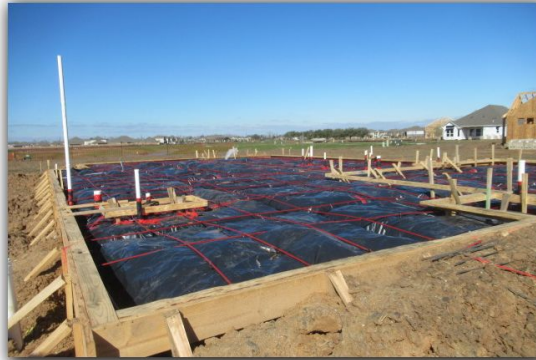
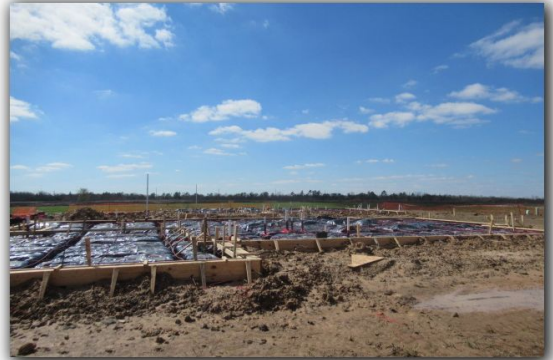
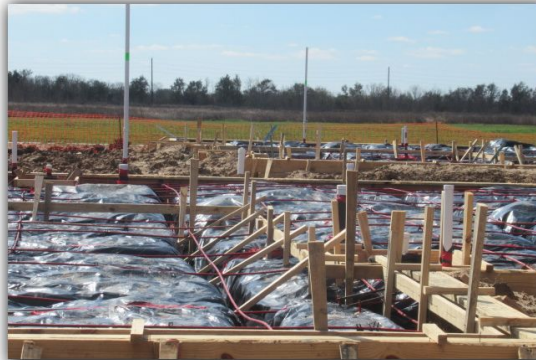
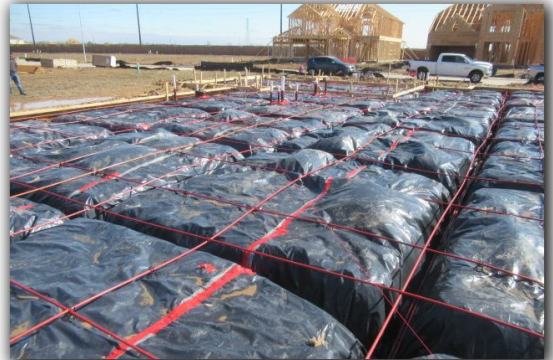
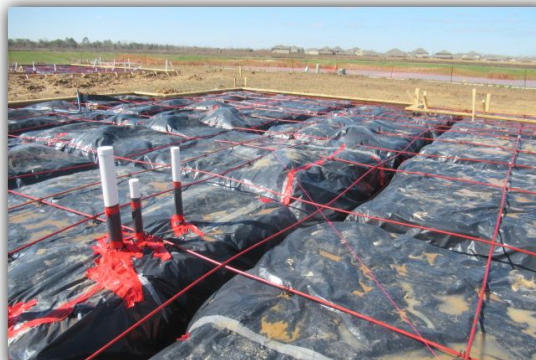
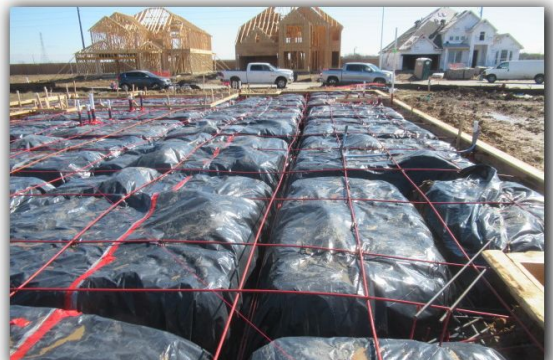
The overall construction of the forms and placement of the reinforcing steel has been done well.

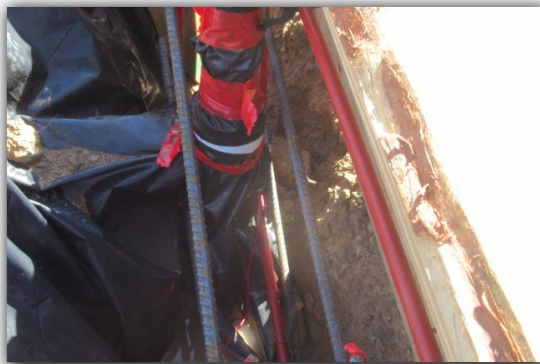
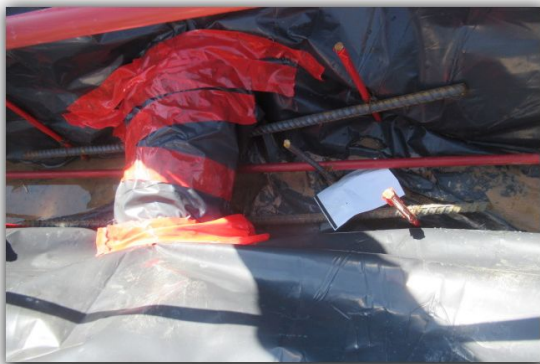
Tendon reinforcing cables are in contact or too close to plumbing drain pipes on the southeast side perimeter footing in the guest bathroom area and at an interior beam in the utility room/master bathroom area. These drain pipes must have a minimum of 1.5 inches clearance from the post tension cables to avoid possible damage to the drain lines.

It is recommended that the builder be consulted regarding the above issues for correction prior to the concrete being poured.

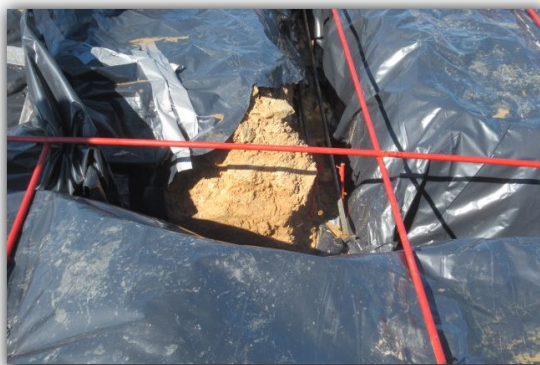
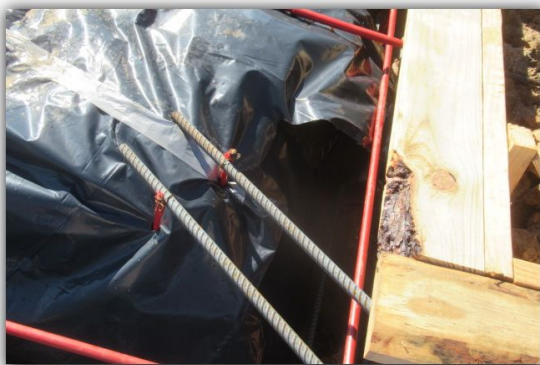
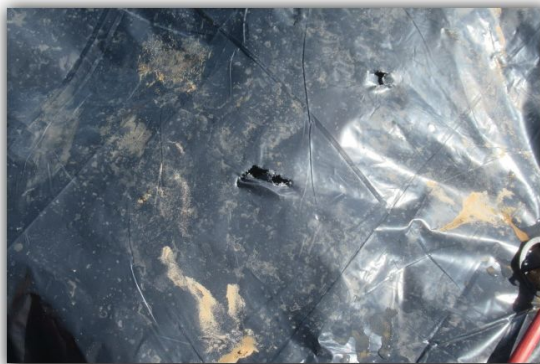
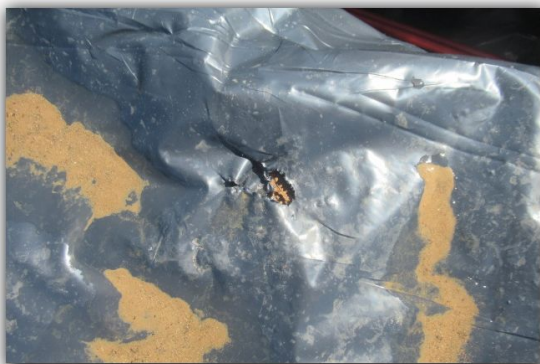
The moisture barrier is torn/incomplete in several areas and should be repaired before the concrete is poured.

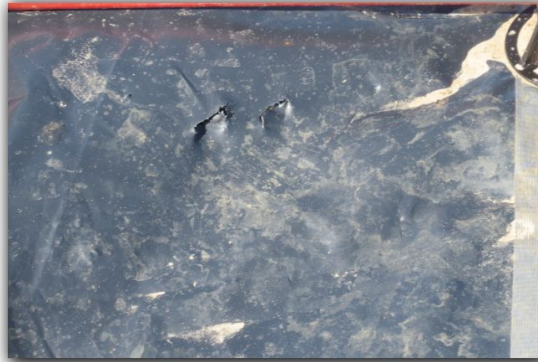
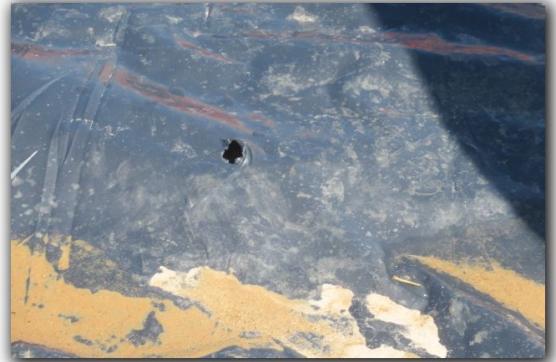
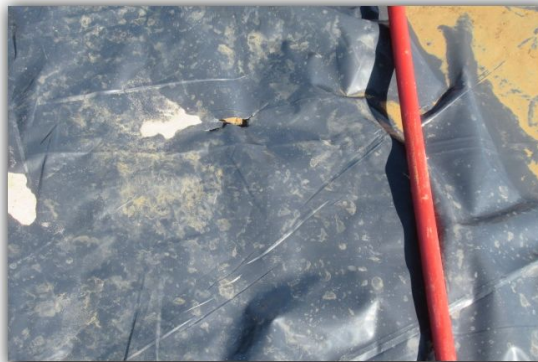
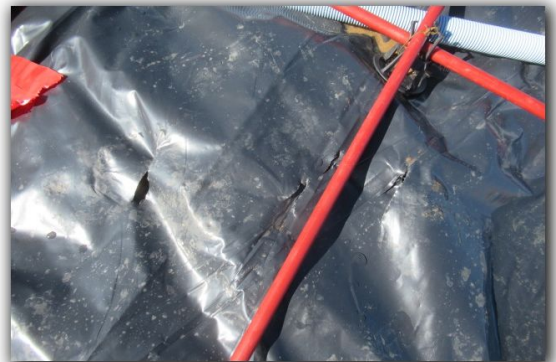
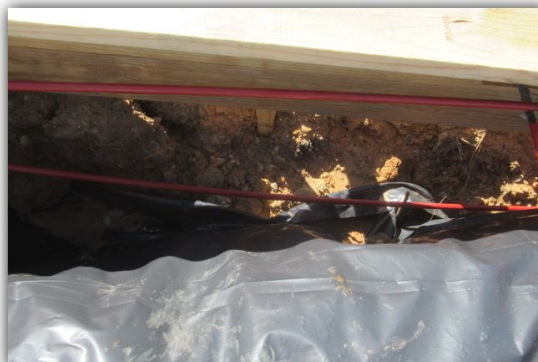
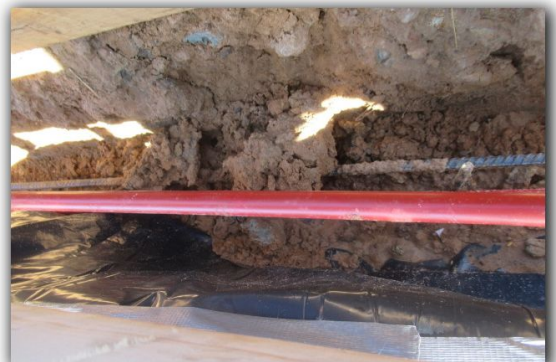
There is loose dirt/mud that needs to be removed in several areas of the perimeter footings to achieve a minimum of 26 inches of depth as is called for before the concrete is poured.

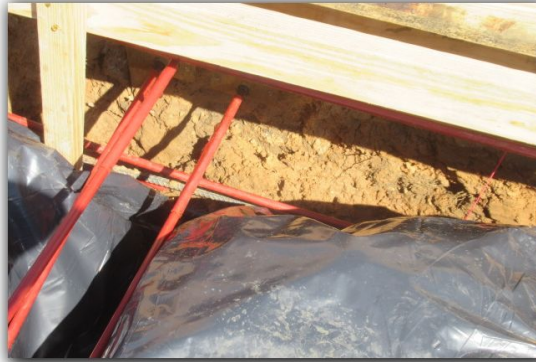
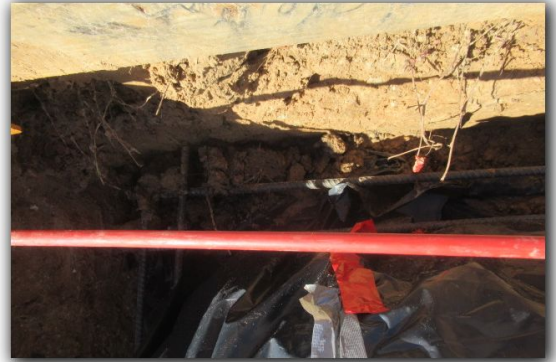
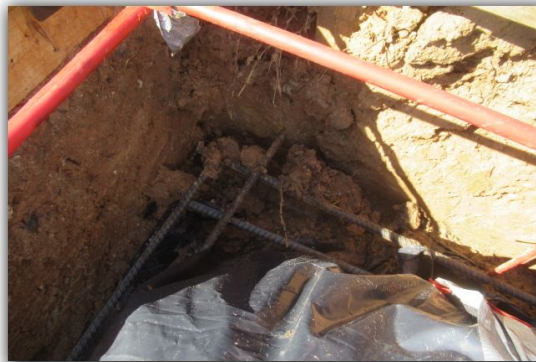
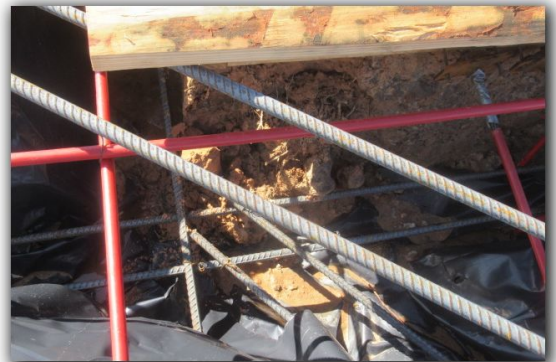
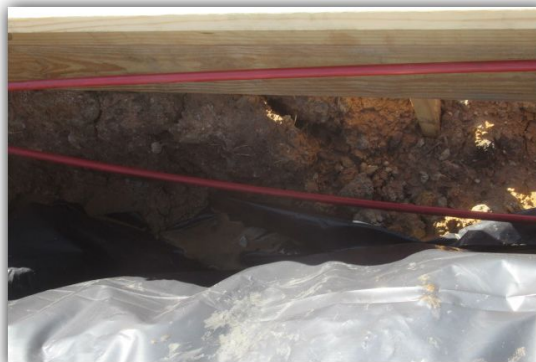
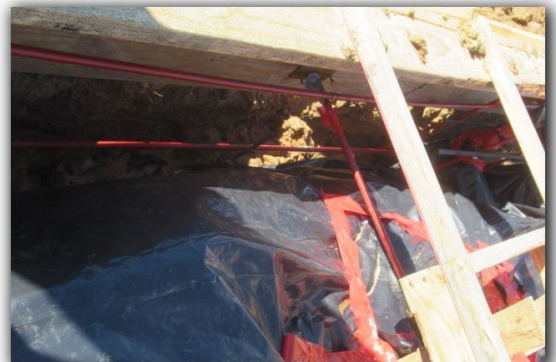
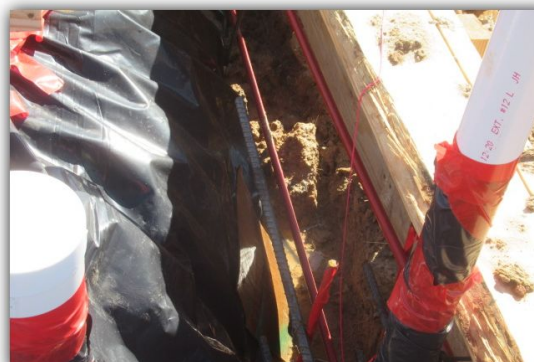
Several of the chair tendon cable spacers are damaged and need to be replaced and some were

not placed where needed.
