SAMPLE INSPECTION REPORT

# Seller Pre-Sale Inspection

Pasadena, Texas

Inspection performed October 3, 2026

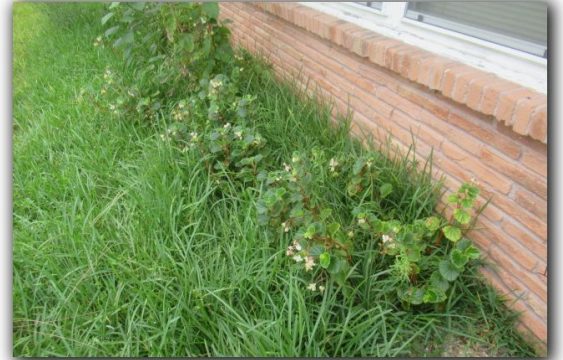
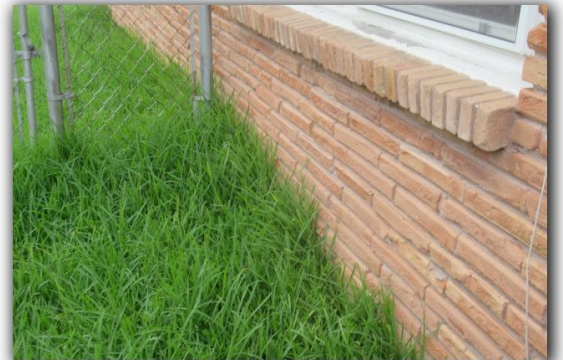
**Comments:** The soil levels are high in relationship with the interior of the home at the front, back and east side of the home. When soil levels are high against the face of the foundation it promotes water penetration of the structure and insect infestation. This item should be corrected so there is some exposure of the foundation face without creating reverse drainage. It is generally accepted that in an ideal situation, a brick veneer house should have about 4-6 inches of clearance. Wood siding houses should have more clearance.

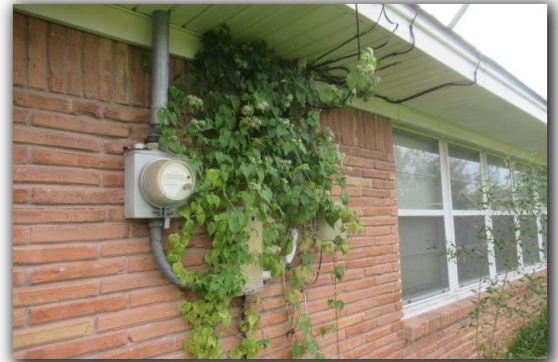
There was heavy foliage at the back of the home, therefore the face of the foundation and the brick walls in these areas were not visible. This condition will also hold moisture in these areas and may be conducive for insect activity. Cutting back the foliage in these areas is recommended.

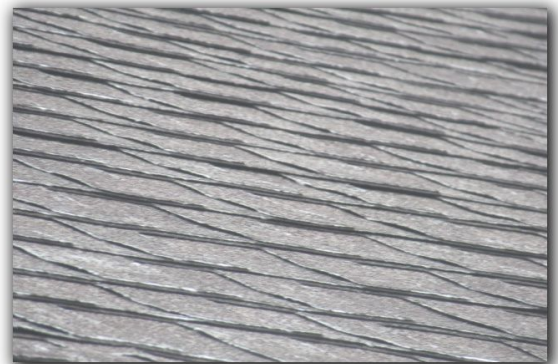
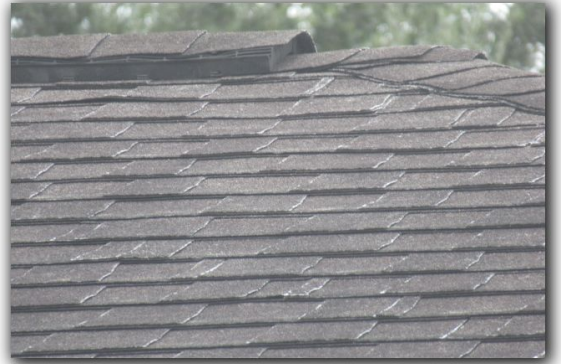
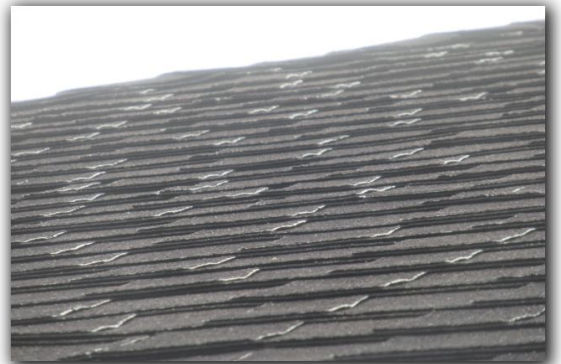
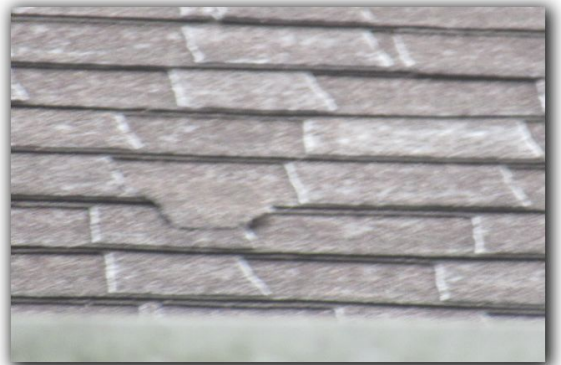
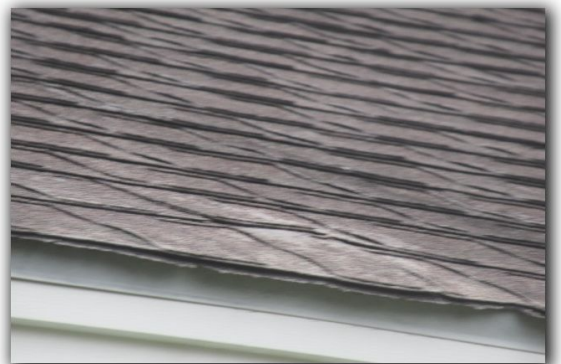
**Comments:** The surface of the roof is heavily worn/loss of aggregate and there are damaged shingles in some areas which is an indication that the shingles should be replaced in the near future.

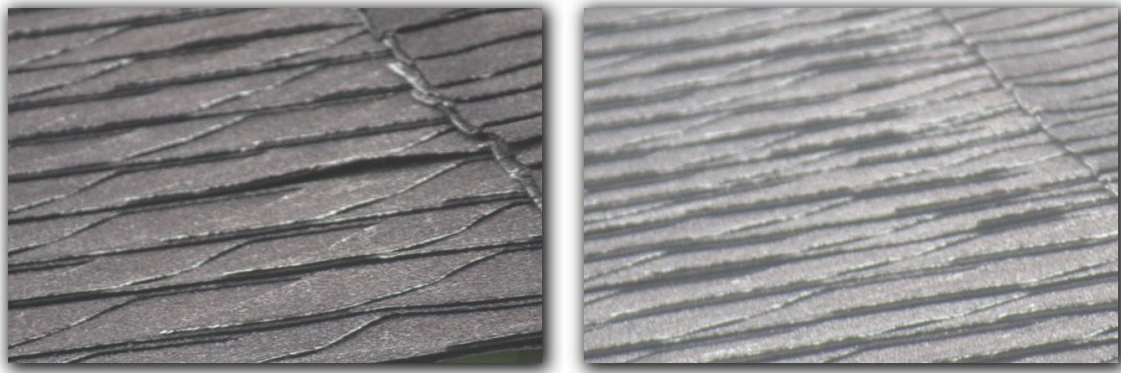
There are several lifted shingles that may be caused by nails backing out. A qualified roofing

contractor should be consulted regarding this condition.

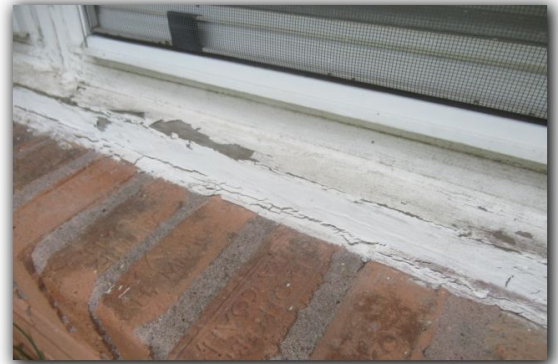
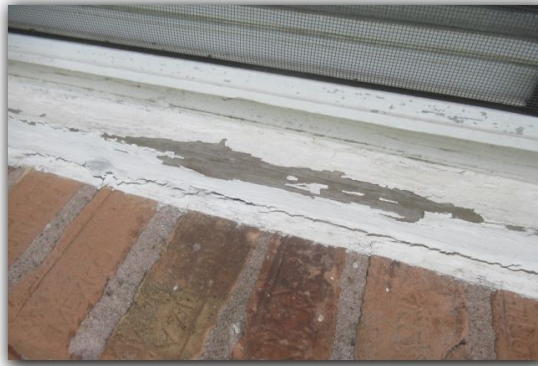
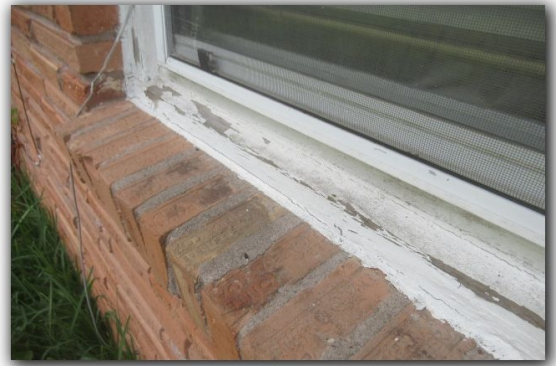
**Comments:** The exterior paint was peeling at several of the windows. Exposed or weathered wood is considered a conducive condition for wood decay and water penetration. It is recommend consulting a painting contractor so a course of corrective action can be further evaluated.

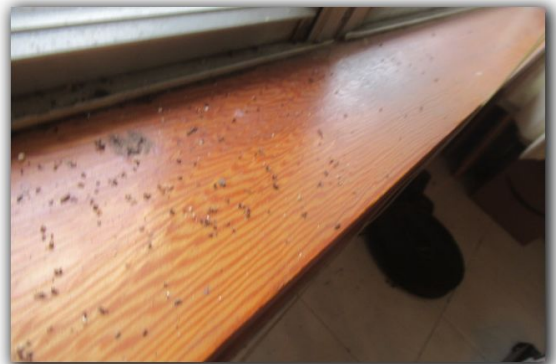
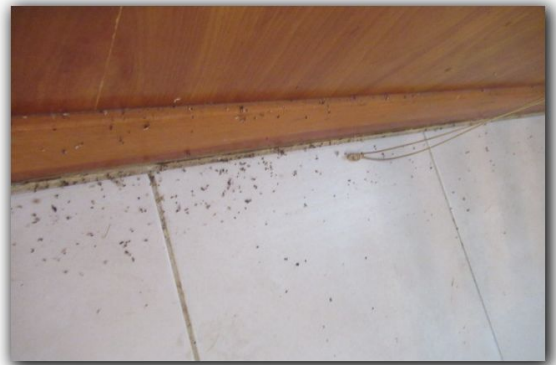
Evidence of insect infestation was observed at the back wall of the dining room. A licensed pest control company should be consulted so a corrective course of action can be evaluated. This inspection will only reveal visible structural damage. Hidden damage is a possibility. All damaged material should be repaired or replaced.

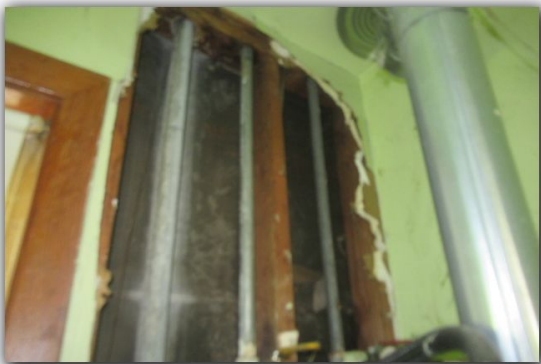
There was damaged/incomplete sheetrock in the utility room area at the back wall of the garage. All damaged elements should be replaced.

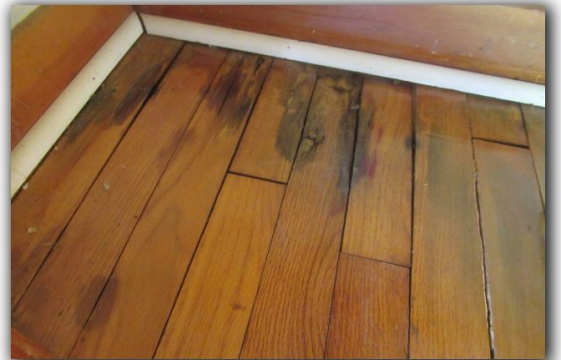
**Comments:** There is water damage to the hardwood flooring in the middle bedroom closet that is behind the master bathroom shower. This condition is an indication that the master bathroom shower leaks or has leaked in the past. Hidden damage is a possibility. All damaged material should be repaired and or replaced. A qualified contractor should be consulted regarding this condition.

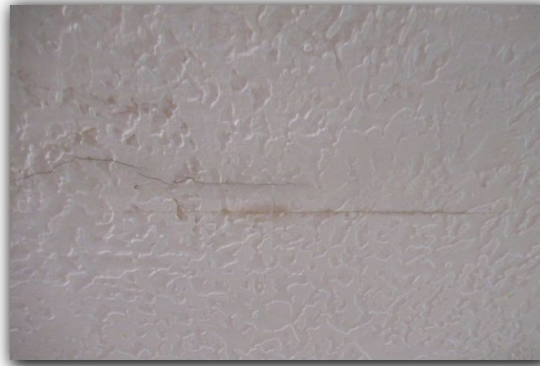
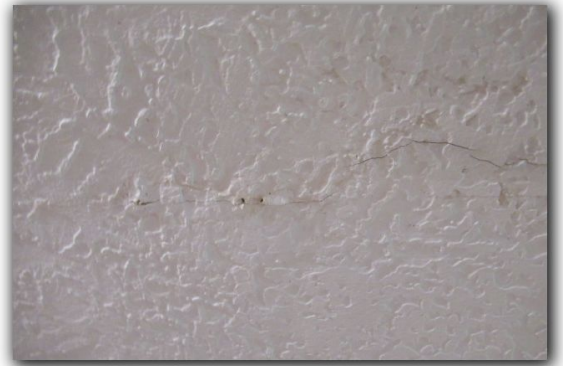
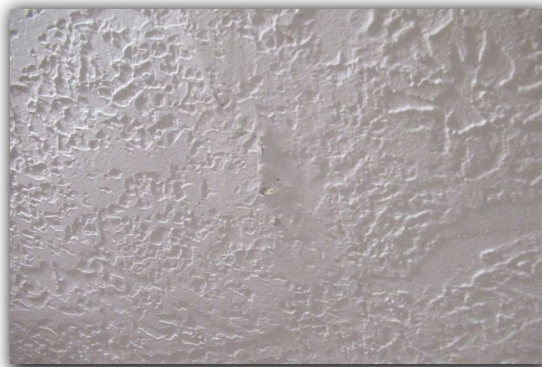
There was evidence of water penetration (water stains and damaged sheetrock) on the ceiling in the kitchen. These areas were dry when tested. Leaks can cause hidden or concealed damage. All damaged elements should be repaired or replaced. The reason for the water penetration is unknown. This/ these areas should be monitored, especially during heavy rain, to determine if there is an active leak.

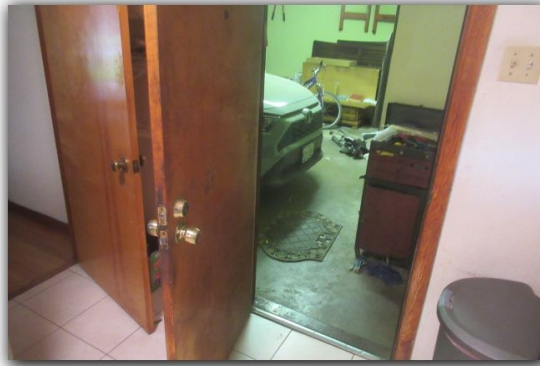
The back door off the garage is not weather stripped.

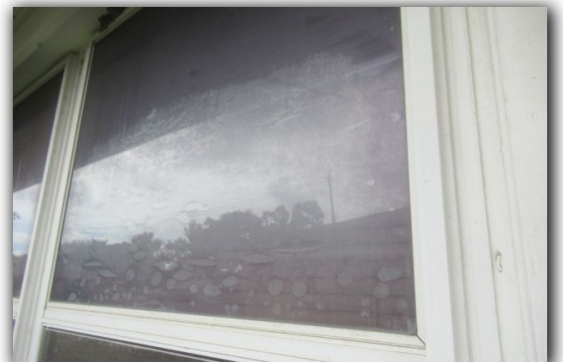
**Comments:** Thermo pane windows appear to have lost their seal as there is discoloration and moisture stains between some of the glass panes where visible.

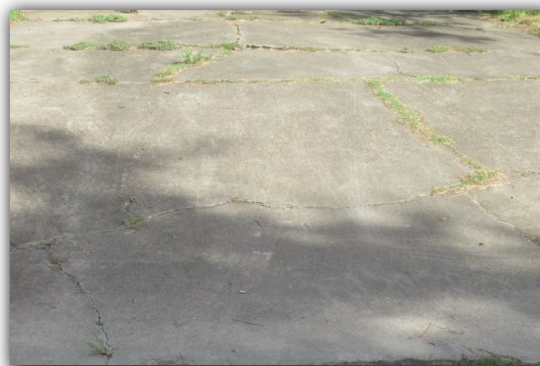
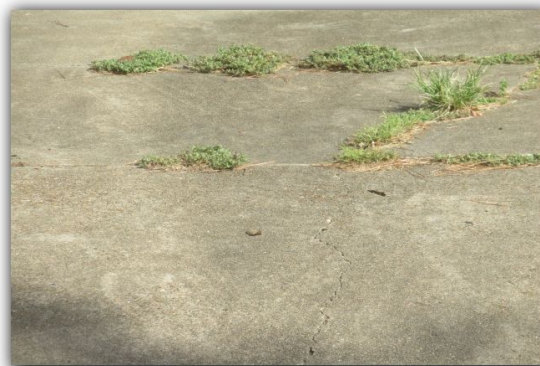
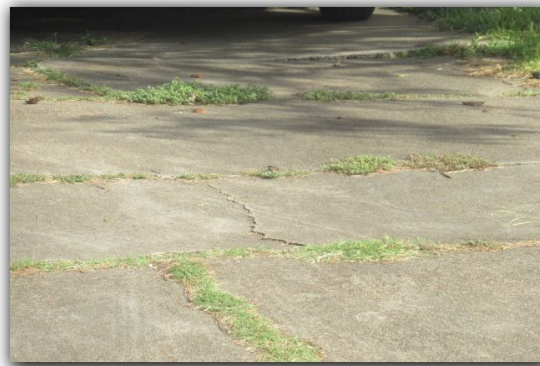
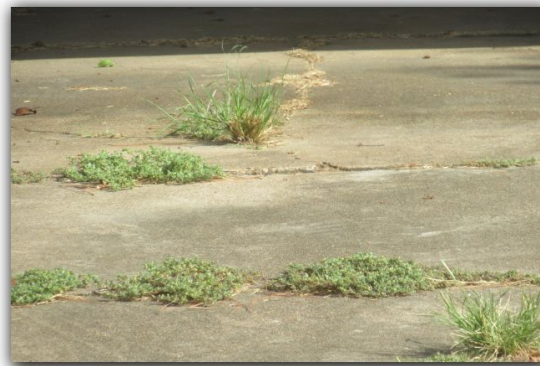
**Comments:** Driveway sections have cracked and lifted/settled unevenly.

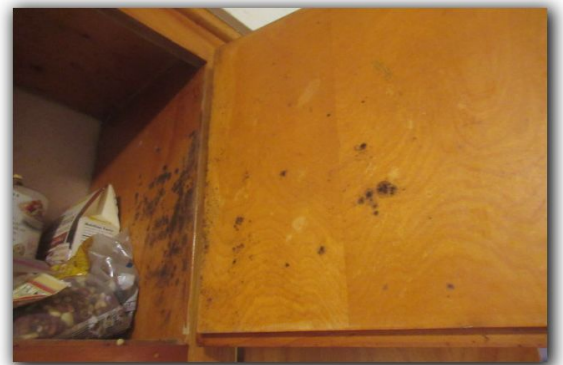
There is discoloration that may be mold inside the cabinet above the vent hood in the kitchen. This area was dry at the time of the inspection. The reason for this condition was not determined. A separate mold inspection would be necessary to determine if this condition has caused mold growth that may be a health concern.

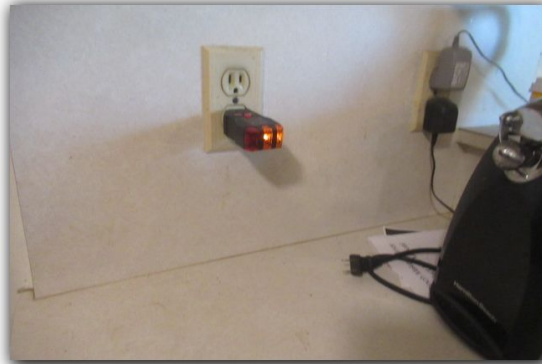
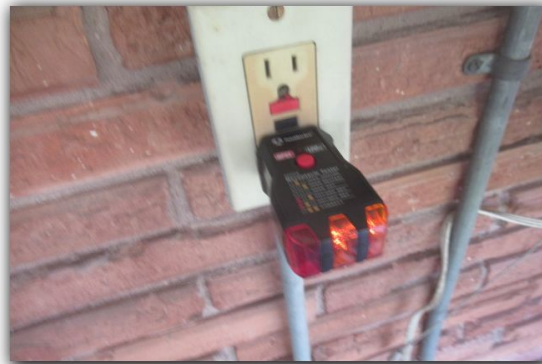
**Comments:** Outlets in the home are not protected by G.F.C.I. (Ground Fault circuit interrupt) breakers. This is required statement by the T.R.E.C.. G.F.C.I. Breakers are required for all outlets within 6' of any water source inside the house, bathrooms, wet bars, or utility room sinks, all exterior outlets, all outlets in the kitchen and all outlets in the garage.

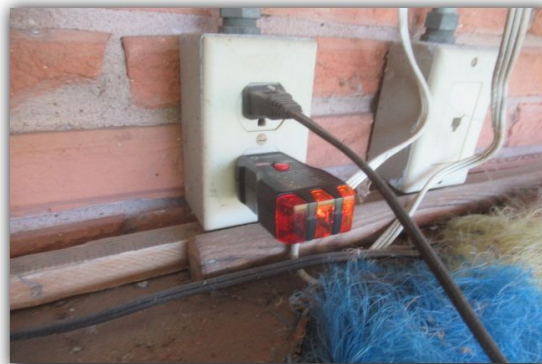
The G.F.C.I. outlet in the back of the home did not trip off when tested. This outlet should be replaced to provide proper protection.

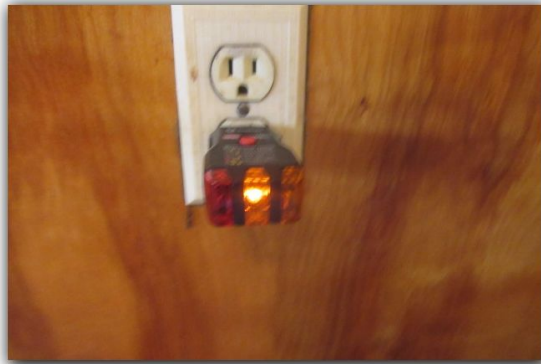
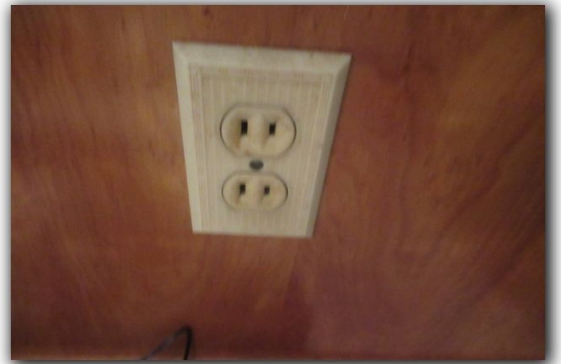
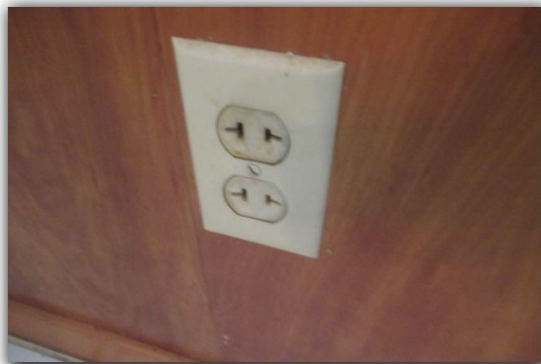
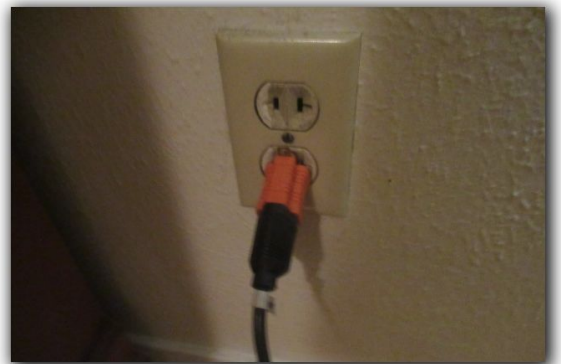
Most all of the outlets in the home are not grounded. I recommend having this corrected/serviced by a licensed electrician.

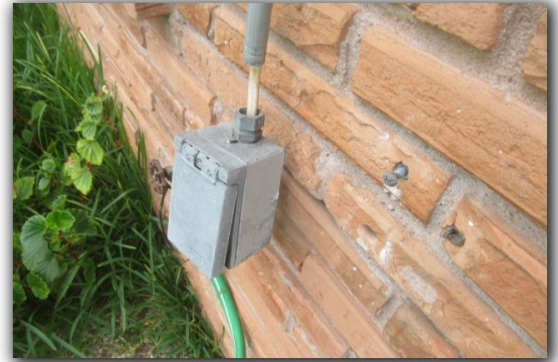
A light fixture and an electrical outlet are not secured in the back of the home and the protective conduit is not complete at the outlet.

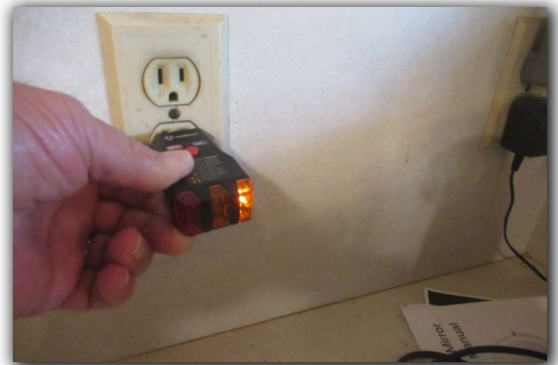
Several of the electrical outlets in the home are loose and need to be secured to avoid possible loose connections/electric shorts.

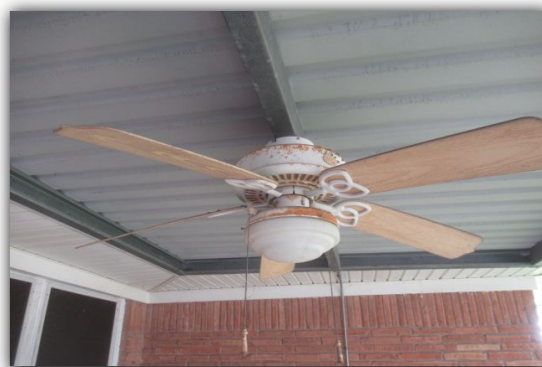
The front porch ceiling fan did not operate as intended.

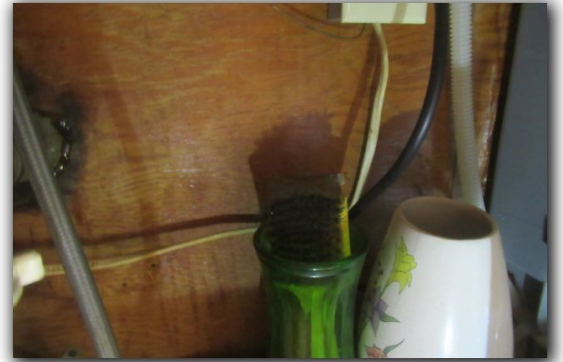
There is exposed wiring that is not installed in protective conduit as is required inside the kitchen sink cabinet.

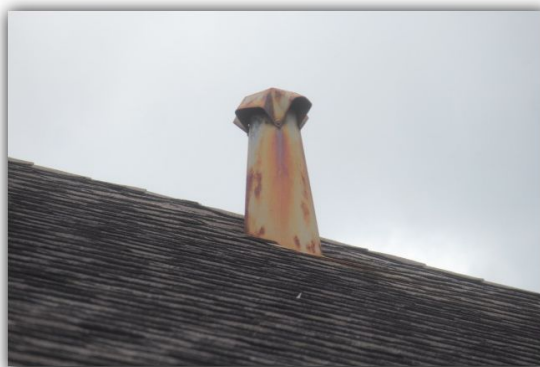
The furnace flue pipe is not terminated with the proper appliance cap on the roof.

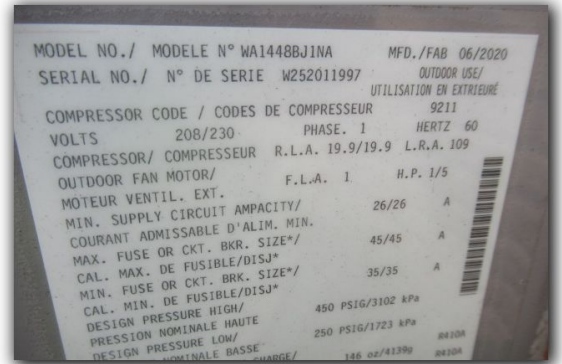
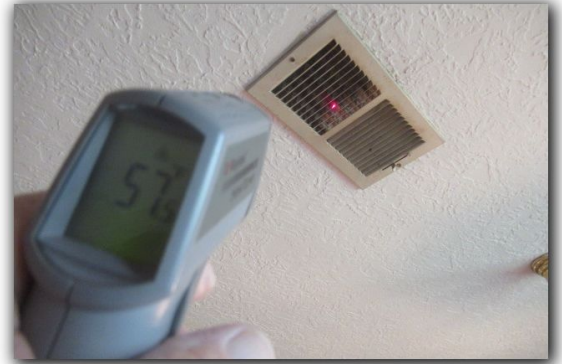
**Differential Air Temperature Drop During Operation:**  
**Air Going Into System: 76 f Returned Air: 57 f**

The air coming out of the vents should be 14 to 21 degrees cooler than where it goes into the cold air return. These readings are within the recommended tolerances for proper operation.

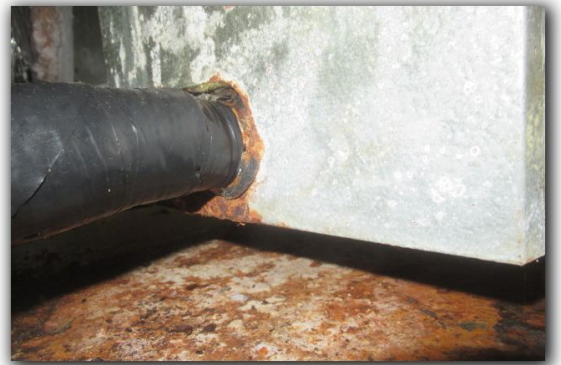
There was corrosion in the safety pan and on the bottom of the coil box. This condition is an indication that the system has leaked in the past or leaks during heavy use.

A qualified HVAC technician should be consulted regarding the repair of the above items as well as check the entire cooling system for any other possible defects.

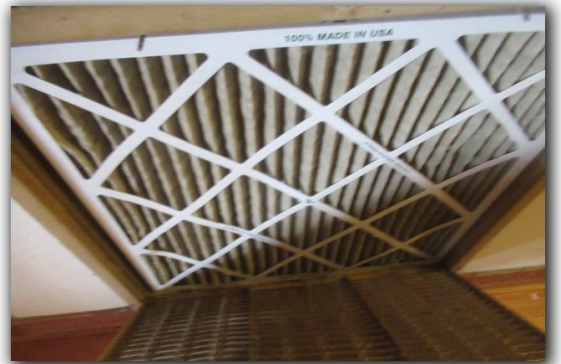
**Comments:** The filter and the return air chase are dirty. Proper filtering of the air is important. A defective filtering system can lead to dirty evaporative coils and allergy problems. It is a good idea to change these filters every month or as suggested by the manufacturer.

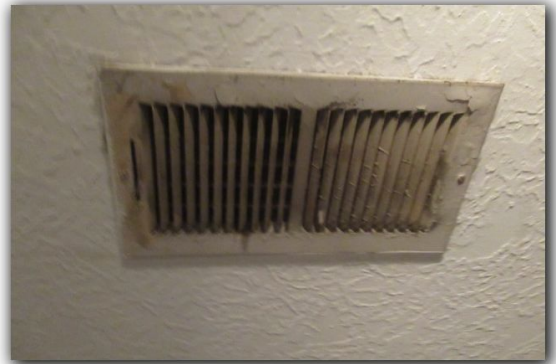
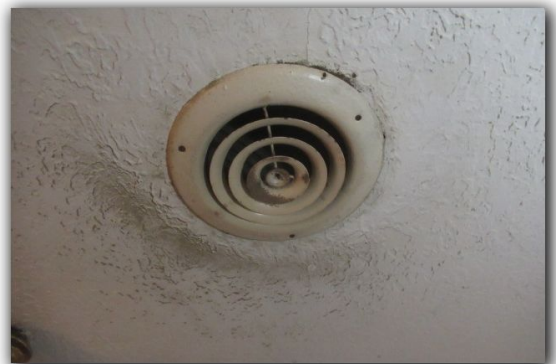
There is dark discoloration on several of the HVAC vent covers.

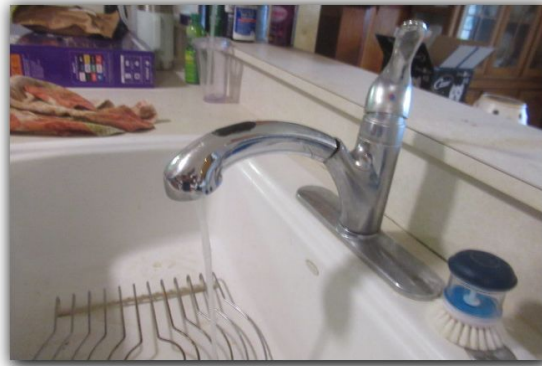
The water pressure was low at the kitchen sink. There is no guideline for flow rates. If the water pressure appears to be very low, it is mentioned in this report. As there are several causes for low water pressure, a licensed plumber should service the utility.

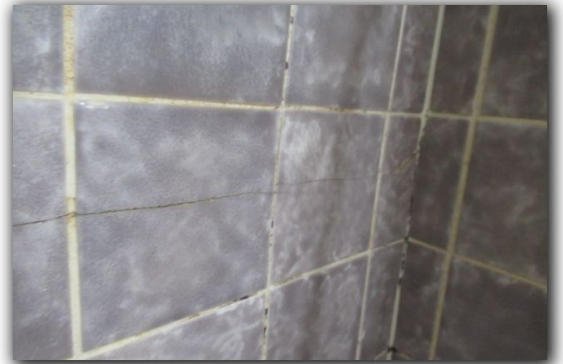
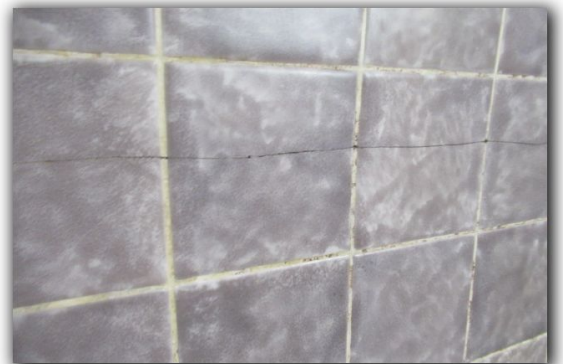
There are cracked tiles in the hall bathtub/shower surround. A qualified tile contractor should be consulted regarding this condition.

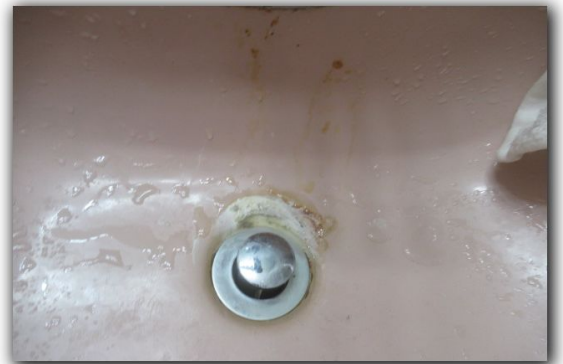
There is corrosion on both of the bathroom sinks.

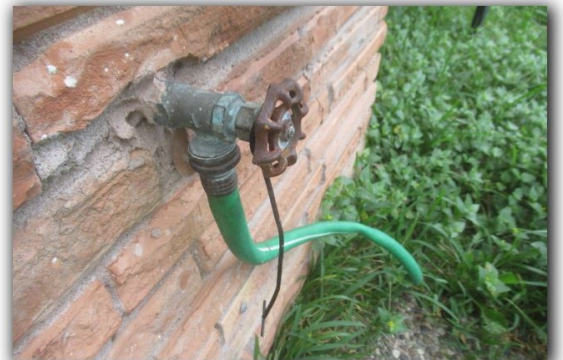
The exterior faucets do not have back flow protectors. Anti-siphon devices keep contaminated water from entering the potable water of the house plumbing. These devices are inexpensive, easy to install, and can be found in most home improvement stores.

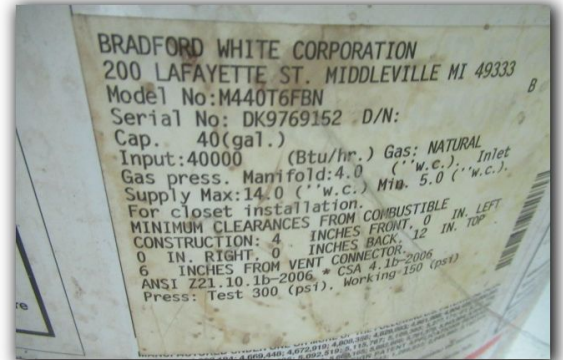
**Comments:** The water heater was not elevated above the floor. It is required that the water heater be elevated 18" above the floor. The combustible gases from a possible gas leak and even some solvents are heavier than air. Proximity of an ignition source poses a definite fire concern.

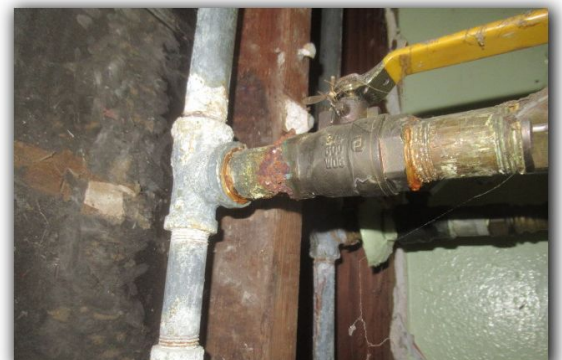
There was corrosion at the water supply lines/valve of the water heater. It is recommended that these fittings be replaced whenever possible to prevent future leaks.

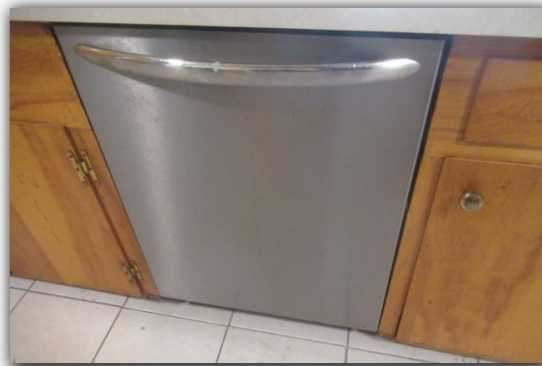
**Comments:** The dishwasher performing properly when tested during this inspection, although it was reported by the occupant that water leaks from the door seal sometimes during operation.

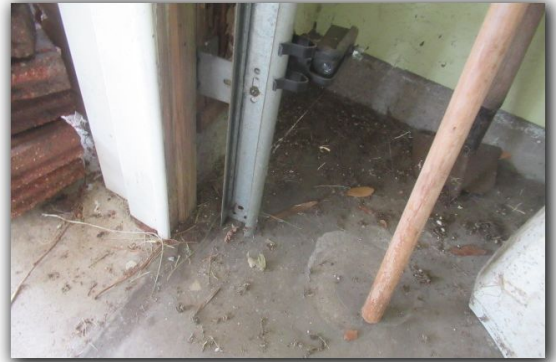
The laser reversing eyes for the west side overhead garage door are higher than 6 inches from the garage floor which could cause injury or damage to property.

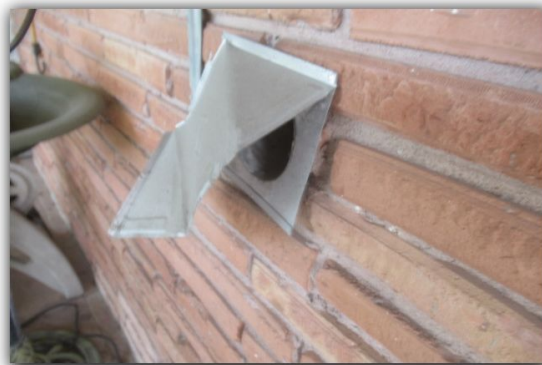
**Comments:** The exterior dryer vent wall cap was not sealed or secured to the wall as it should be in order to prevent possible water penetration to the structure and is damaged.
