SAMPLE INSPECTION REPORT

# Waterfront Elevated Home

Hitchcock, Texas

Original inspection: August 28, 2026

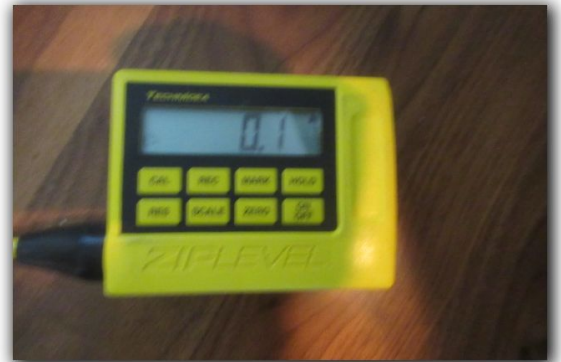
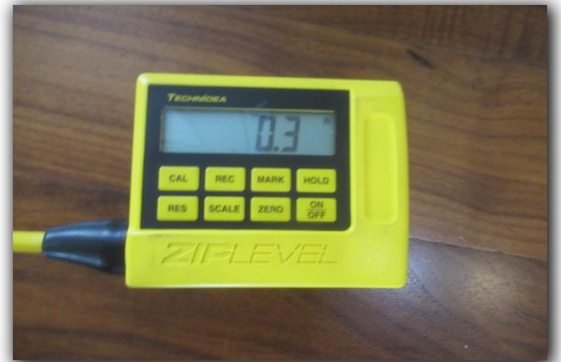
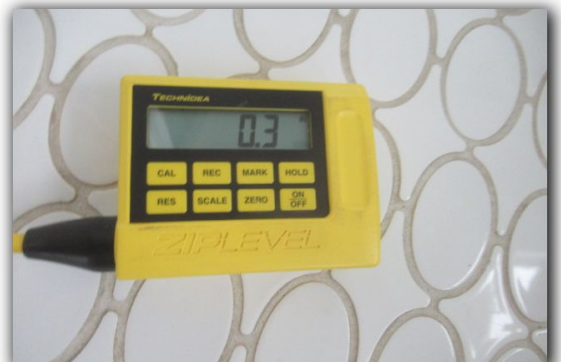
**Comments:** In my opinion the foundation is performing as it was intended at this time, when measured it was well within allowable tolerances.

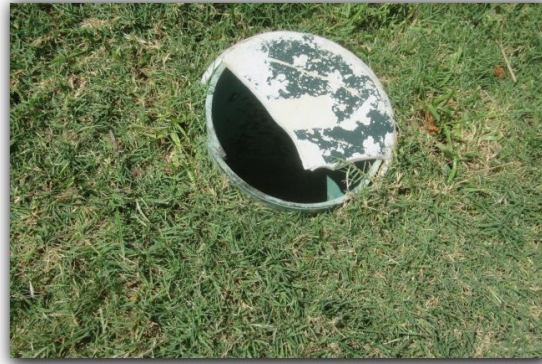
**Comments:** A cover for what appears to be part of the yard drain system is damaged/incomplete in the southwest front yard.

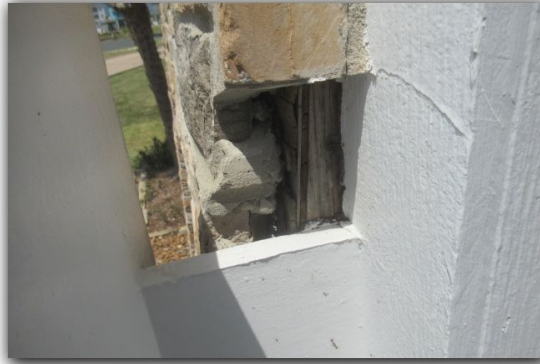
**Comments:** The exterior siding is not complete at the front staircase landing area which has caused some damage to the sheathing behind the stones. All damaged material should be repaired and or replaced. Hidden damage is a possibility.

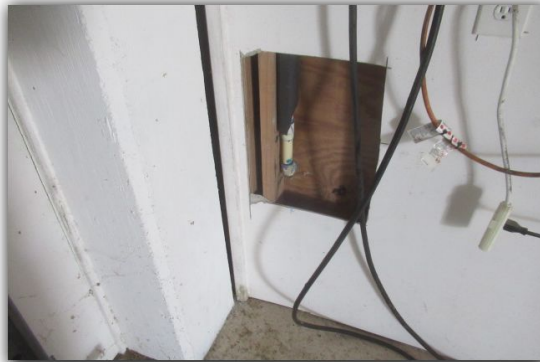
There was damaged/incomplete sheetrock in the north side garage that should be repaired/replaced.

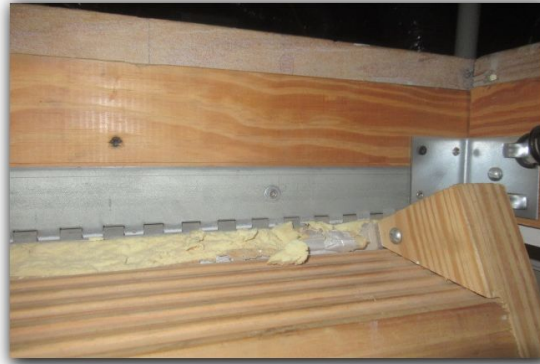
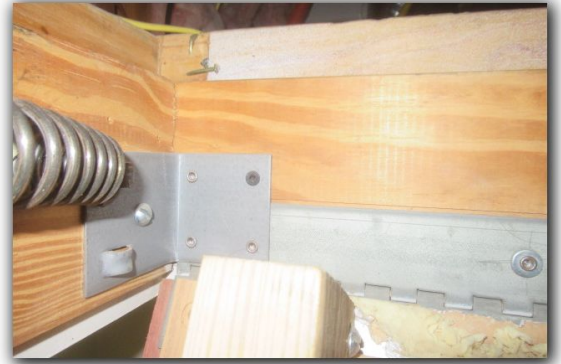
**Comments:** The attic access ladder is installed with drywall/decking screws. Drywall screws should not be used as that their use can cause "sudden and catastrophic failure". 16d nails or 1/4" x 3" lag screws as the only acceptable fasteners. The nails can easily be added without even removing the screws.

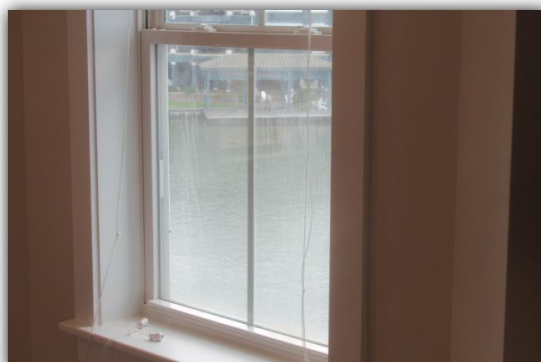
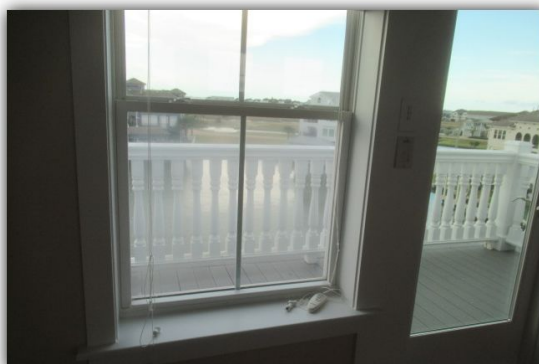
**Comments:** Double pane windows at the third level bedrooms and one of the fourth level windows appear to have lost their seal which is causing discoloration between the glass panes.

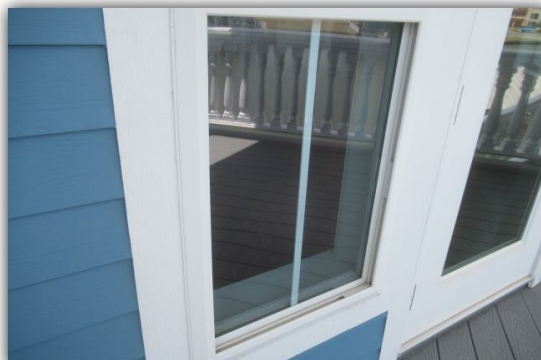
Window screens were missing. Screens are mentioned in this part of the report as they are a specific item in the T.R.E.C. Guidelines. All windows that have channels for screens should have them installed.

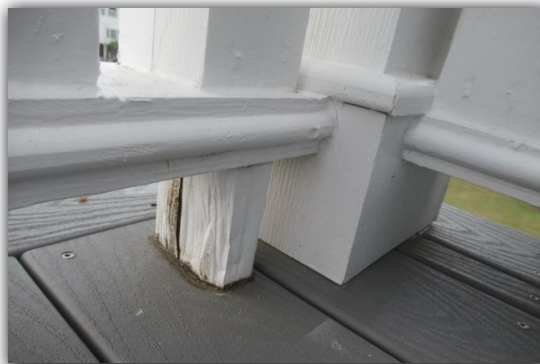
**Comments:** There is water damage to the fourth level deck handrail. All damaged material should be repaired and or replaced.

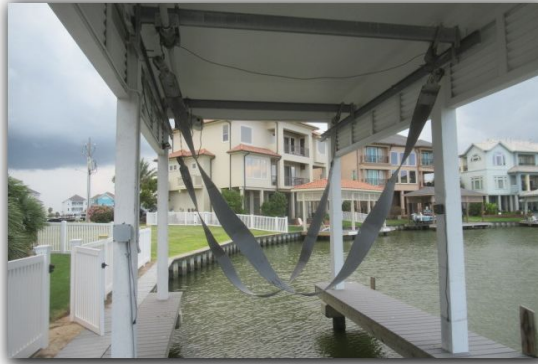
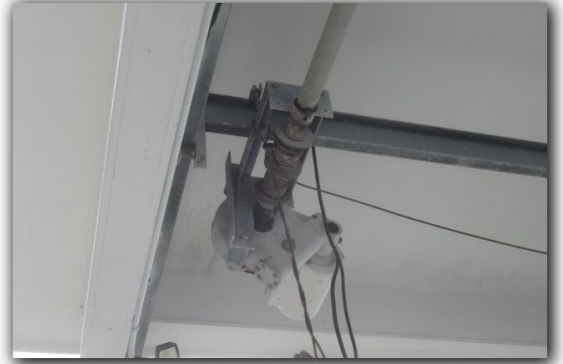
**Comments:** The boat lift did not operate as intended. A qualified contractor should be consulted regarding the repair of this lift system.

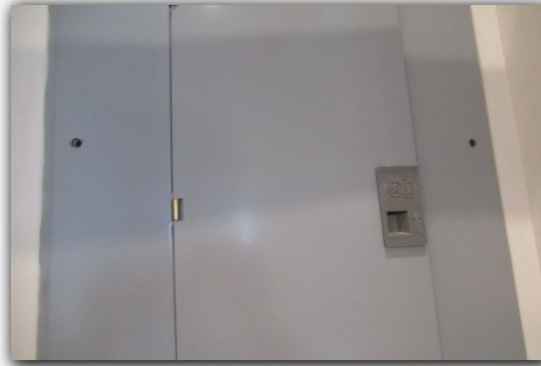
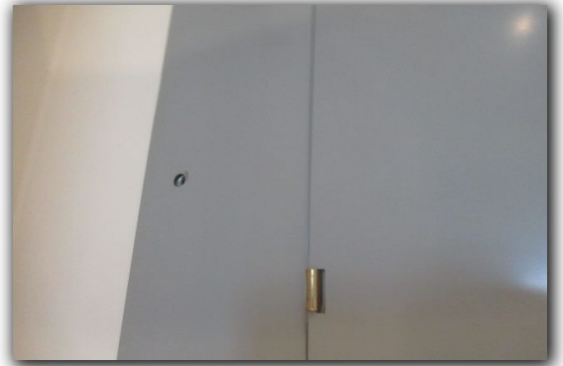
**Comments:** Dead front securing screws were missing at the sub panels.

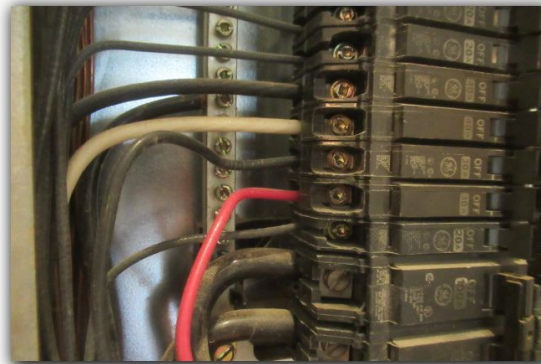
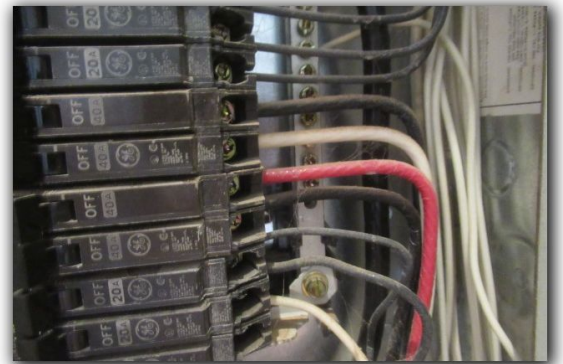
White wires were used as a "hot" wire and are connected to a circuit breaker in sub panel #1. In most instances the white wires are the grounded conductors, and if they are used as a "hot" wire, they must be wrapped with black or red tape to identify them as a "hot" wire.

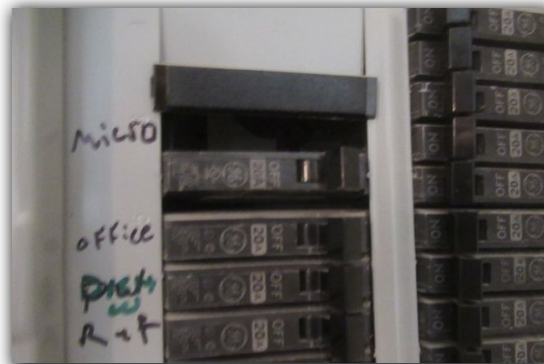
One of the panel knock-outs is missing in the sub panel #1. This condition is considered a safety concern and is an item that is specifically checked in a real estate inspection.

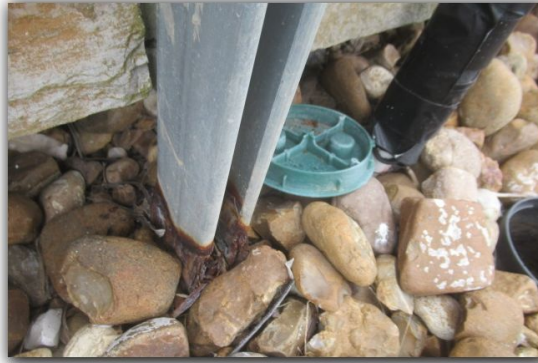
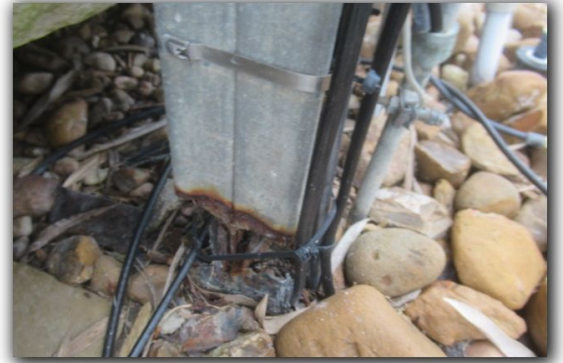
There heavy corrosion on the metal supports for the main breaker and meter boxes on the north side of the home.

A licensed electrician should be consulted regarding the repair of the above items as well as check the entire electrical system for any other possible defects.

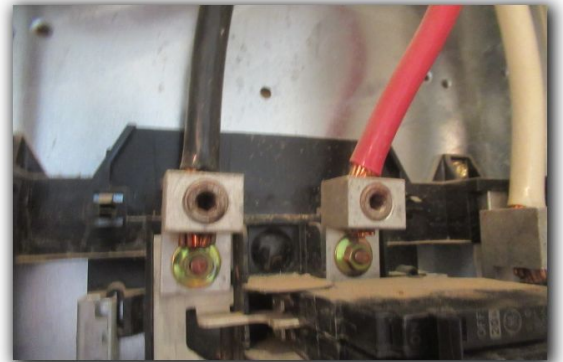
Service entrance barriers have not been installed over the main electric cables inside of the breaker boxes.

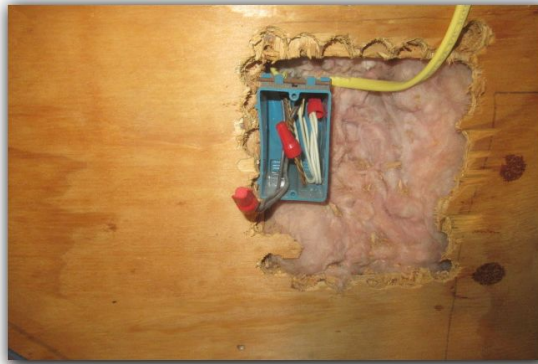
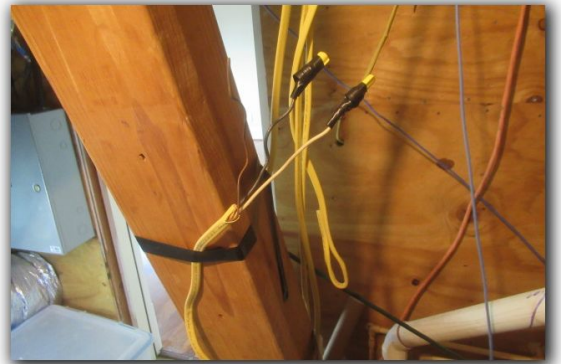
**Comments:** Wires were improperly spliced terminated in the attic. Wire ends or splices should be in junction boxes that are properly mounted with cover plates. This condition is considered an electrocution/fire concern and should be serviced by a licensed electrician.

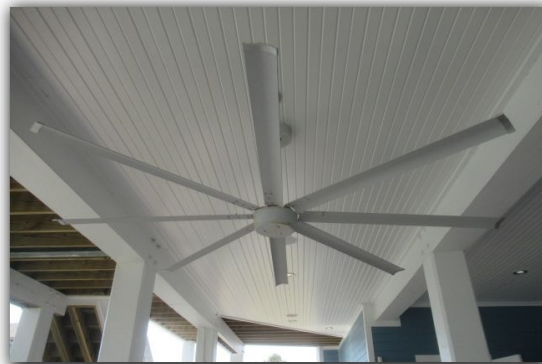
The ceiling fan at the first level patio did not operate at the time of the inspection.

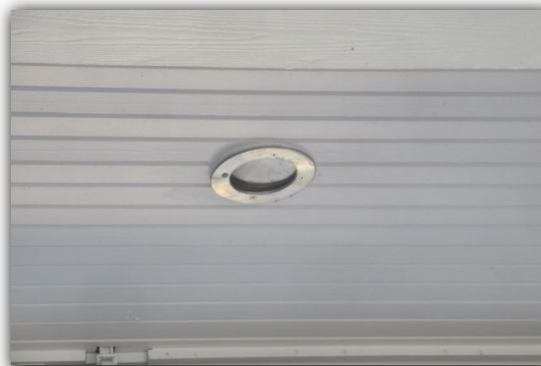
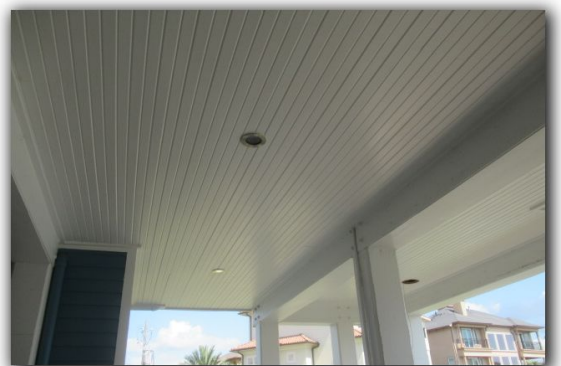
Several of the lights were not working. This condition may be a result of a need for light bulb replacement. After bulb replacement it is recommended that their operation is rechecked to determine any other possible issues.

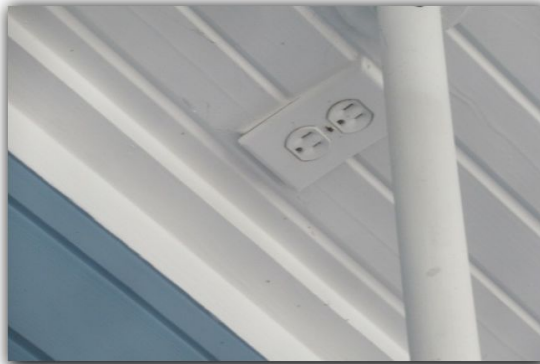
All exterior outlets should have weather guard cover plates installed to protect them from water penetration and possible electric shorts.

A licensed electrician should be consulted regarding the repair of the above items as well as check the entire electrical system for any other possible defects.

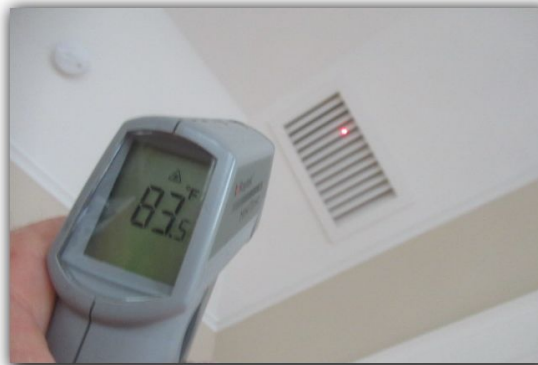
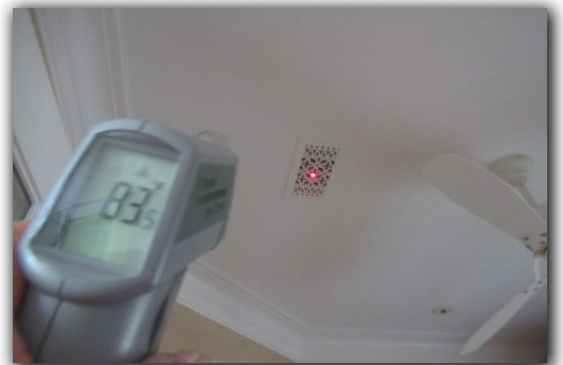
**South side Zone Air Going Into System: 83 f Returned Air: 83 f**

**Comments:** The south side zone system was not cooling as intended. The air coming out of the vents should be 14 to 21 degrees cooler than where it goes into the cold air return. It is recommended that a qualified contractor be consulted regarding this matter.

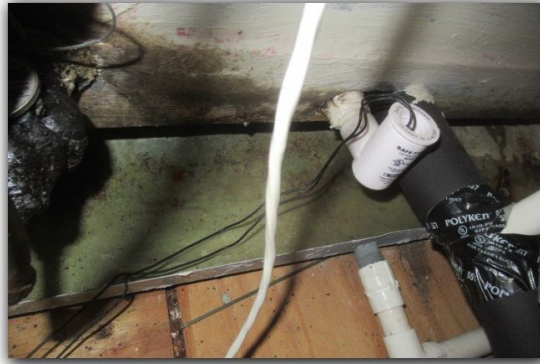
Water was observed in the safety pan under the evaporator coil box in the 4th level attic area. This condition can cause severe damage if the safety pan was to overfill. A licensed technician should address this situation as soon as possible.

A qualified HVAC technician should be consulted regarding the repair of the above items as well as check the entire cooling system for any other possible defects.

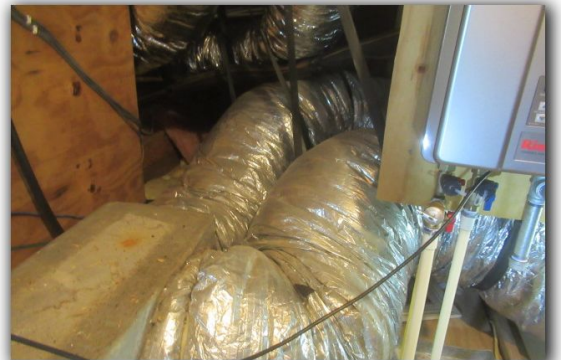
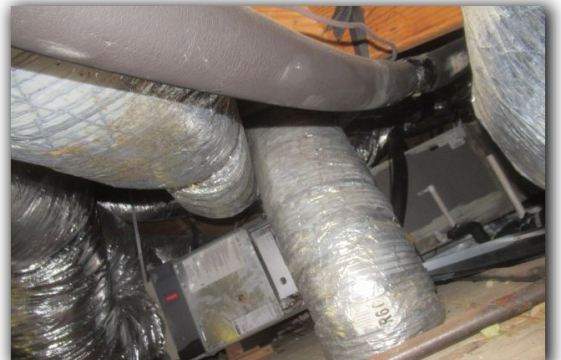
**Comments:** Ducts in the attic area are in contact with each other which may cause condensation and damage to the outer coating. These ducts should be separated a minimum of one inch or unfaced insulation placed between them.

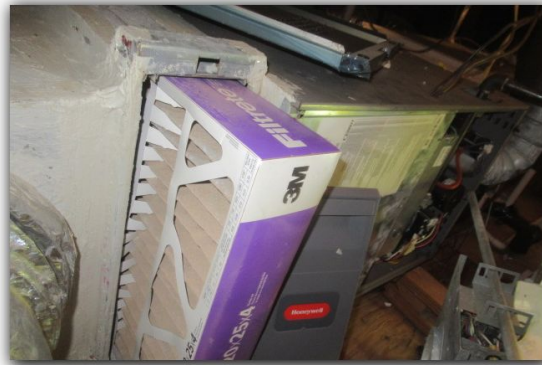
The media filters were dirty. Proper filtering of the air is important. A defective filtering system can lead to dirty evaporative coils and allergy problems. It is a good idea to change these filters as suggested by the manufacturer.

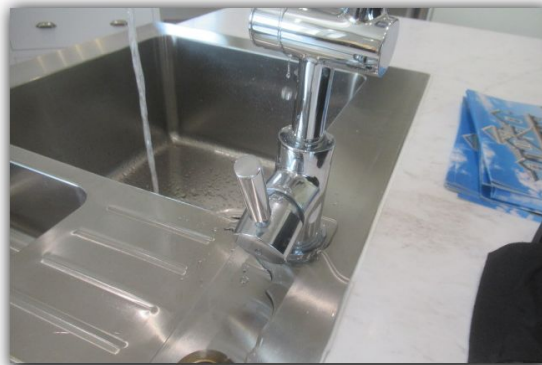
**Comments:** There is a leak at the kitchen sink faucet. Leaks can promote water penetration to the structure. Concealed damage is a possibility. The faucet should be serviced and any damaged elements replaced or repaired.

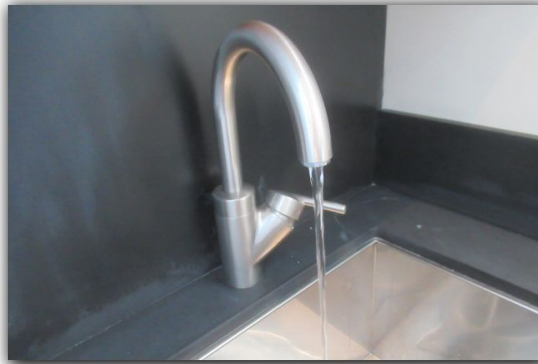
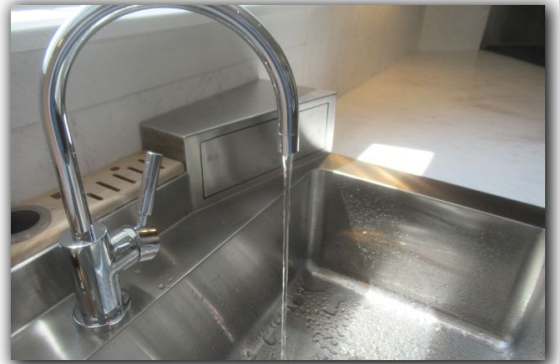
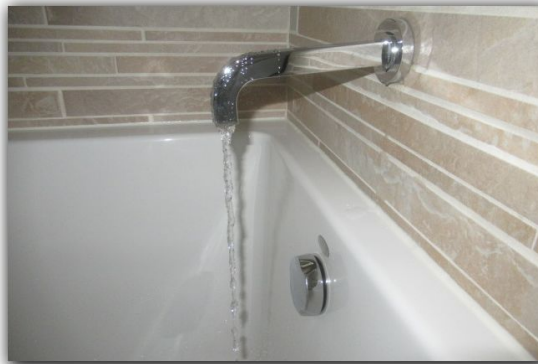
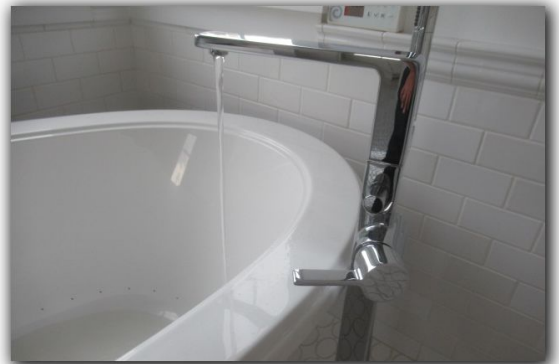
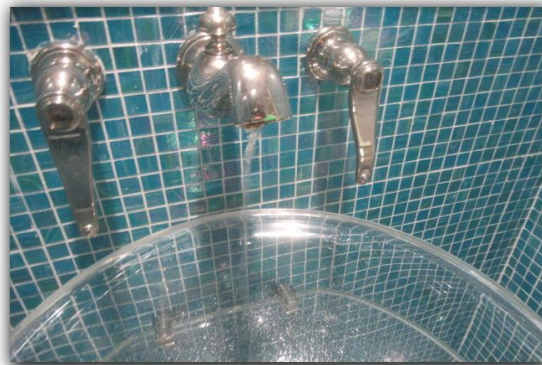
The water pressure was low at the small window sink in the kitchen, the 3rd level south side bathtub/shower, the half bath sink, the utility room sink and the master bathtub. There is no guideline for flow rates. If the water pressure appears to be very low, it is mentioned in this report. As there are several causes for low water pressure, a licensed plumber should service the utility.

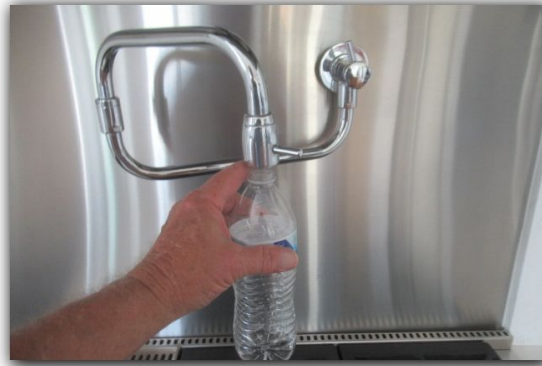
The pot filler spout at the range in the kitchen did not operate when tested.

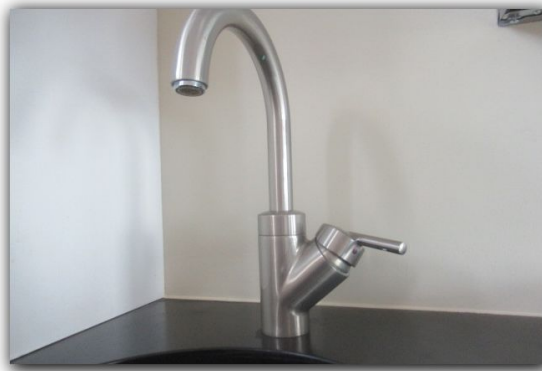
The water supply was turned off to the 4th level bar sink.

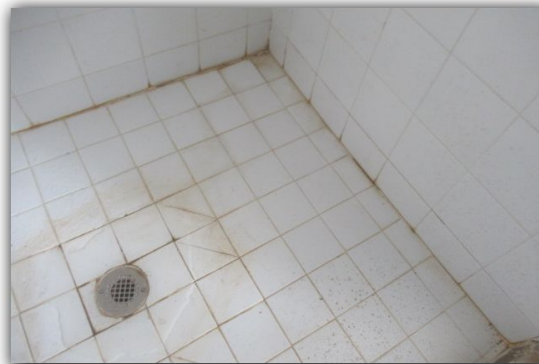
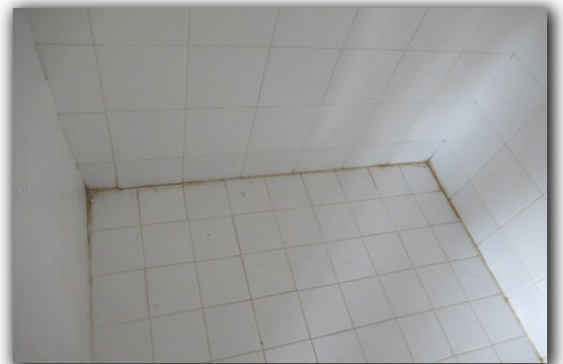
There were voids/cracks in the grout of the 1st level tile shower surround. It is recommended that this shower be well cleaned and re-sealed.

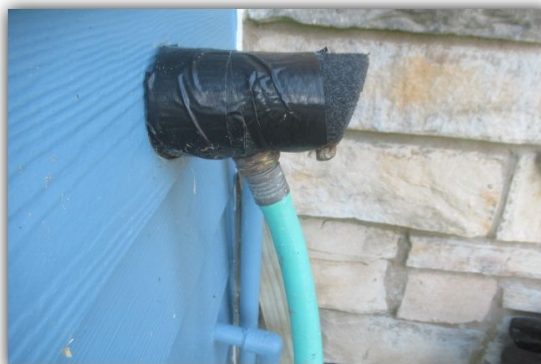
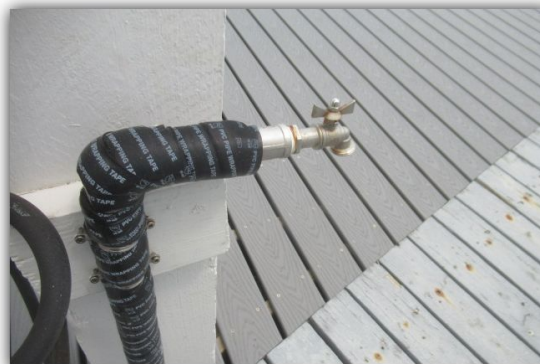
All exterior faucets should have back flow protectors installed. Anti-siphon devices keep contaminated water from entering the potable water of the house plumbing. These devices are inexpensive, easy to install, and can be found in most home improvement stores.

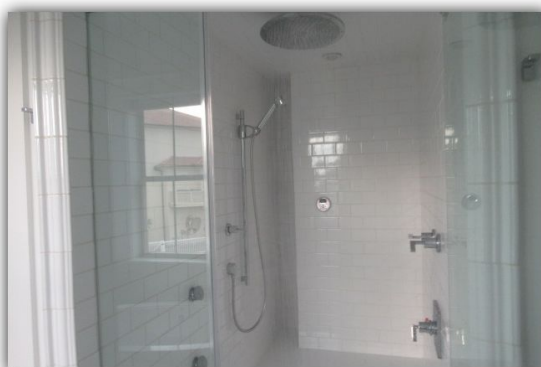
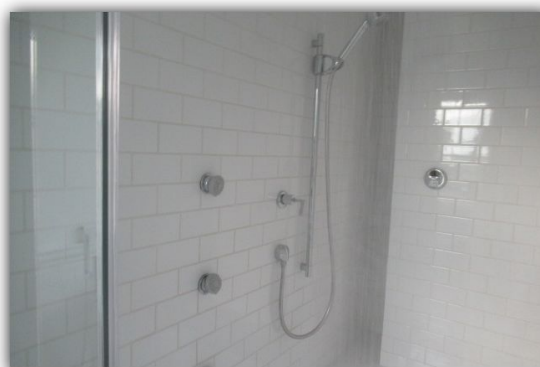
It was not determined how to operate the body sprays, the hand held shower and the steam feature in the master bath shower.

A qualified plumber should be consulted regarding the repair of the above items as well as check the entire plumbing system for any other possible defects.

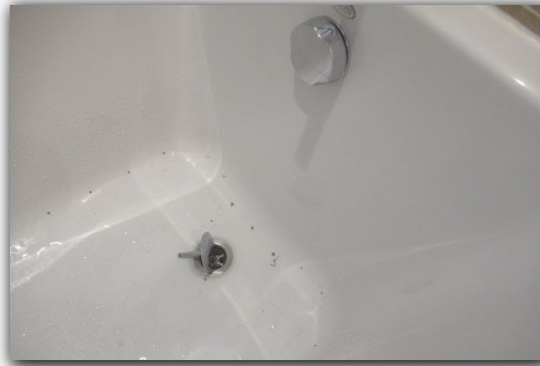
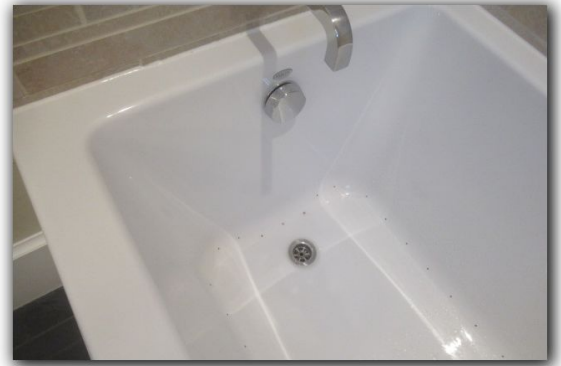
**Comments:** The drain stops were not operating properly in the 3rd level bathtubs. Sometimes a drain stop can be adjusted or it may need to be replaced.

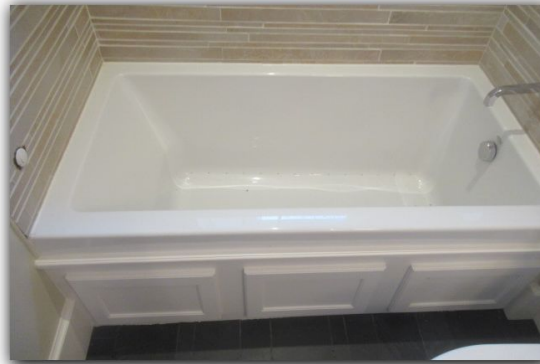
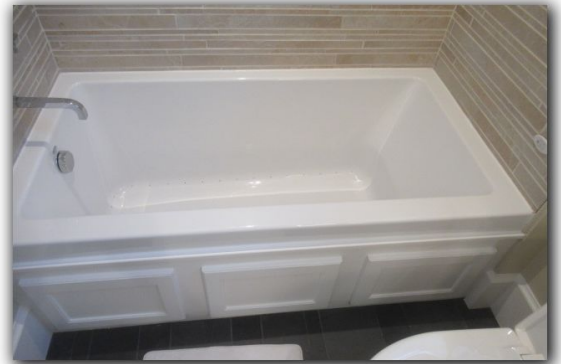
It is recommended that there be inspection ports provided for all bathtub/showers so that it is possible to check for leaks, as well as for service to be performed on the plumbing if needed.

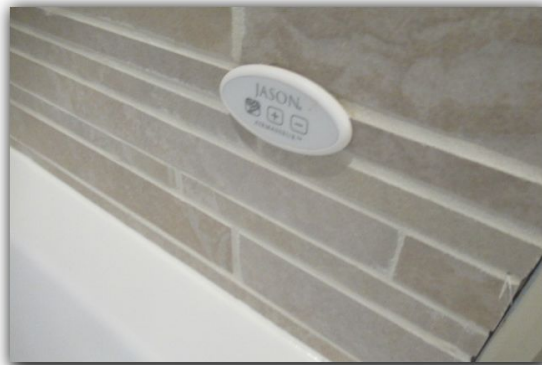
The whirlpool bathtub in the south side 3rd level bathroom did not operate when tested.

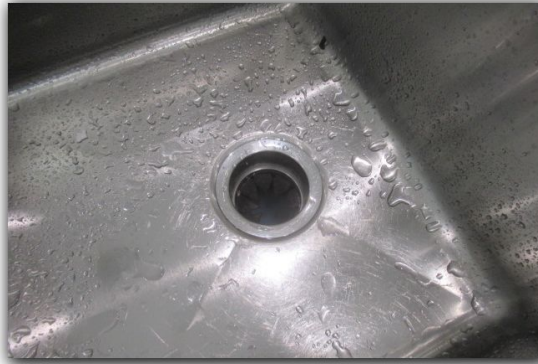
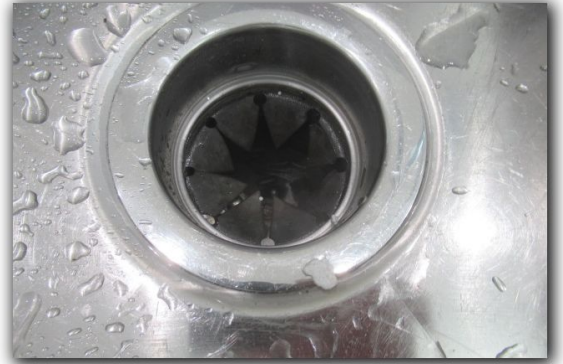
**Comments:** The splash guard was worn and should be replaced at the main kitchen sink garbage disposal.

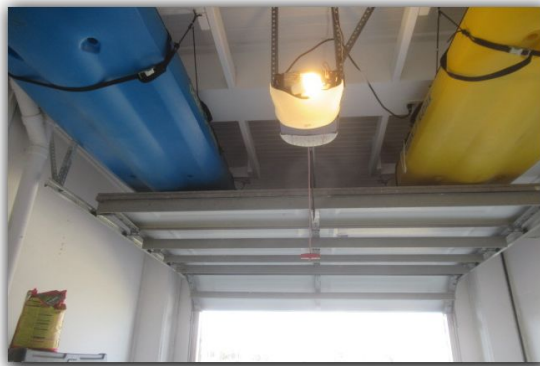
**Comments:** The safety reversing mechanism for the north side garage door did not operate when tested. When the inspector tests the safety reversing mechanism of the overhead garage door, the motor should reverse itself. (5 lbs of pressure over a 2 second period should be sufficient to reverse most doors) Failure to reverse is considered a recognized safety concern by the Texas Real Estate Commission (T.R.E.C.) These motors can usually be adjusted.
