## SAMPLE INSPECTION REPORT

# Frame Phase / Pre-Sheetrock

## Manvel, Texas

Brad Leland | TREC License #5229

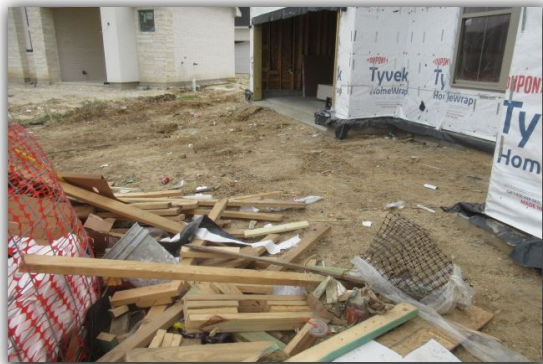
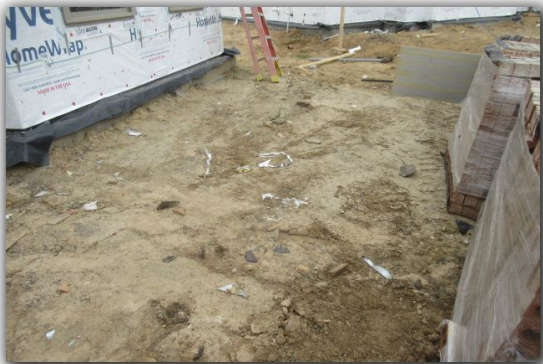
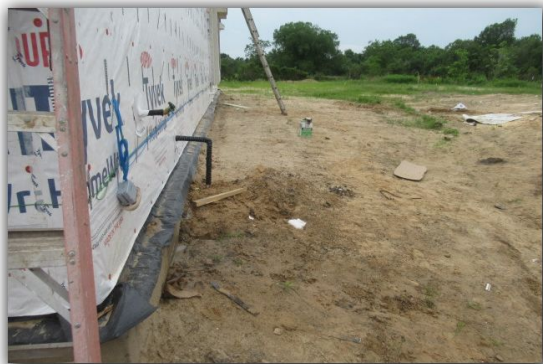
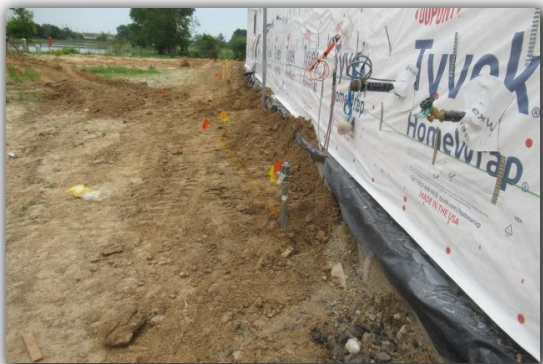
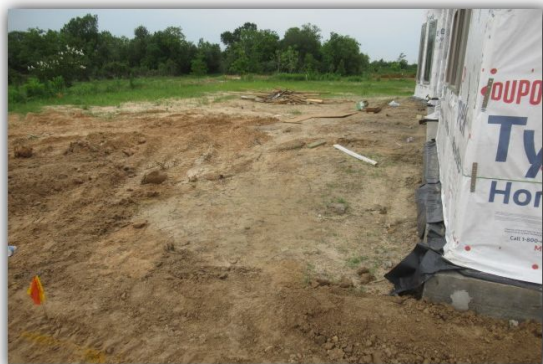
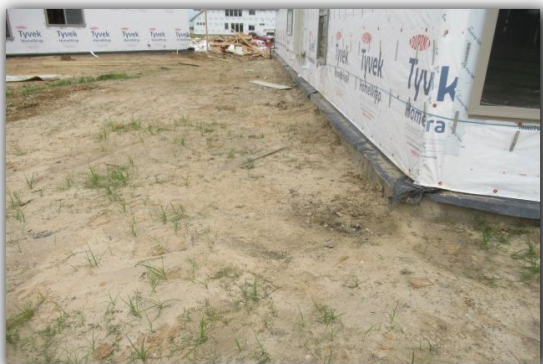
**Comments:** The landscaping and finish grading was not complete at the time of the inspection

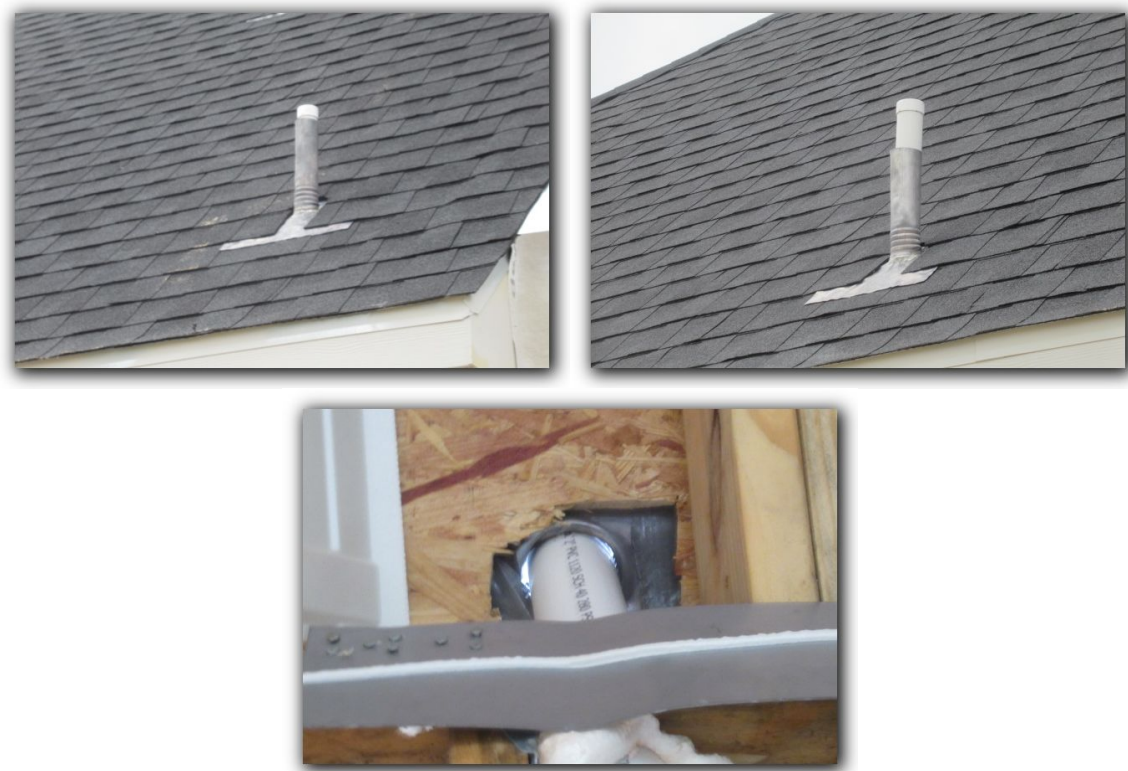
**Comments:** The lead roof jacks are not sealed over the PVC plumbing drain vent pipes on the north side of the roof which will allow rain water to enter the interior structure. A qualified roofing contractor should be consulted regarding the repair of this condition as well as check the entire roof covering for any other possible defects.

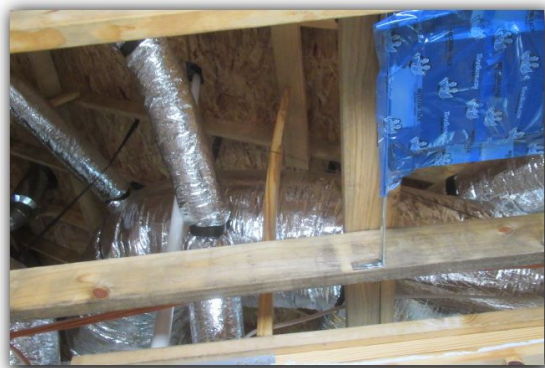
**Comments:** One of the mid span rafter supports is incomplete and notably bowed above the upstairs rear southeast bedroom. This brace should be reinforced and straightened.

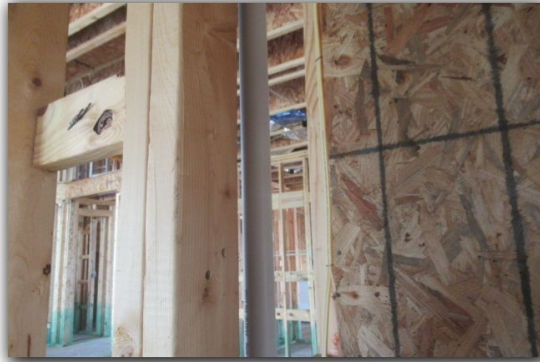
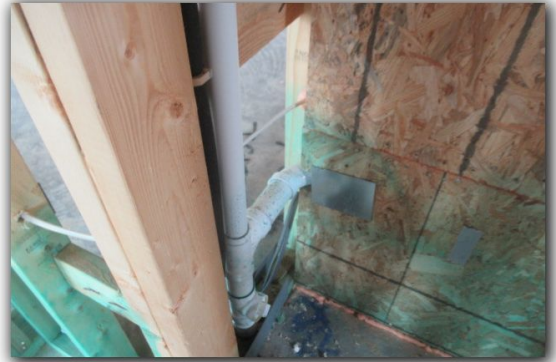
**Comments:** The wall framing is not complete for the sheetrock backing inside the small closet off the north side of the kitchen.

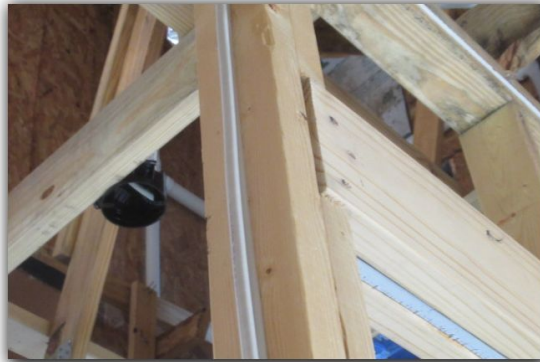
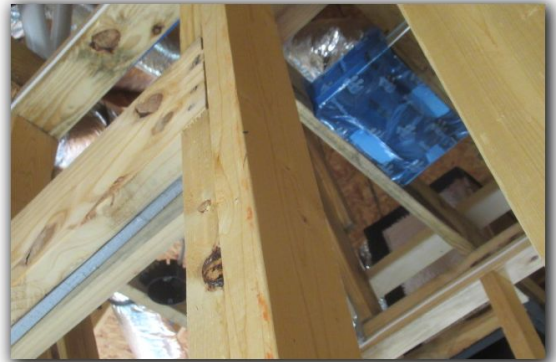
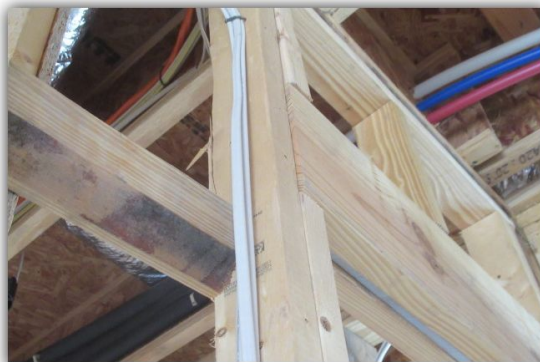
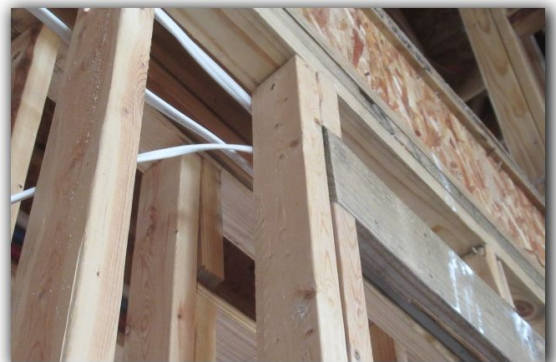
It is necessary to provide additional nailing through the wall studs into the supporting headers in several areas. After the wall studs are properly joined/fastened to the supporting headers the remaining gaps should be filled with a heavy duty construction adhesive.

It is recommended the builder be consulted regarding the repair of the above the items.

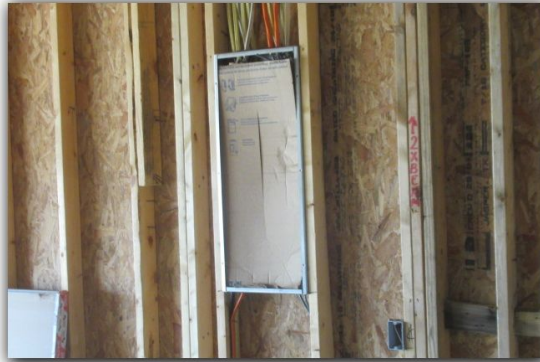
**Comments:** Properly installed for this phase of inspection
☒ ☐ ☐ ☒
**B. Branch Circuits, Connected Devices, and Fixtures****Type of Wiring:** Copper**Comments:** Multiple switch boxes should be secured on both sides.

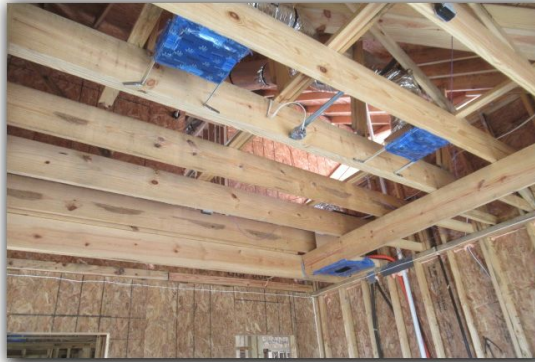
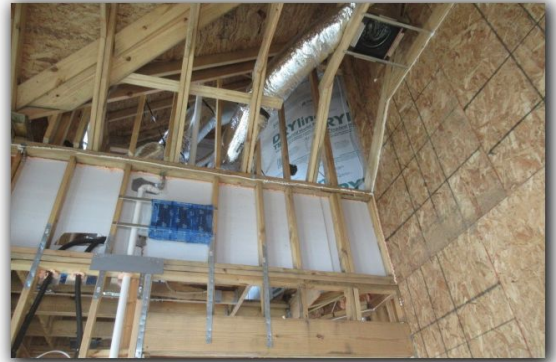
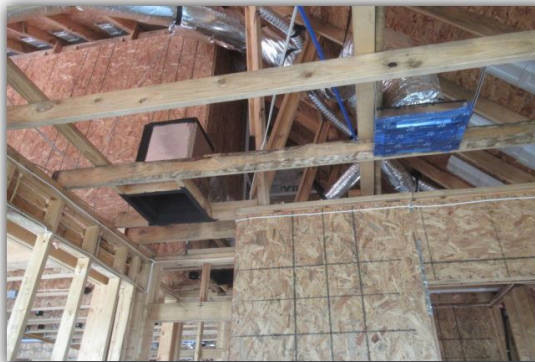
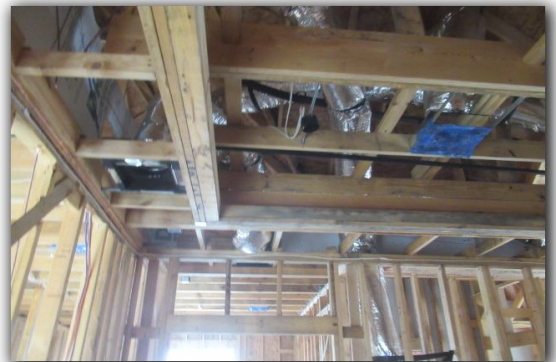
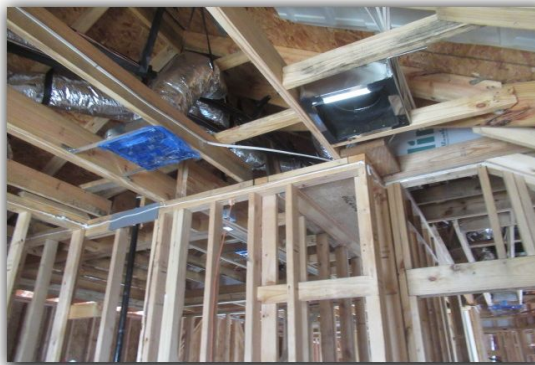
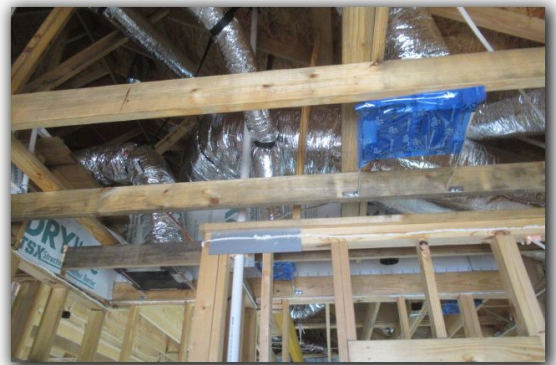
**Comments:** The return and supply vents for the HVAC system in the bedroom, the study and the media room are very close to each other. It is generally accepted that supply vents should be located near the exterior walls for better circulation and efficiency of the system.

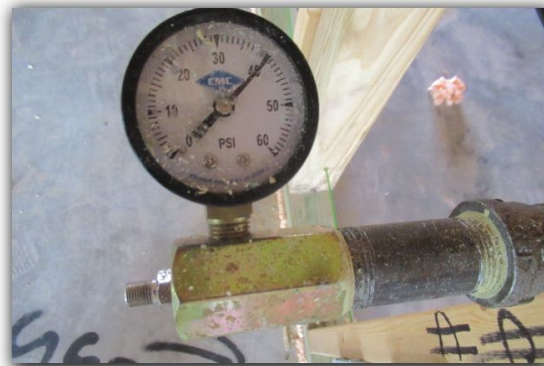
**Comments:** The gas lines were pressured up and holding 40 psi.
