# Insurance Renewal Inspection

4-POINT SAMPLE REPORT / LA PORTE, TEXAS

Roofing / Heating & Cooling / Plumbing / Electrical

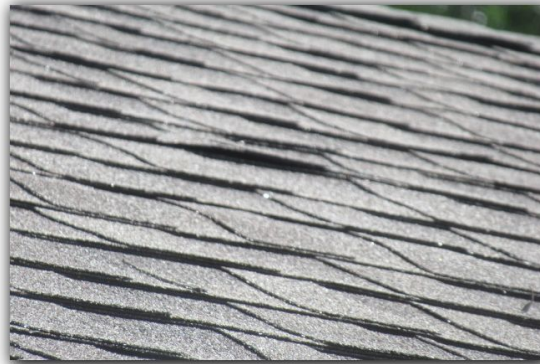
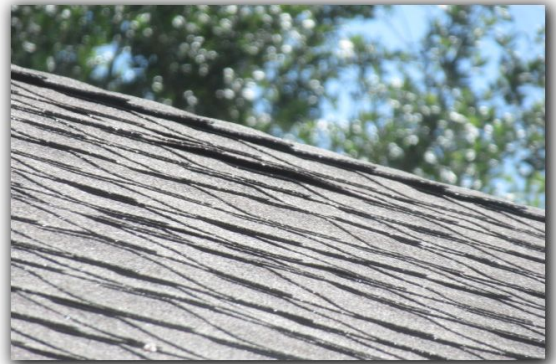
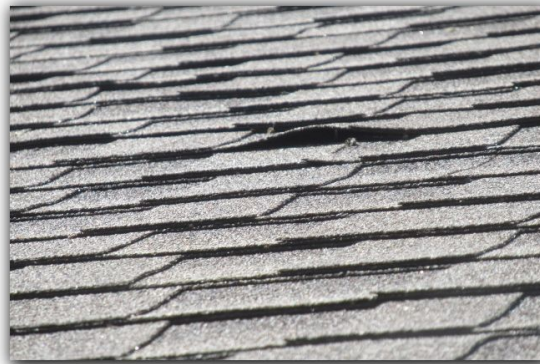
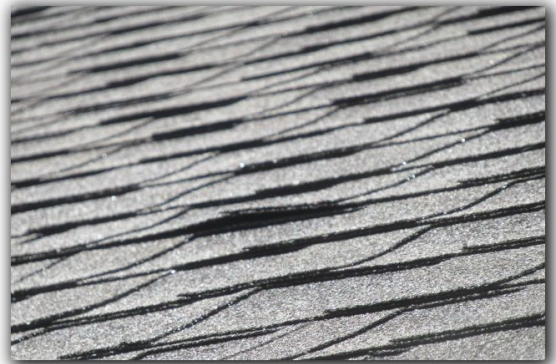
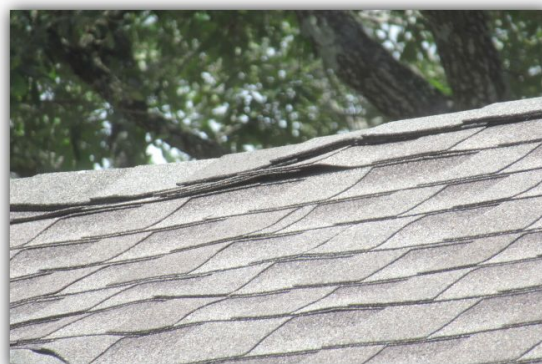
Front and Back Roof Photos

**Comments:** There are lifted shingles that may be caused by nails backing out on both sides of the roof and at the south side of the ridge. A qualified roofing contractor should be consulted regarding this condition.

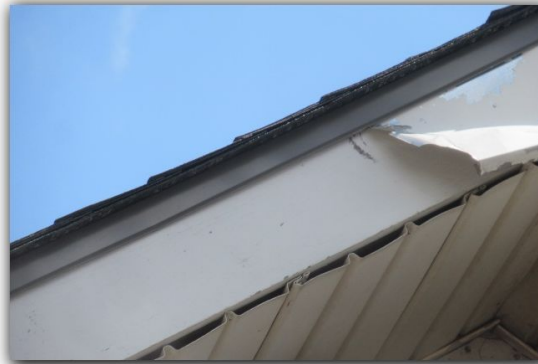
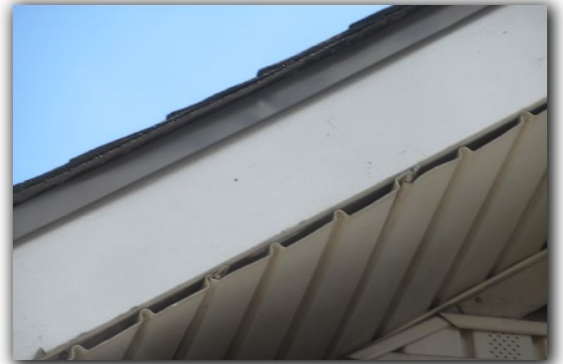
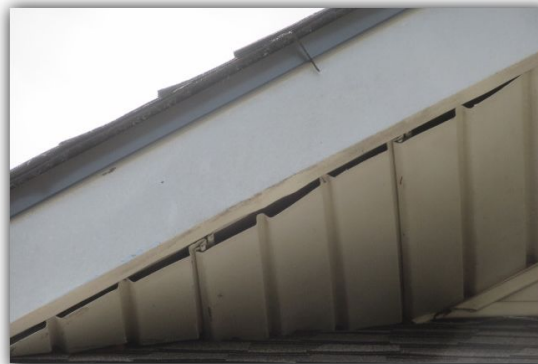
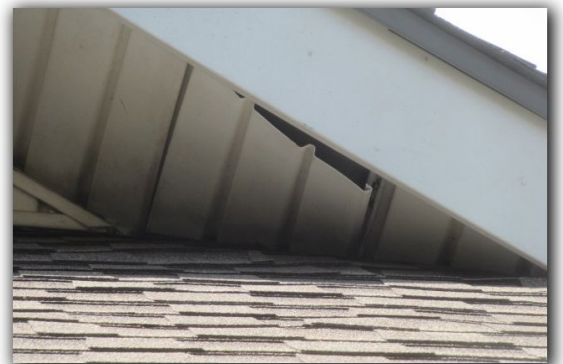
**Comments:** There are openings or gaps in the roof structure (soffit & fascia) at the small gables on both sides of the home. These gaps should be sealed to keep rain water from entering the interior structure.

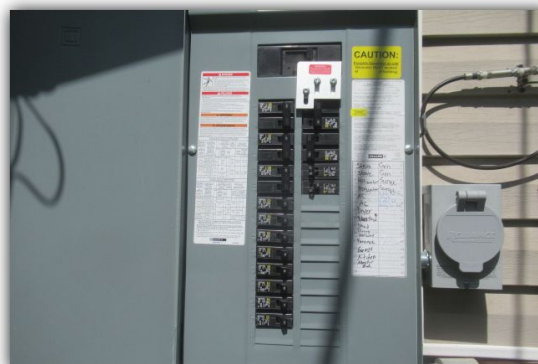
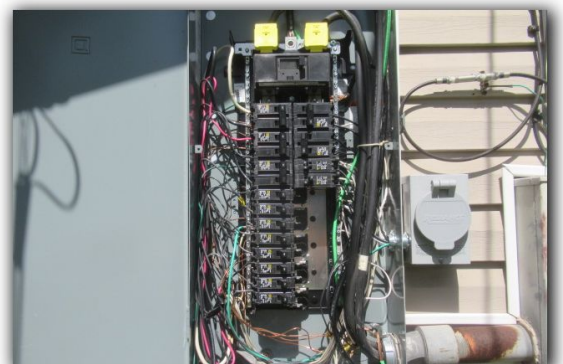
**Amp Service Box:** 200 amp service

**Type of Main Service Cables:** Copper

**Location of Breaker Box:** Back of home

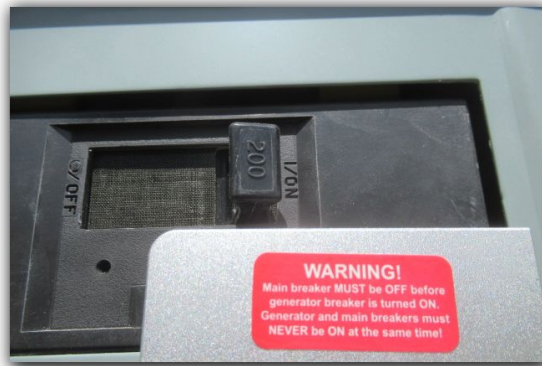
**Comments:** One white wire is being used as a “hot” wire and is connected to a circuit breaker. In most instances the white wires are the grounded conductors, and if they are used as a “hot” wire, they must be wrapped with black or red tape to identify them as a “hot” wire.

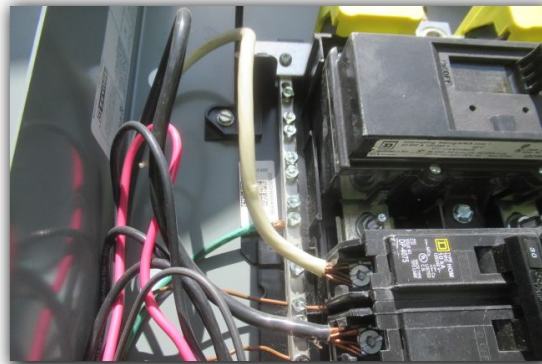
Arc fault breakers have not been installed for all the outlet and lighting branch circuits as would now be required. Arc fault breaker protection is now required for kitchens, family rooms, dining room, living rooms, parlors, libraries, dens, bedrooms, sunroom, recreation rooms, closets, hallways and the laundry areas.

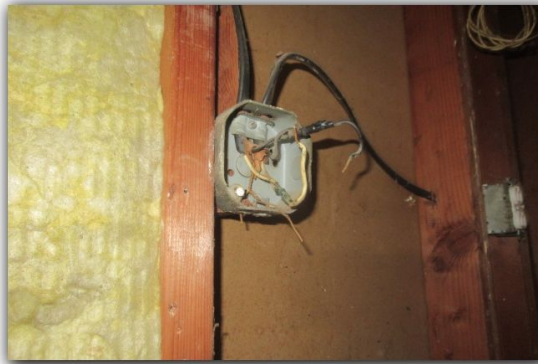
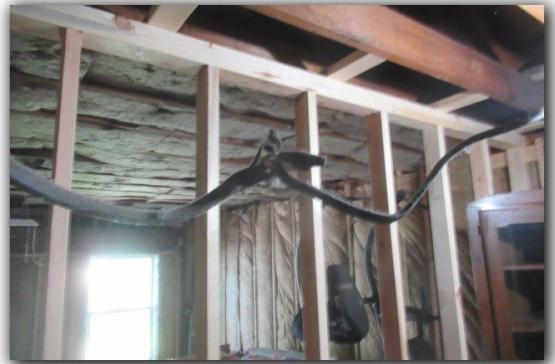
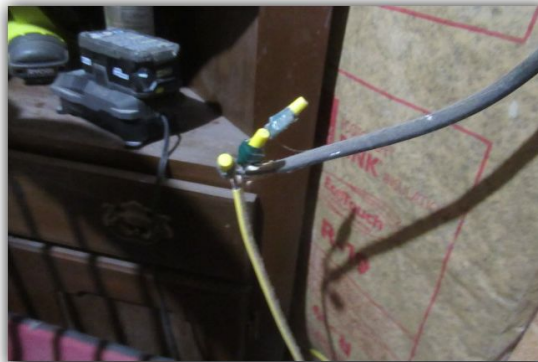
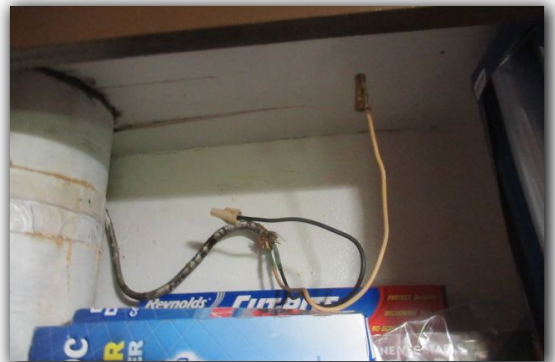
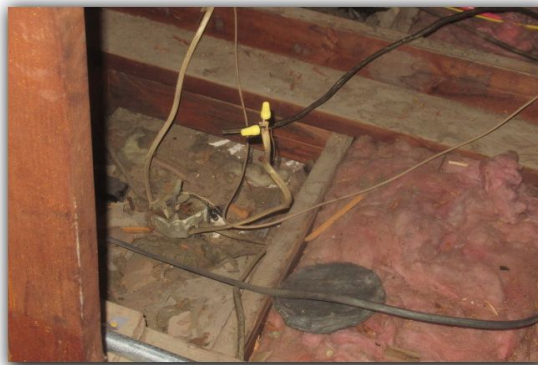
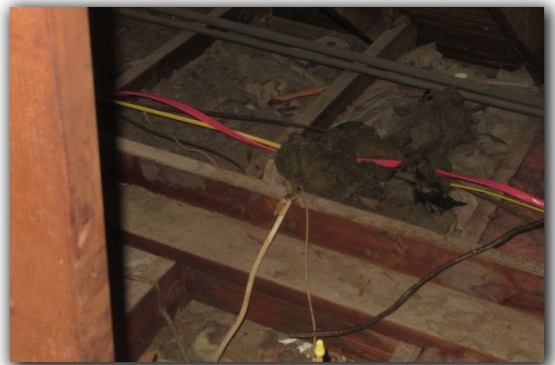
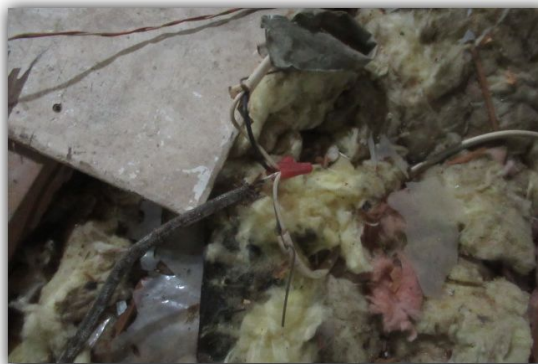
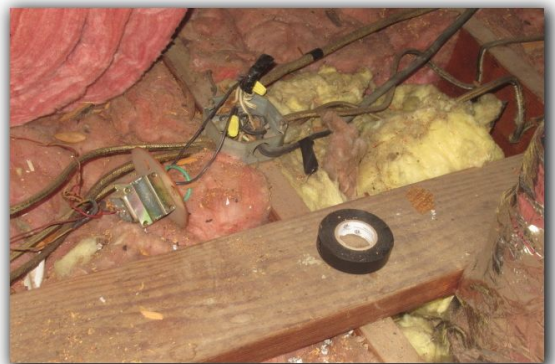
**Comments:** Wires were improperly spliced terminated in the attic, the garage conversion room and in the kitchen cabinet above the vent hood. Wire ends or splices should be in junction boxes that are properly mounted with cover plates. This condition is considered an electrocution/fire concern and should be serviced by a licensed electrician.

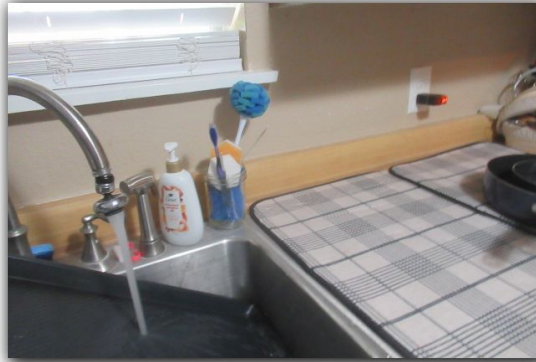
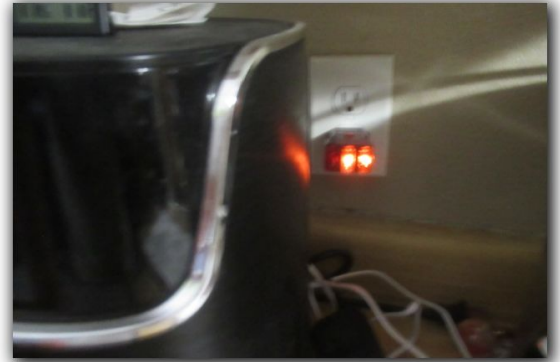
The outlets in the kitchen are not protected by G.F.C.I. (Ground Fault circuit interrupt) breakers.

This is required statement by the T.R.E.C.. G.F.C.I. Breakers are required for all outlets within 6' of any water source inside the house, bathrooms, wet bars, or utility room sinks, all exterior outlets, all outlets in the kitchen and all outlets in the garage.

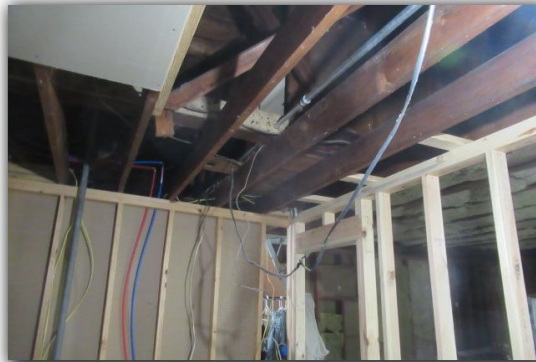
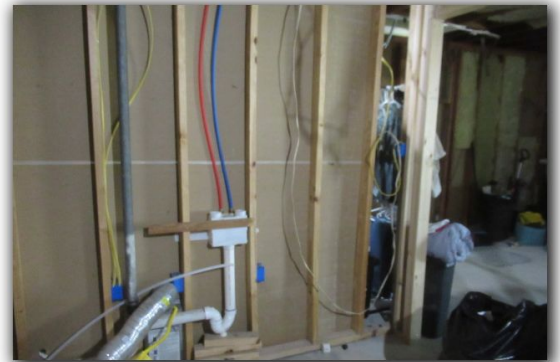
Electrical wiring is not secured to the structure in the garage conversion room and in the attic.

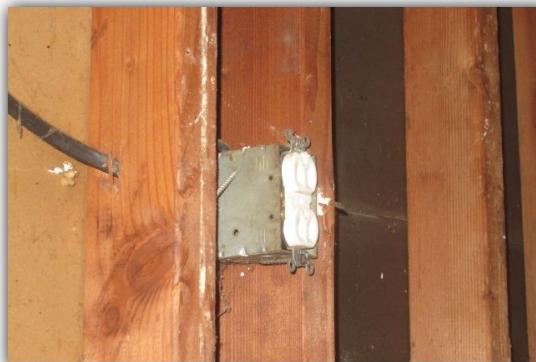
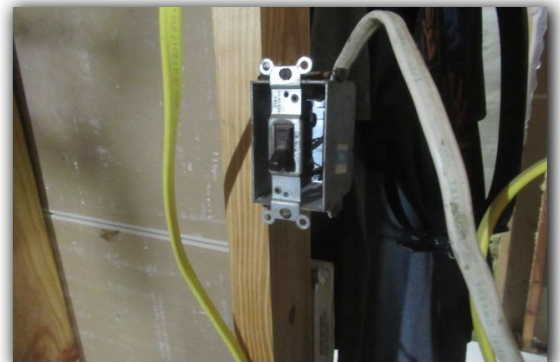
Several electrical fixture face plates were missing in the garage conversion room. Face plates that are missing for either light switches or electrical outlets are considered a safety concern and are an item that is specifically checked in a real estate inspection.

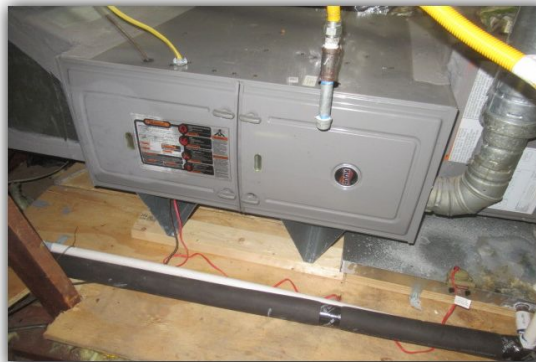
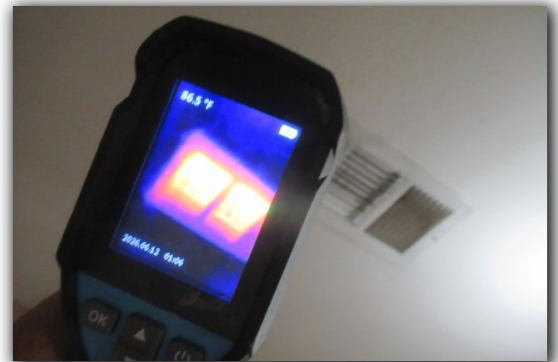
**Comments:** The furnace flue pipe is in contact with the roof decking and an HVAC duct. Gas appliance flue pipes must have a minimum of 1" clearance from any combustible materials.

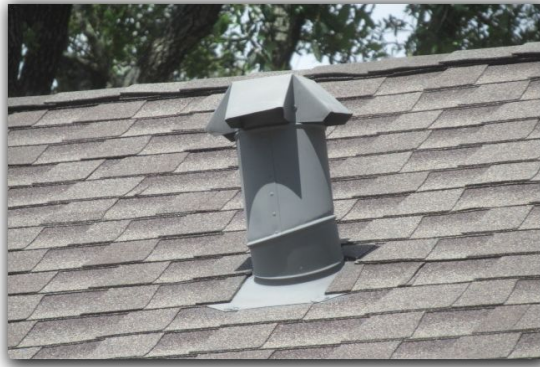
The furnace flue pipe is not terminated with the proper gas appliance cap on the roof.

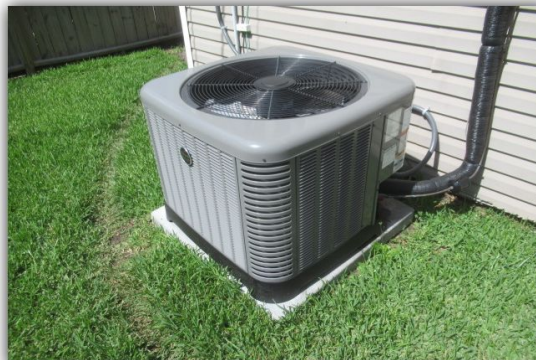
Type of Systems: Central - Air Conditioner

Exterior Compressor: 3 tons

Differential Air Temperature Drop During Operation:

Air Going Into System: 75 f Returned Air: 58 f

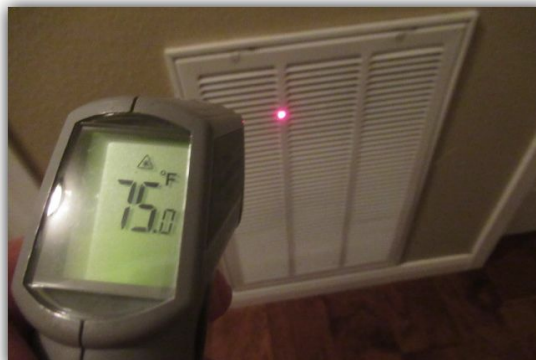
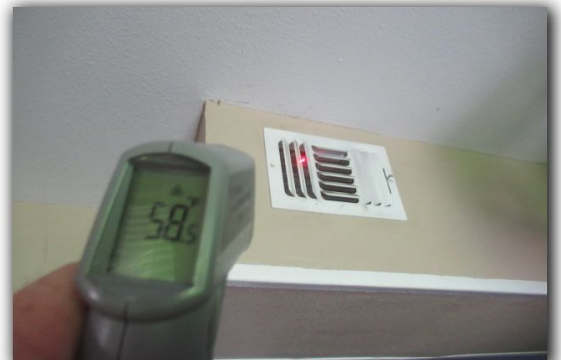
The air coming out of the vents should be 14 to 21 degrees cooler than where it goes into the cold air return. These readings are within the recommended tolerances for proper operation.

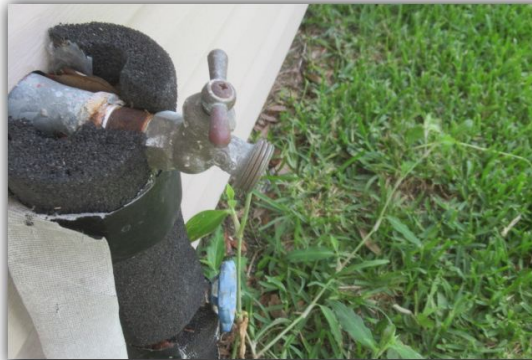
The exterior faucets do not have back flow protectors. Anti-siphon devices keep contaminated water from entering the potable water of the house plumbing. These devices are inexpensive, easy to install, and can be found in most home improvement stores.

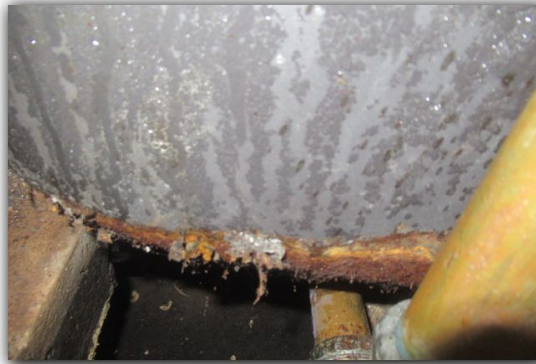
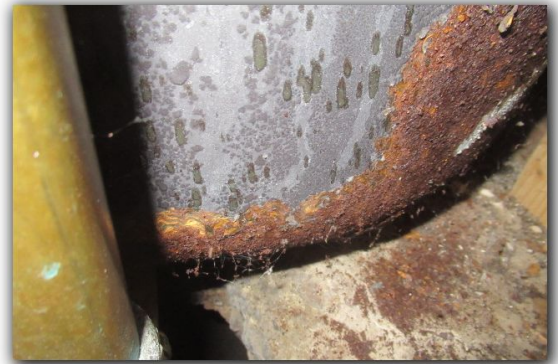
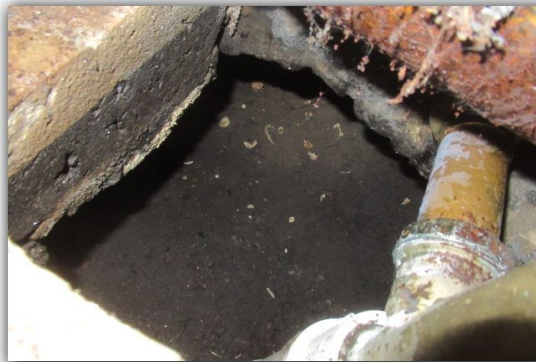
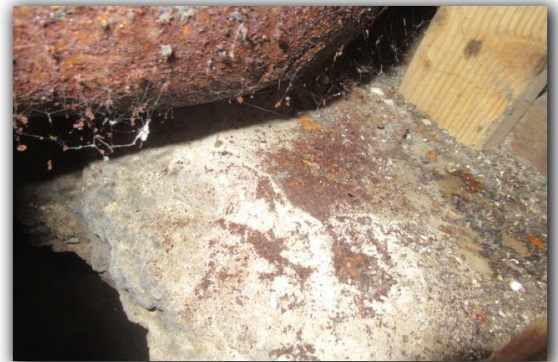
Note: There is corrosion on the bottom of the hall bathtub as seen from the inspection port. There is no leak visible,

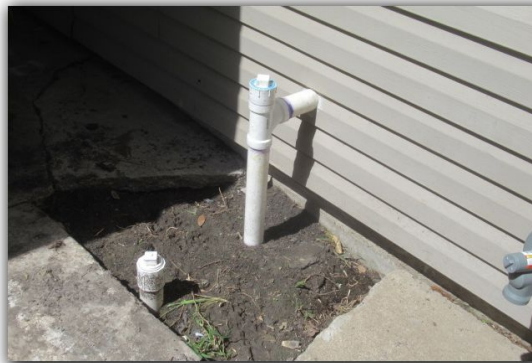
**Type of Drain Piping Material:** PVC where visible

**Comments:** The drain system appears to be performing properly at this time.

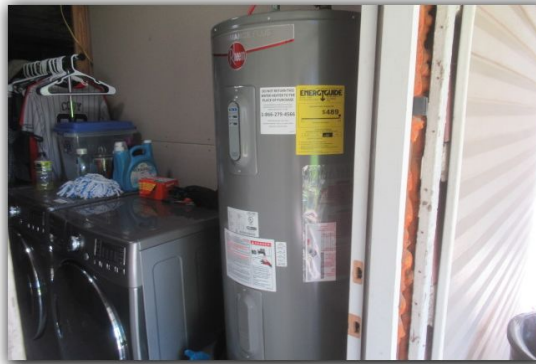
**Comments:** The electrical supply wiring is not protected by conduit.

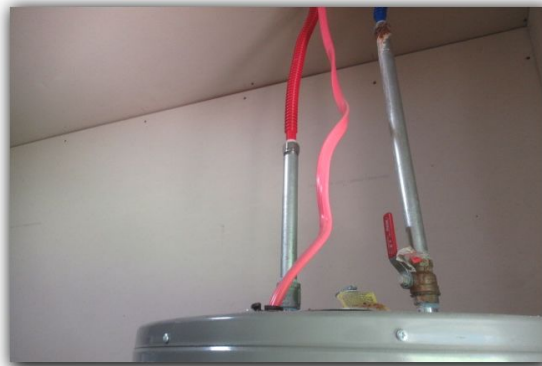
There was corrosion at the water supply line of the water heater. It is recommended that this/these fittings be replaced whenever possible to prevent future leaks.

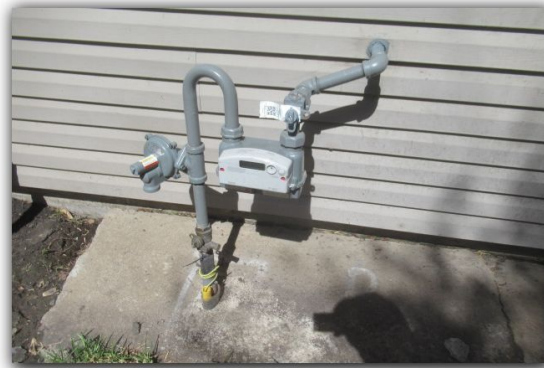
**Type of gas distribution piping material:** Black Pipe/Galvanized

**Comments:** No defects noted.
