SAMPLE INSPECTION REPORT

# 11-Month Builder Warranty Inspection

Missouri City, Texas

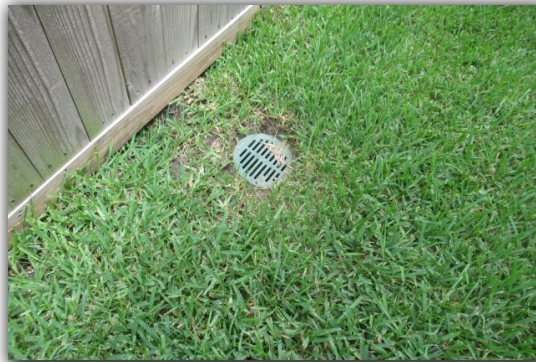
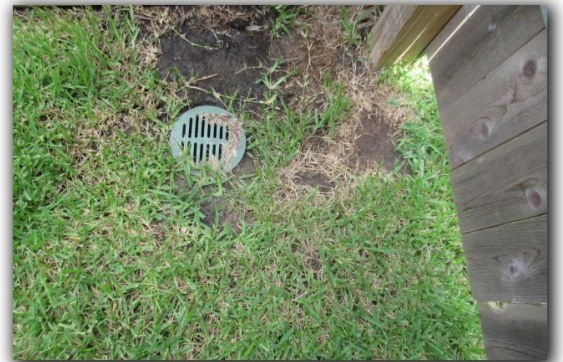
There is a sub surface drain system. This drain system should assist in diverting rain water to the street or storm sewer. The overall effectiveness of this system was not determined. Underground drains can become clogged or obstructed.

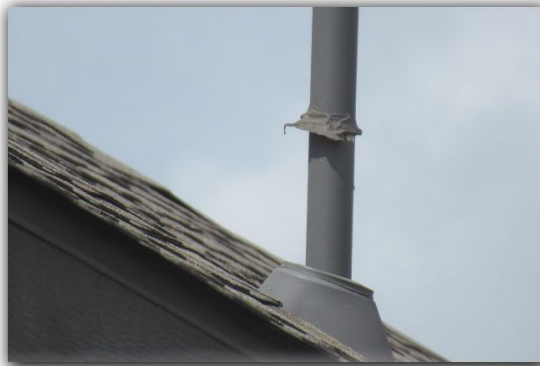
**Comments:** The seal on the plumbing drain vent pipe is not in place on the roof jack as intended on the northwest side of the roof.

A qualified roofing contractor should be consulted regarding the repair of the above items as well as check the entire roof covering for any other possible defects.

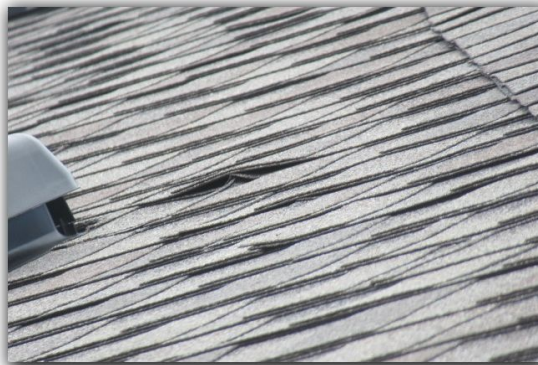
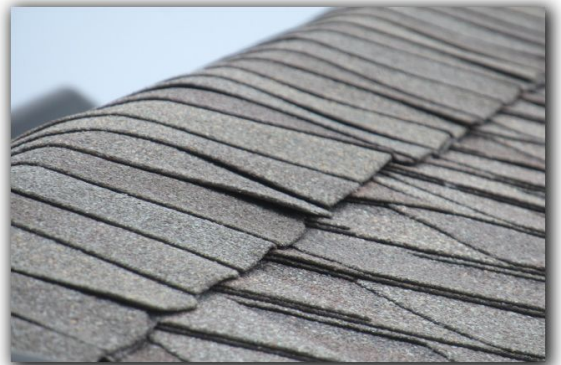
There are lifted shingles that may be caused by nails backing out at the front east roof area. A qualified roofing contractor should be consulted regarding this condition.

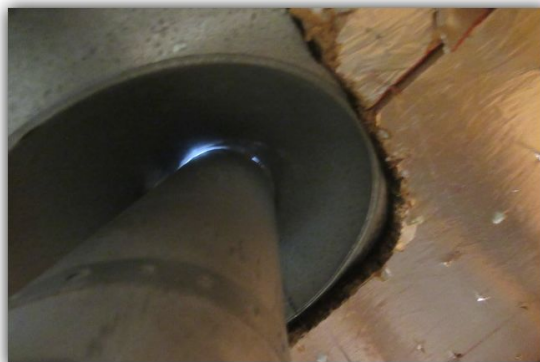
The furnace flue pipe does not appear to be completely sealed at the rain collar on the roof as daylight can be seen around this pipe in the attic area.

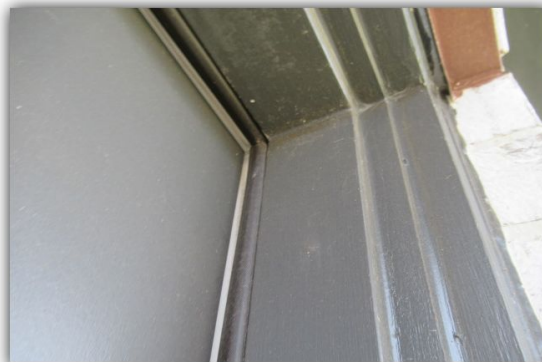
**Comments:** The back door does not seal against the weather stripping at the top when shut.

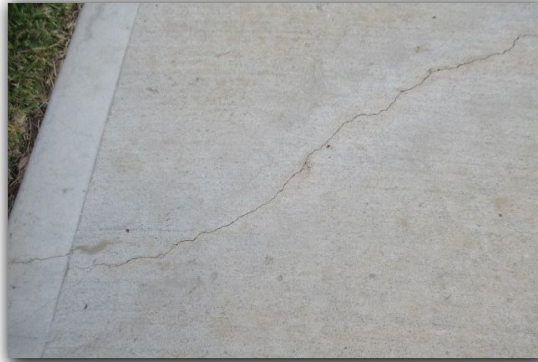
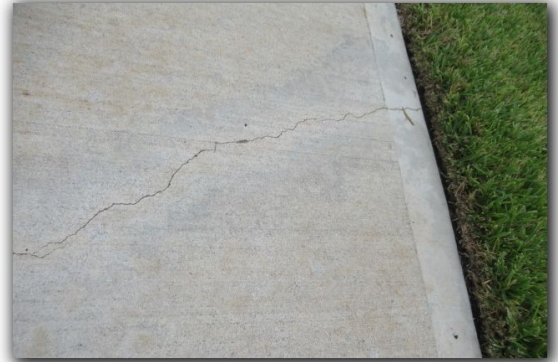
**Comments:** One of the sidewalk section sections next to the driveway is cracked.

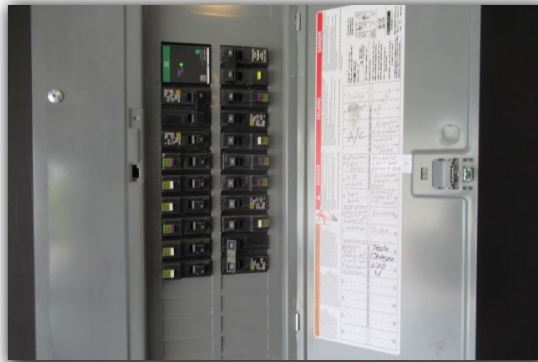
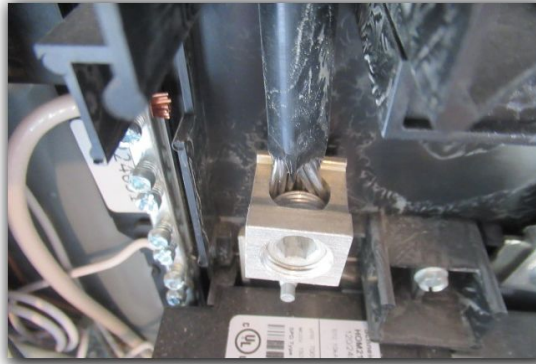
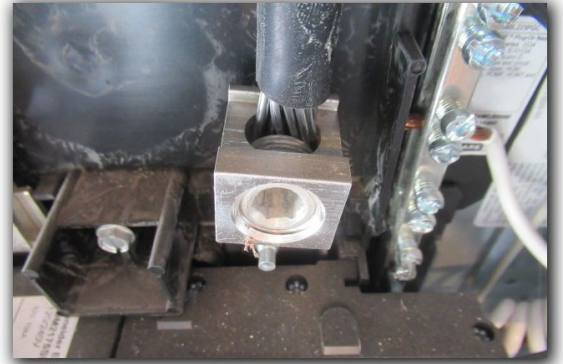
**Comments:** An inhibitor paste has not been applied to the main aluminum wires. The surface of aluminum can oxidize when it is exposed to air resulting in a poor connection.

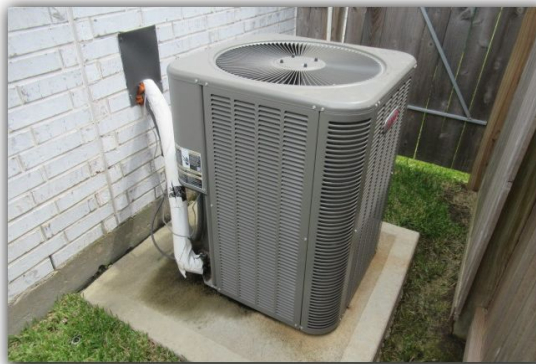
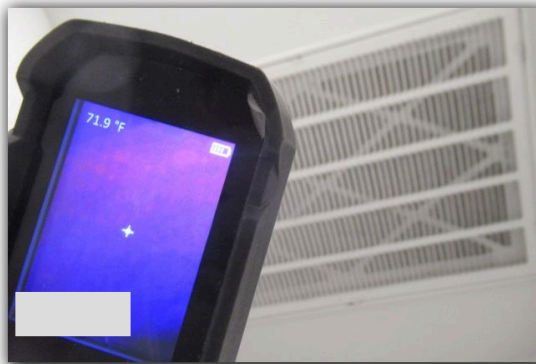
**Differential Air Temperature Drop During Operation:**

**Air Going Into System: 71 f Returned Air: 52 f**

The air coming out of the vents should be 14 to 21 degrees cooler than where it goes into the cold air return. These readings are within the recommended tolerances for proper operation.

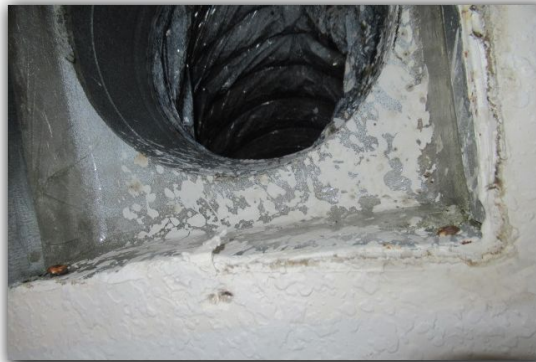
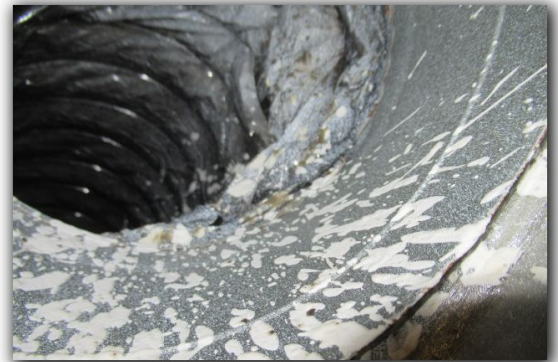
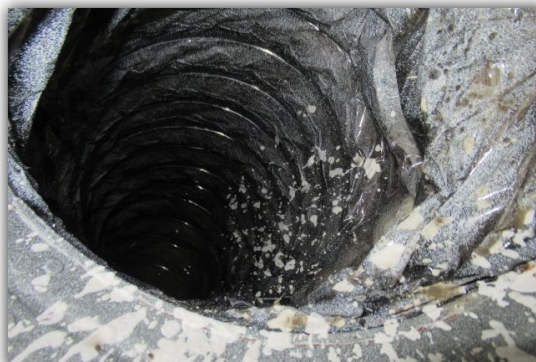
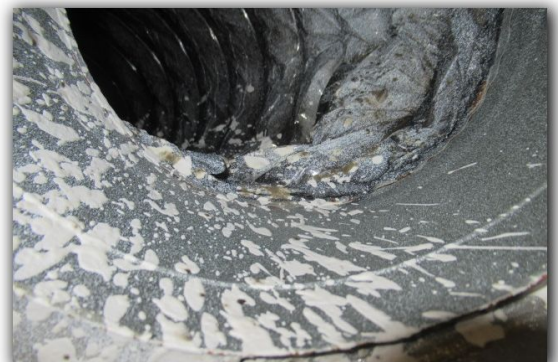
**Comments:** Dark discoloration was observed inside some of the HVAC ducts behind a vent cover. This may be an indication of microbial growth. Cleaning and further evaluation by a licensed HVAC professional or mold specialist is recommended.

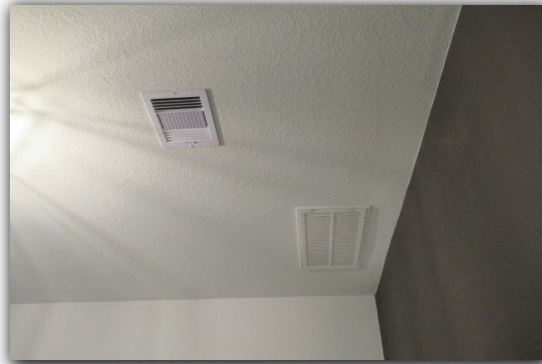
The return and supply vents for the HVAC system are very close to each other in the master bedroom and the supply vents in the guest bedrooms are very close to the doors rather than near the exterior walls. It is generally accepted that supply vents should be located near the exterior walls for better circulation and efficiency of the system.

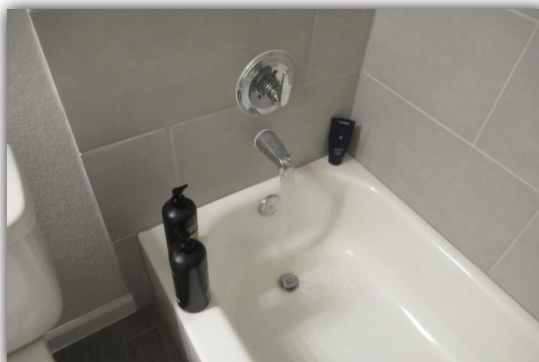
It is recommended that there be an inspection port provided for the hall bathtub/shower so that it is possible to check for leaks, as well as for service to be performed on the plumbing if needed.
