# Inspection Report

## EXISTING-HOME BUYER INSPECTION

**PASADENA, TEXAS**

Brad Leland  
Professional Real Estate Inspector  
T.R.E.C. License #5229  
Office 281-794-9102

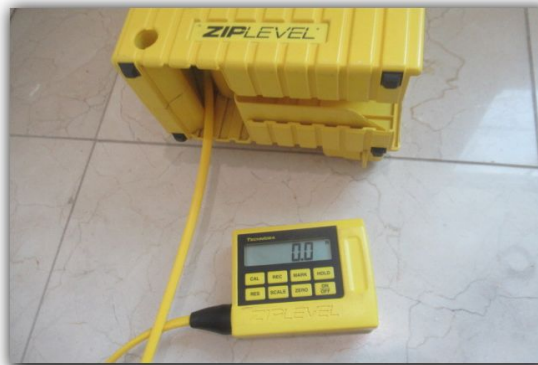
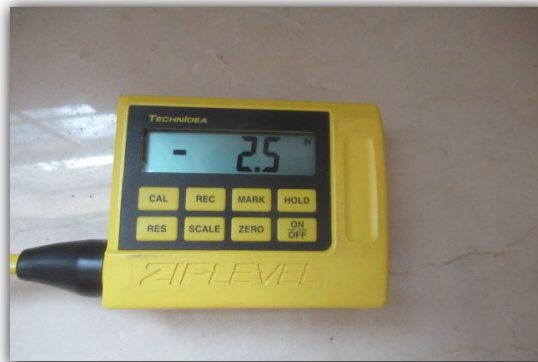
**Comments:** There are signs of more than normal past movement/settlement in the structure such as cracks in the interior sheetrock, cracks in the exterior bricks, doors that are not operating properly and when measured the west side and front of the home were approximately 1.6" to 2.6" low. As discussed, these conditions indicate that the foundation may require a permanent remedy to stabilize the structure in some areas. The best course to follow for foundation settlement is to consult a professional (structural) engineer so that a course of corrective procedures can be evaluated. This can consist of a certification that the foundation is functioning as intended at this time, or alternately, a plan may be designed for underpinning.

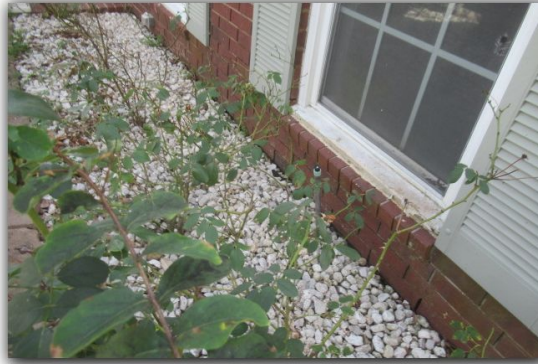
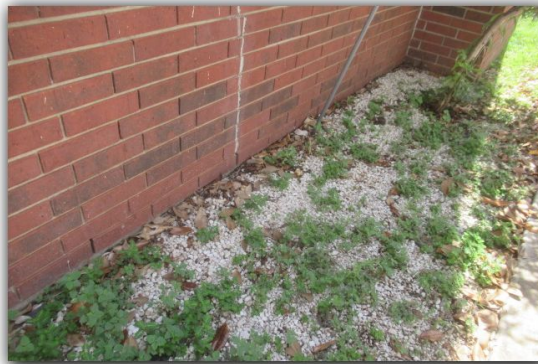
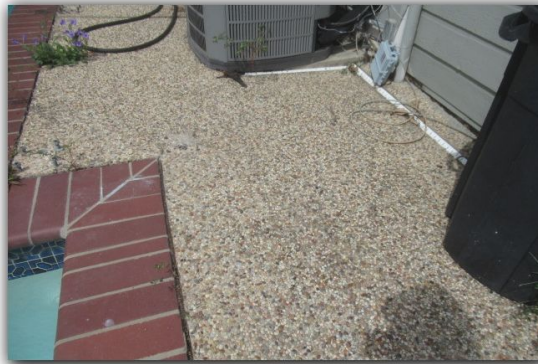
The foundation does not appear to have positive grading as the back patio/pool decking slopes towards the home. The drainage strategy of the yard as it relates to the foundation is important. Expansive soils can be destructive to the foundation if the moisture content of the perimeter varies.

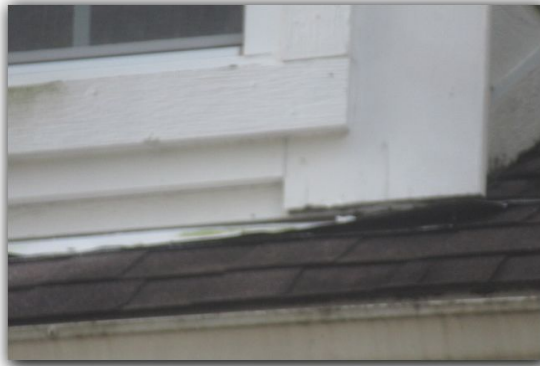
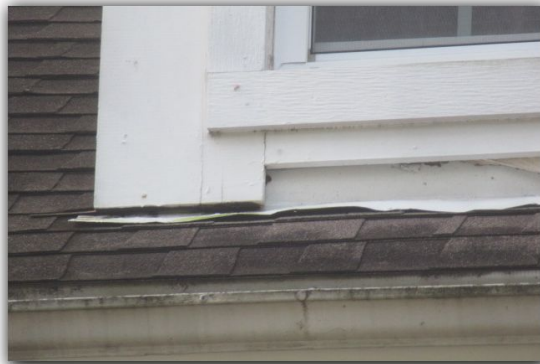
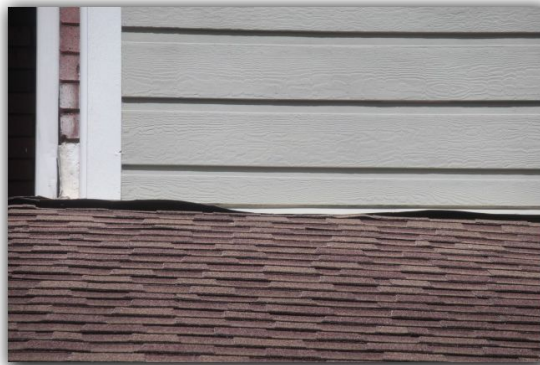
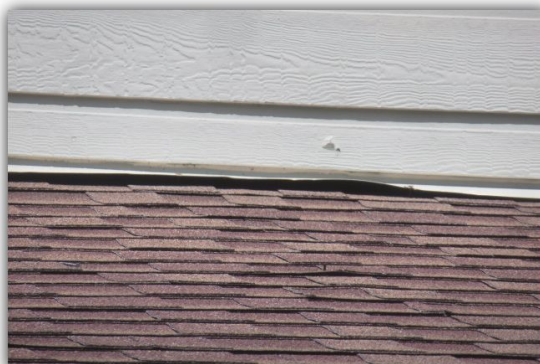
There are several lifted shingles that may be caused by nails backing out. A qualified roofing

contractor should be consulted regarding this condition.

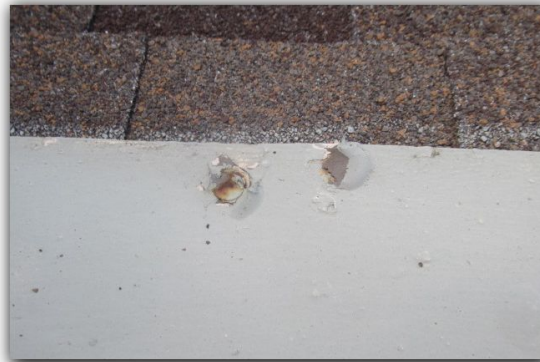
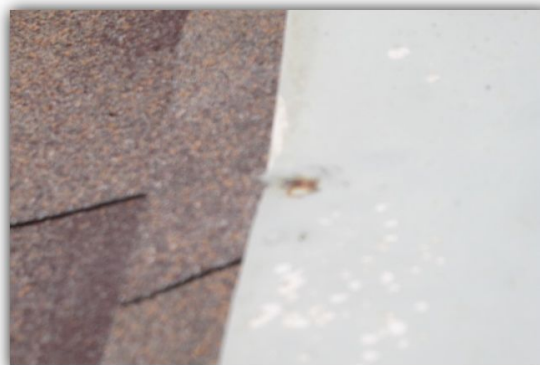
There are some damaged shingles and some repairs to the roof.

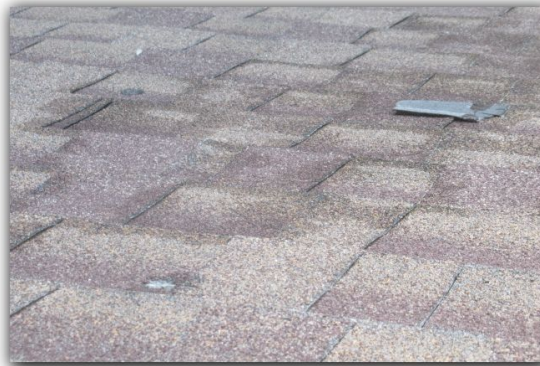
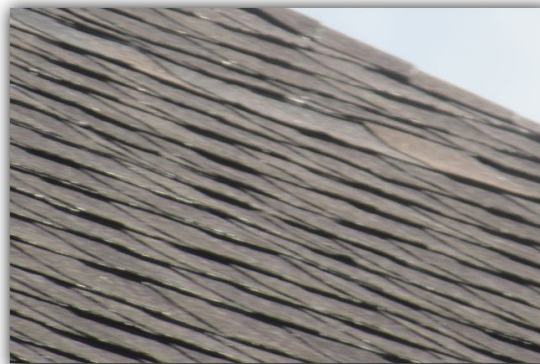
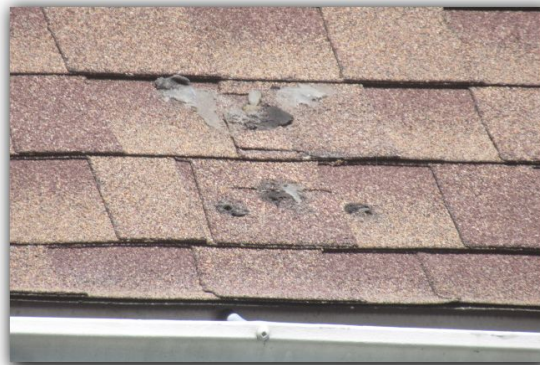
The surface of the roof is worn/loss of aggregate in several areas which is an indication that the shingles may need to be replaced in the near future.

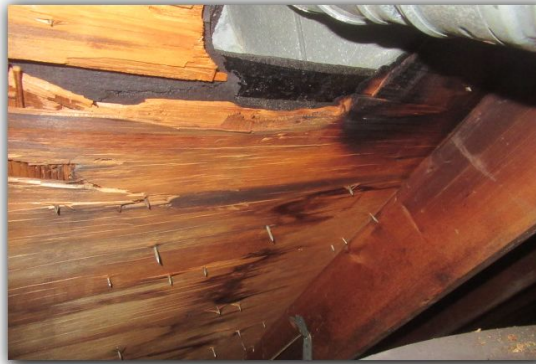
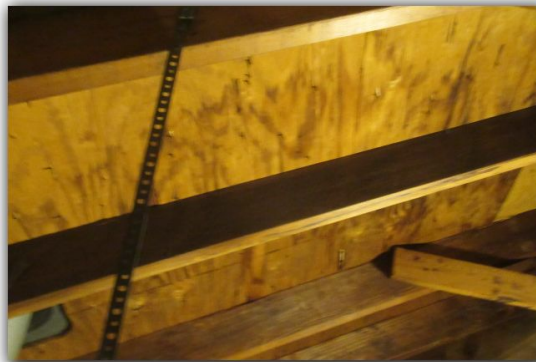
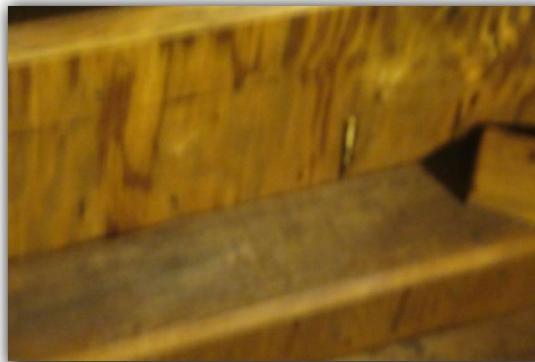
**Comments:** There were water stains/water damage on the roof decking in several areas. These areas appear dry at this time. This condition is an indication of previous water penetration. The areas should be monitored during heavy rain to determine if the leaks are active.

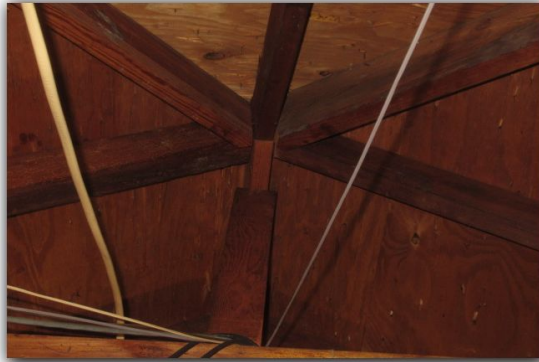
The intersection of the main hip rafters and ridge are not supported/braced properly to meet current building standards.

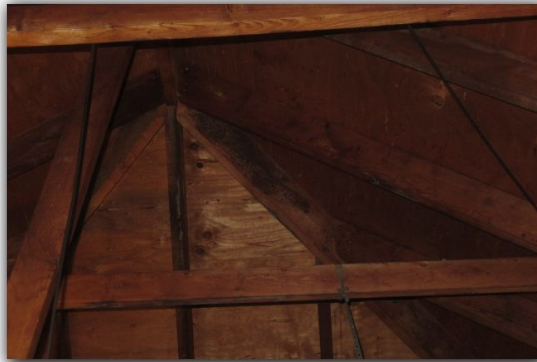
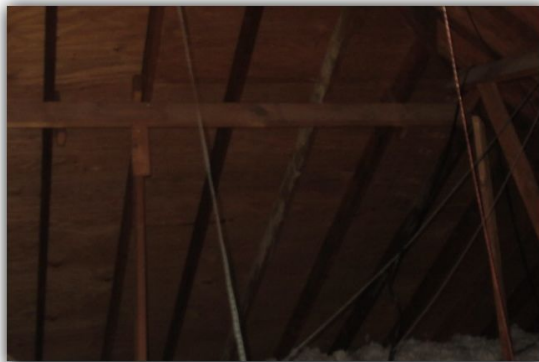
The mid span rafter supports have not been installed for the roof structure every four feet as would now be required.

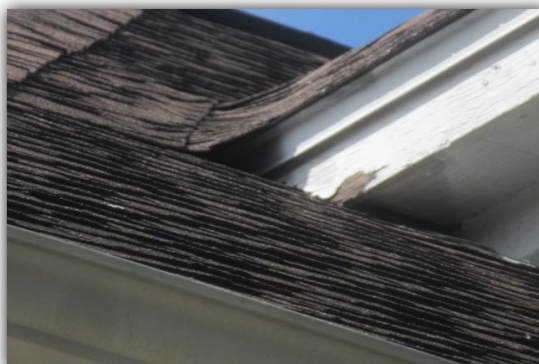
The exterior paint was peeling at the east side dormer in the front of the home. Exposed or weathered wood is considered a conducive condition for wood decay and water penetration.

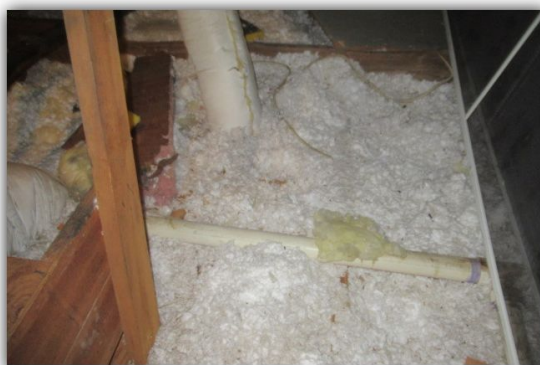
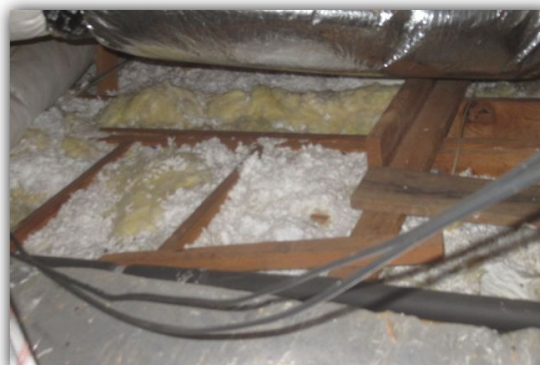
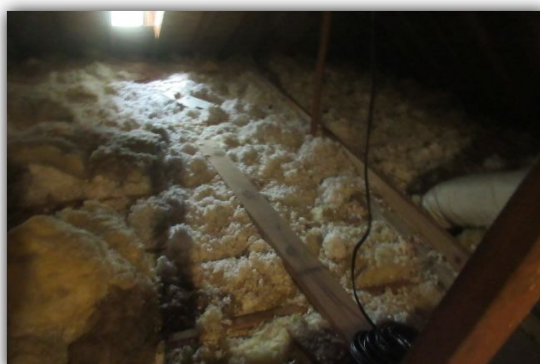
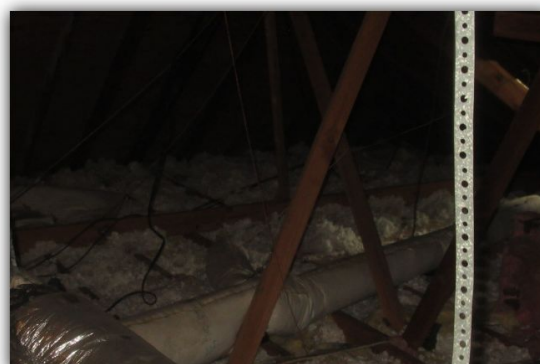
The insulation on the attic floor was thin to meet minimum current standards (R-30). It is recommended that additional insulation be added for energy efficiency.

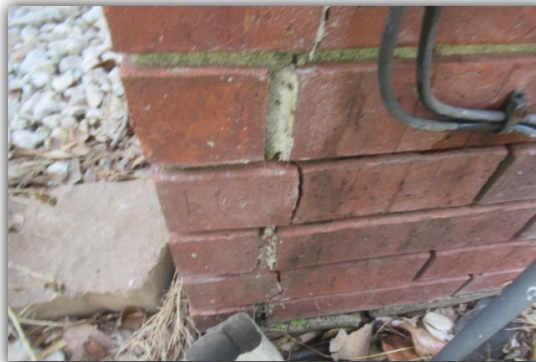
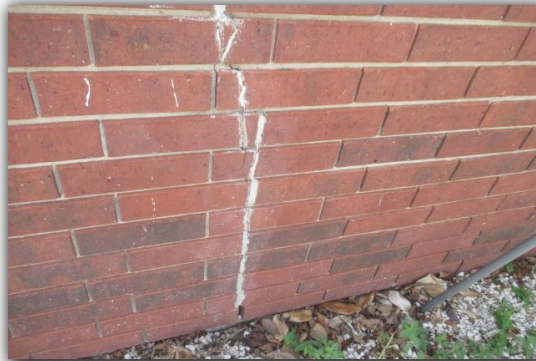
There were cracks in the exterior brick on the west side of the home. Cracks in the bricks are usually indications that there is some degree of movement occurring in the structure. The severity of the cracks can be an indication of the amount of movement in a structure.

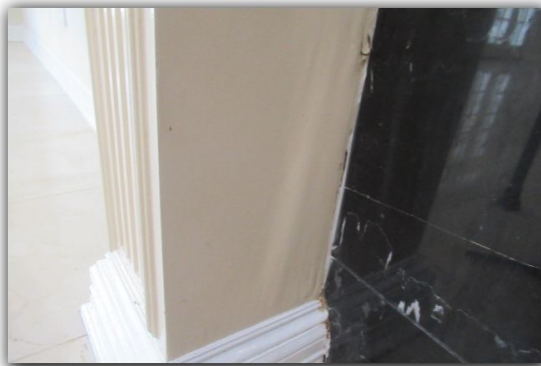
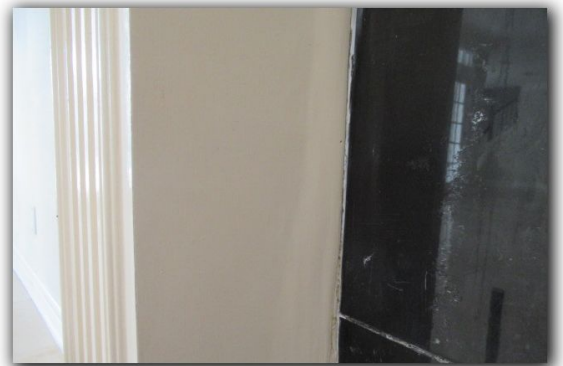
There is water damage to the walls on both sides of the fireplace. All damaged material should be repaired or replaced.

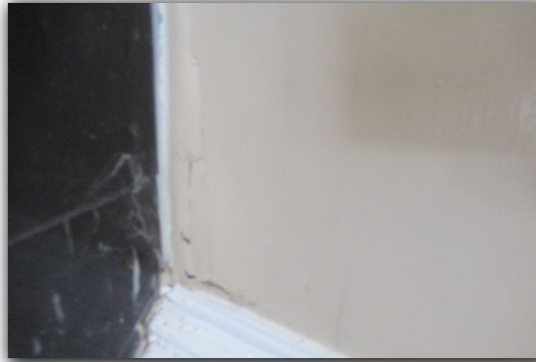
There are water stains on the sheetrock on the west wall of the living room. This area was dry at the time of the inspection. This condition is an indication of previous water penetration in this area. This area should be monitored for additional signs of water penetration. Hidden damage is a possibility.

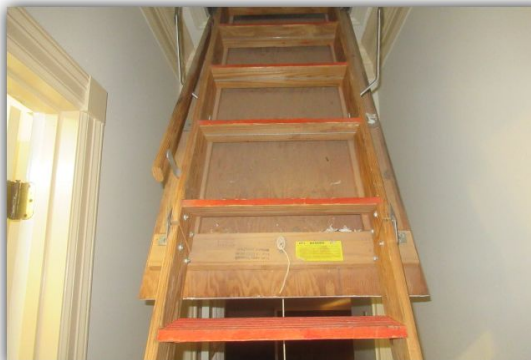
The attic access ladder panel is not insulated. The attic ladder panel should be insulated to prevent radiant heat from transferring from the attic to the living quarters.

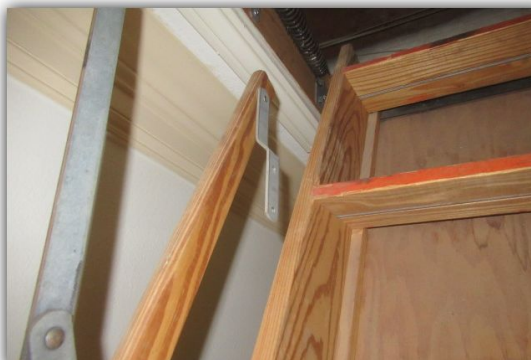
The attic access pull down stairway handrail is not secured. Injury could result if not repaired.

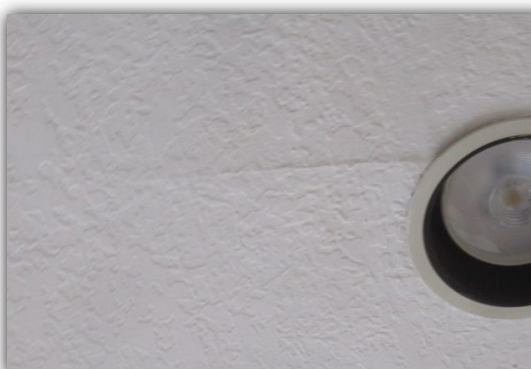
There were cracks in the interior sheetrock ceiling board in the upstairs hallway. Cracks in the ceilings are usually indications that there is some degree of movement occurring in the structure. The severity of the cracks can be an indication of the amount of movement in a structure.

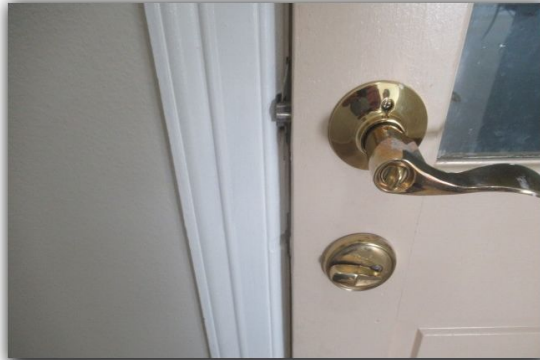
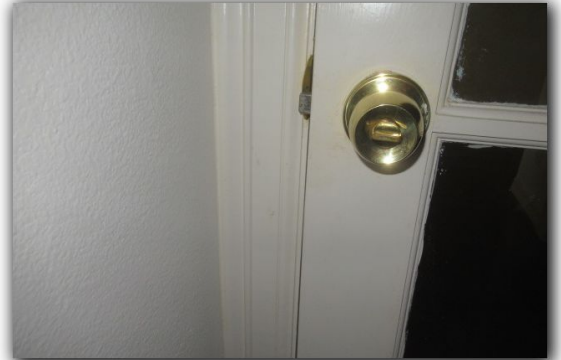
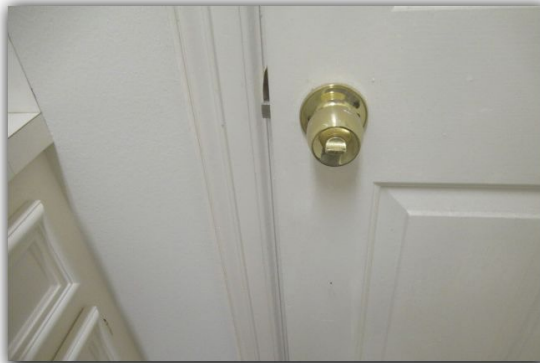
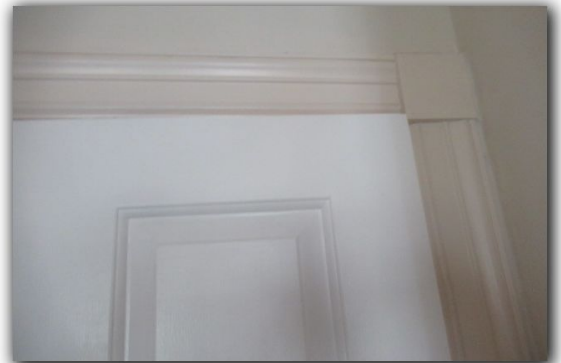
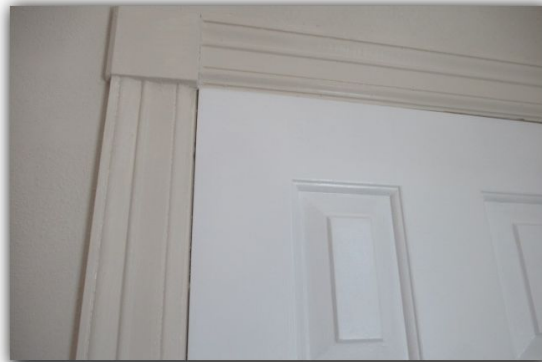
**Comments:** Several of the doors stuck or did not latch properly when they were opened or closed. All doors should be present and in working order. Doors that stick or do not latch properly can usually be adjusted. In most cases, doors that stick or do not latch properly are an indication of past movement in the structure.

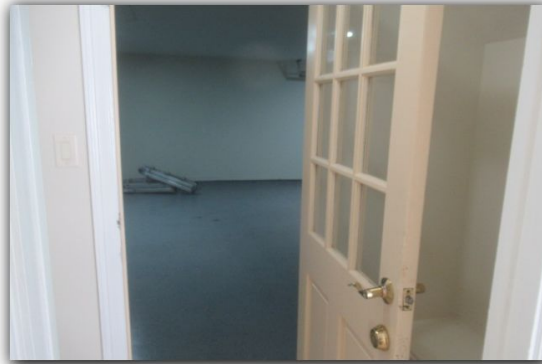
The door from the garage to inside the home does not have a 20-minute fire-resistive rating as would be required under current building standards. A 1-3/8" solid wood door or a metal clad door are commonly used to meet the fire-resistive rating. This is considered a fire safety issue.

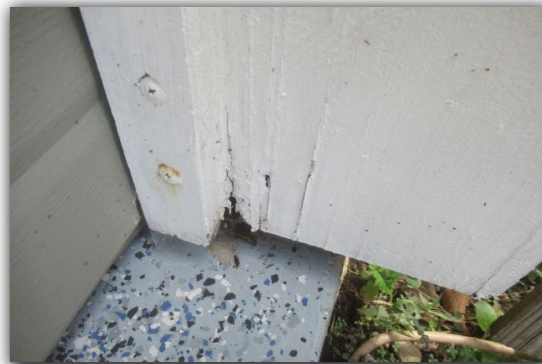
The rear overhead garage door frame has been water damaged. All damaged elements should be repaired or replaced.

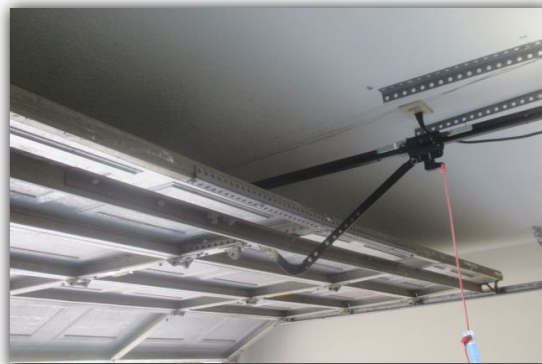
The top panel on the front overhead garage door is damaged.

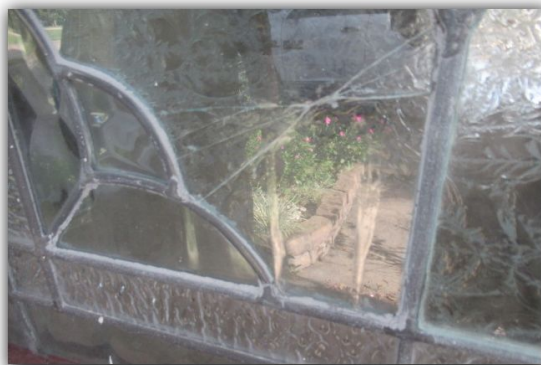
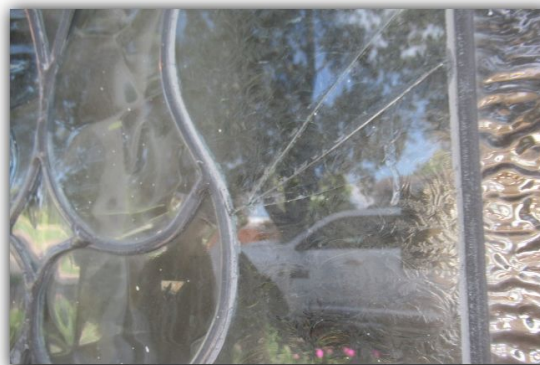
The decorative glass in the front door is cracked.

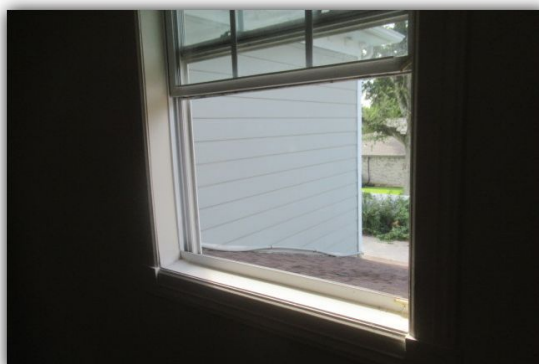
**Comments:** The upstairs rear middle bedroom window screen was missing. Screens are mentioned in this part of the report as they are a specific item in the T.R.E.C. Guidelines. All windows that have channels for screens should have them installed.

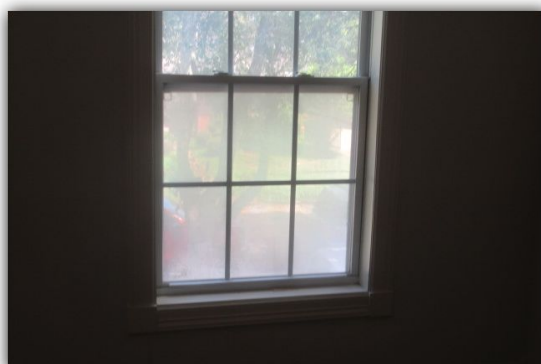
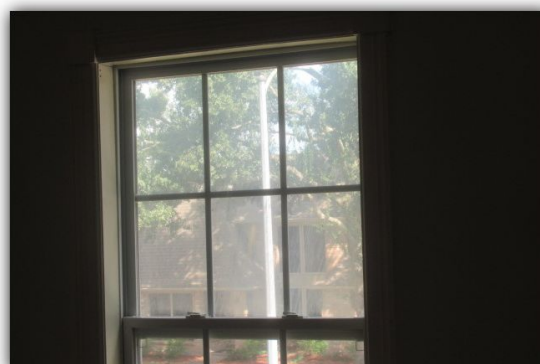
Several of the thermo pane windows may have lost their seal as there is notable discoloration. It is recommended that these windows be cleaned and rechecked.

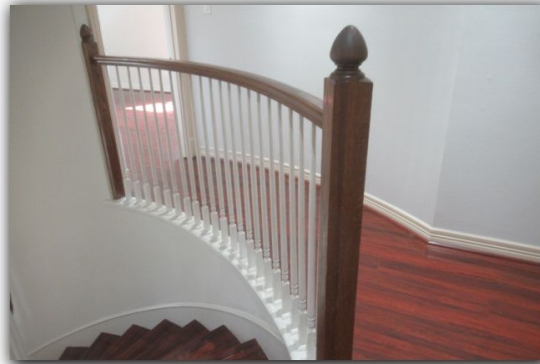
**Comments:** The stair case handrails were loose at the top and bottom of the stairs. It is recommended that all banisters and handrails be able to withstand 800 pounds of pressure to ensure the safety of the occupants.

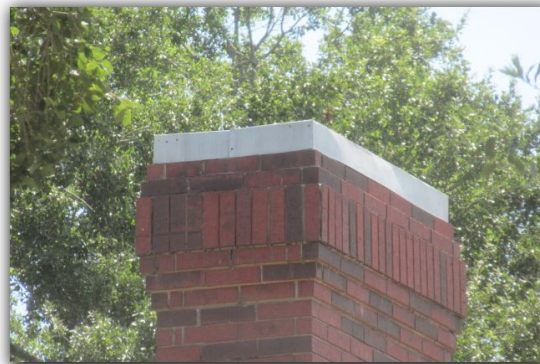
**Comments:** The chimney cap was missing. The cap should keep water out of the flue and fireplace. The screen keeps out birds, animals, and insects. The screen also has spark arresting properties.

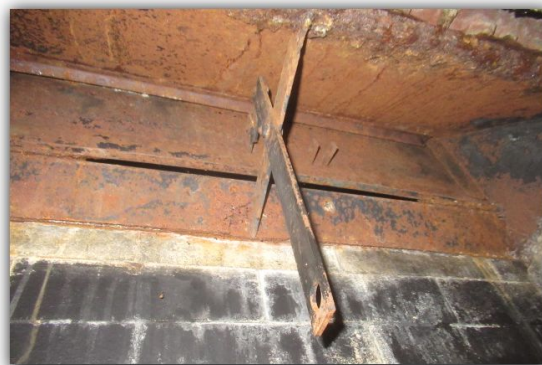
There was corrosion on the damper assembly and it would not open. This condition is an indication of possible moisture penetration.

It is recommended that a chimney sweep be consulted regarding these conditions as well as check the entire fireplace/chimney system for any other possible defects.

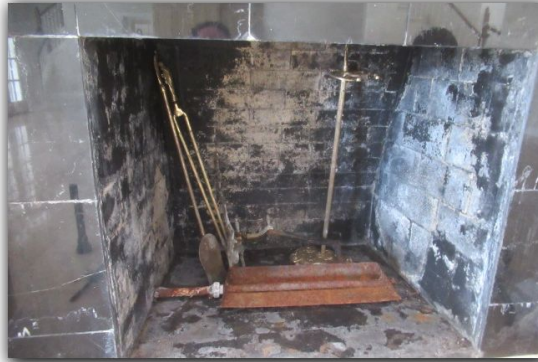
The igniter tube is heavily corroded therefore the gas feature was not performance tested.

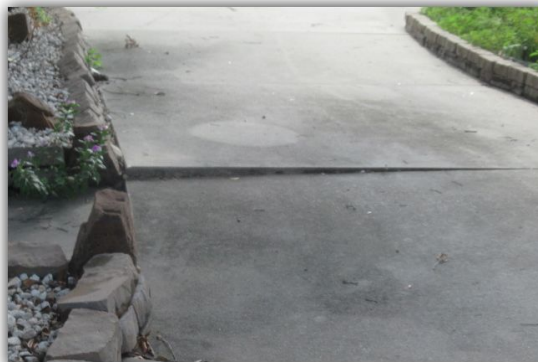
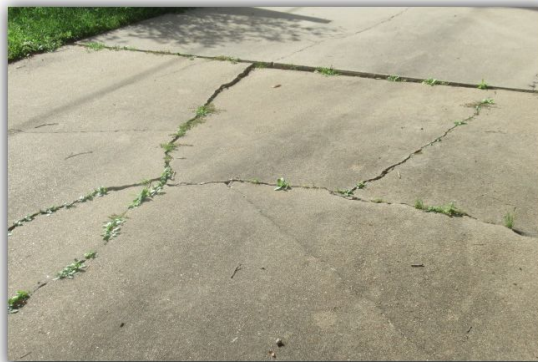
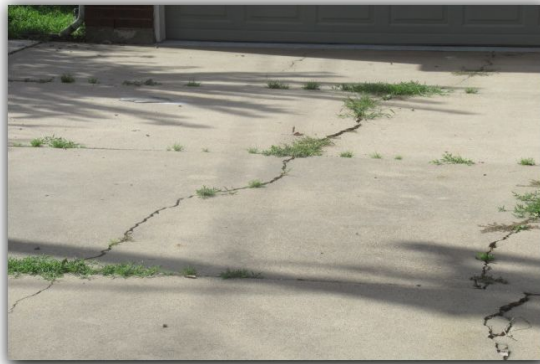
☒ ☐ ☐ ☒      **L. Other**  
**Comments:** Driveway sections have cracked and lifted/settled unevenly.

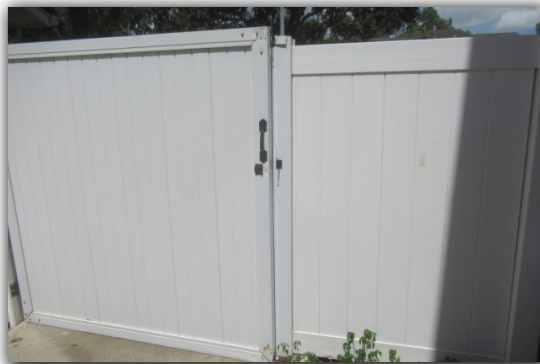
The gate on the west side of the home would not close and latch as intended.

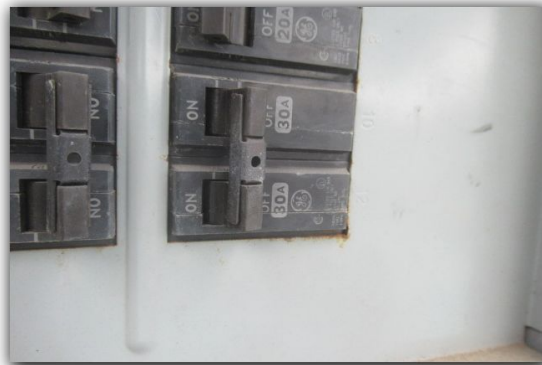
**Comments:** A 30 amp breaker in the sub panel was in the off position at the time of the inspection.

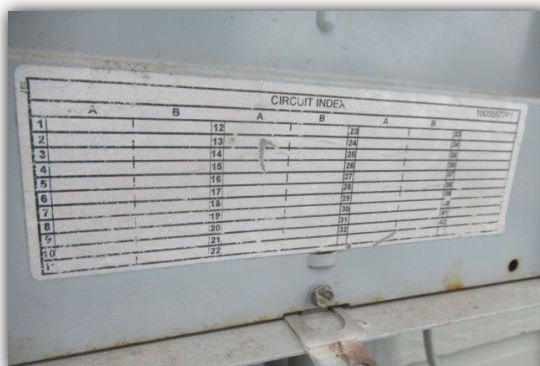
Two of the dead front panel securing screws for the main breaker box were missing.

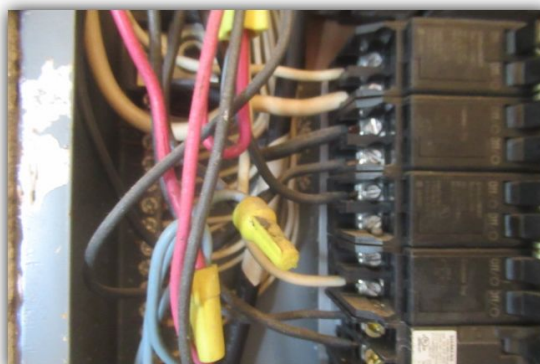
White wires were used as a “hot” wire and are connected to a circuit breaker. In most instances the white wires are the grounded conductors, and if they are used as a “hot” wire, they must be wrapped with black or red tape to identify them as a “hot” wire.

A licensed electrician should be consulted regarding the repair of the above items as well as

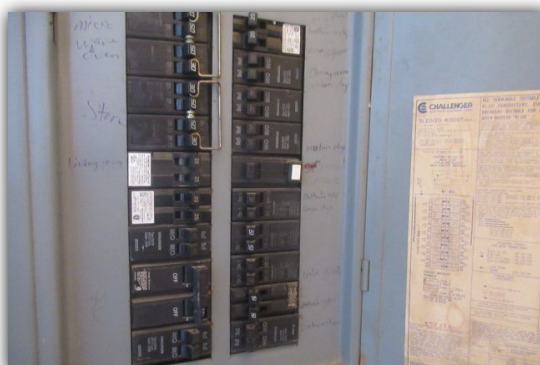
Arc fault breakers have not been installed for all the outlet and lighting branch circuits as would now be required. Arc fault breaker protection is now required for kitchens, family rooms, dining room, living rooms, parlors, libraries, dens, bedrooms, sunroom, recreation rooms, closets, hallways and the laundry areas.

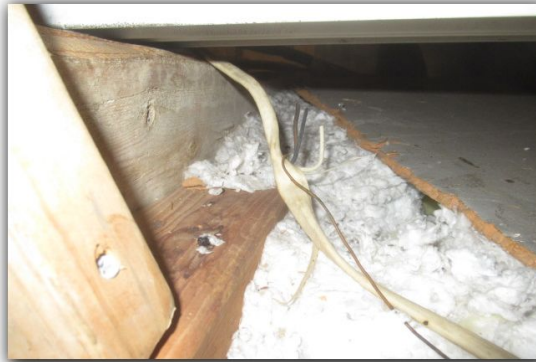
Wires were improperly spliced terminated in the attic. Wire ends or splices should be in junction boxes that are properly mounted with cover plates. This condition is considered an electrocution/fire concern and should be serviced by a licensed electrician.

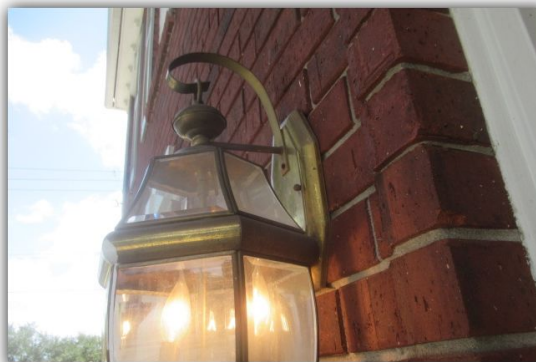
The base of the exterior light fixtures are not sealed properly where they meet the home as they should be in order to prevent water penetration into the fixture where the electric connections are located.

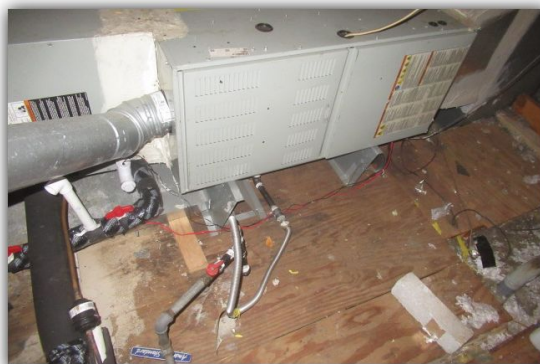
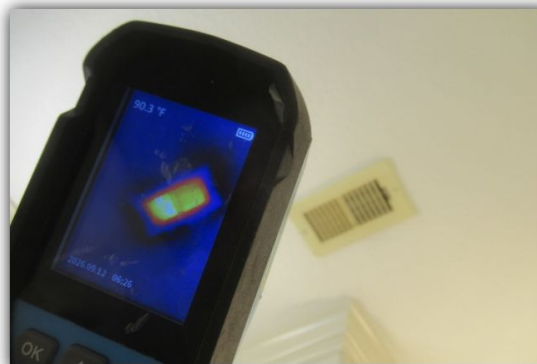
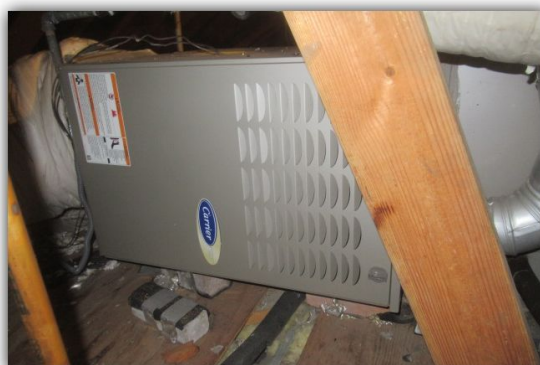
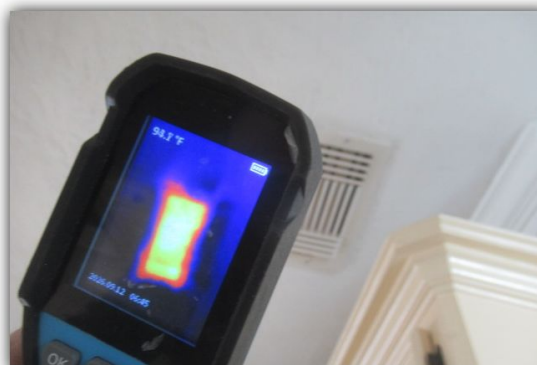
**Comments:** The upstairs zone furnace flue pipe is in contact with an HVAC duct. Gas appliance flue pipes must have a minimum of 1" clearance from any combustible materials.

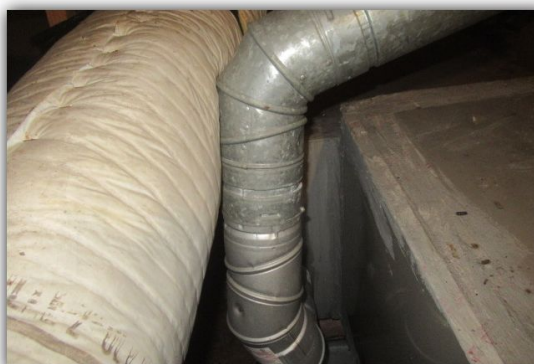
The furnace flue pipes should extend 2' higher than any roof area within 10' horizontally.

The downstairs zone furnace flue pipe has sections secured with duct tape.

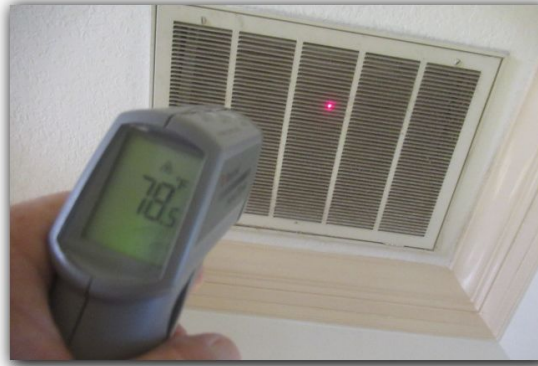
**Comments:** The downstairs zone system did not operate within the allowable tolerances. The air coming out of the vents should be 14 to 21 degrees cooler than where it goes into the cold air return. It is recommended that a qualified contractor be consulted regarding this matter.

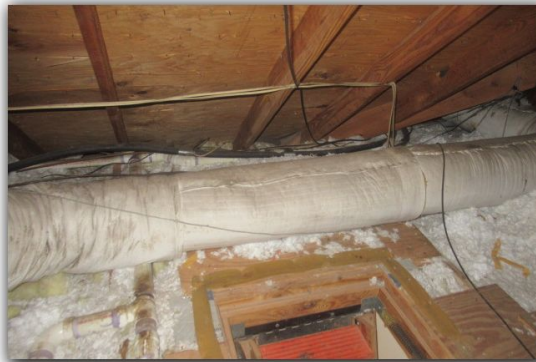
Ducts in the attic area are in contact with each other which may cause condensation and damage to the outer coating. These ducts should be separated a minimum of one inch or unfaced insulation placed between them.

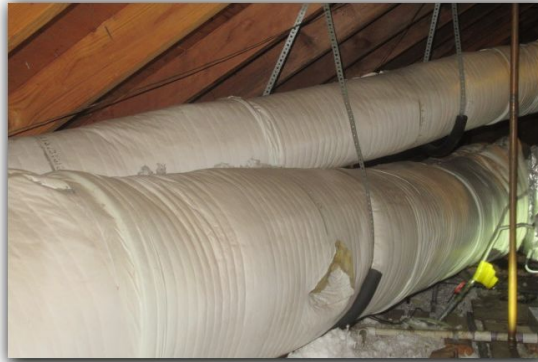
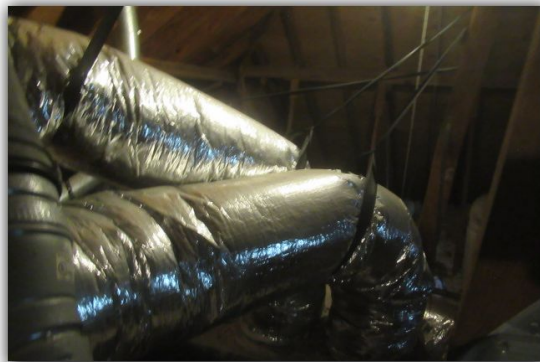
The ductwork coating is torn on some of the ducts in the attic area. It is recommended that the coating and insulation be complete for energy efficiency of the HVAC system.

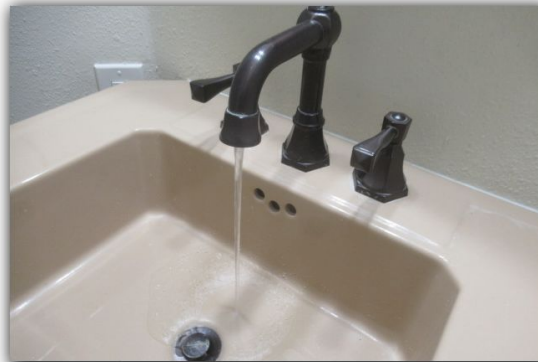
The water supply was not being delivered to the sink in the garage and to the cold water at the middle sink in the jack and jill bathroom.

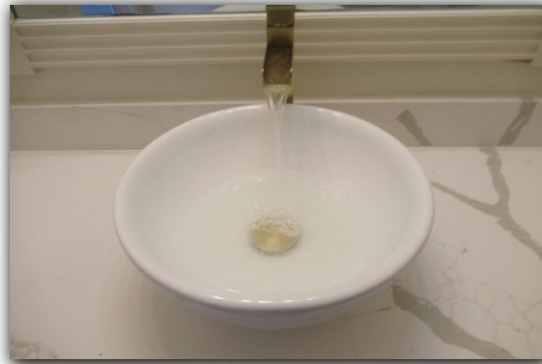
A flexible drain pipe is being used at the front sink in the jack and jill bathroom. Flexible drain pipes should not be used as they can more easily collect debris and become clogged.

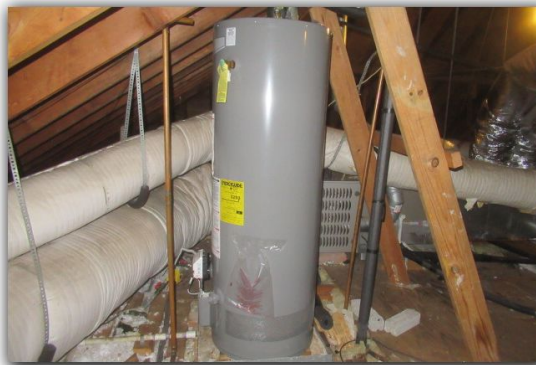
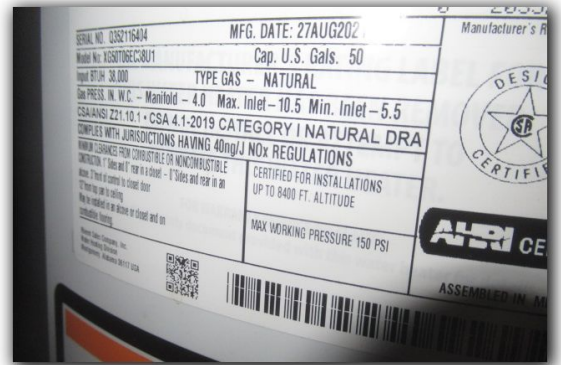
**Comments:** The temperature and pressure relief valve should drain into a line that is plumbed to the outside and may go horizontally or down, but cannot go back up. (This keeps debris from going back to the valve) This line can be  $\frac{3}{4}$ " C.P.V.C Plastic (not reduced in size) and should terminate from 2 to 6 inches from the ground.

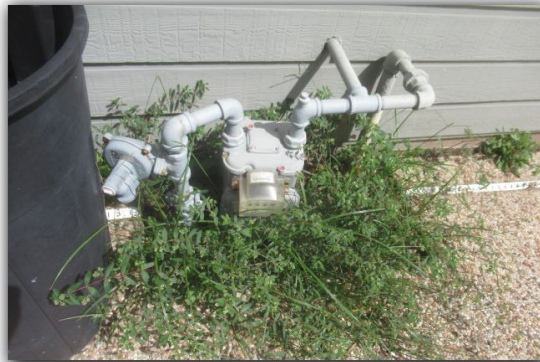
**Comments:** Performing properly

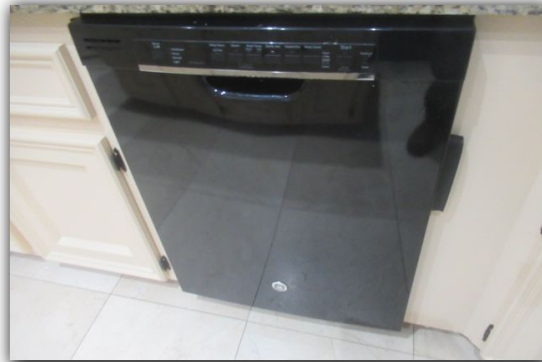
The dishwasher drain line (discharge hose) did not have an anti-siphon valve or a vacuum break. The dishwasher drain line usually attaches to the garbage disposal. The drain line should arch above the level of the sink drain, have an anti-siphon valve, or have a vacuum break. This keeps debris in the disposal from siphoning back to the clean dishes. The drain lines should be elevated or a back flow device installed.

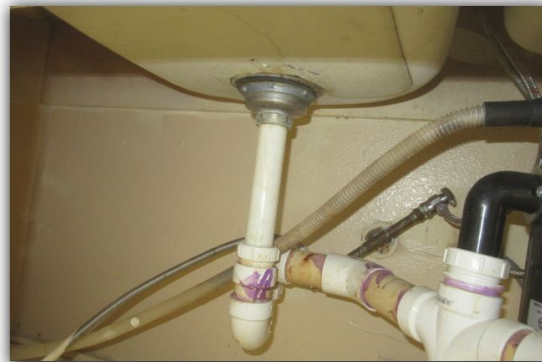
The electrical supply for the dishwasher is not completely protected by conduit.

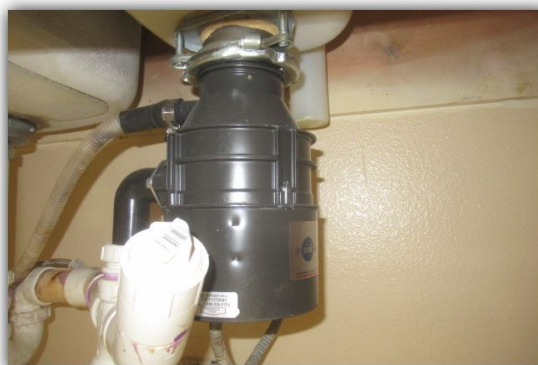
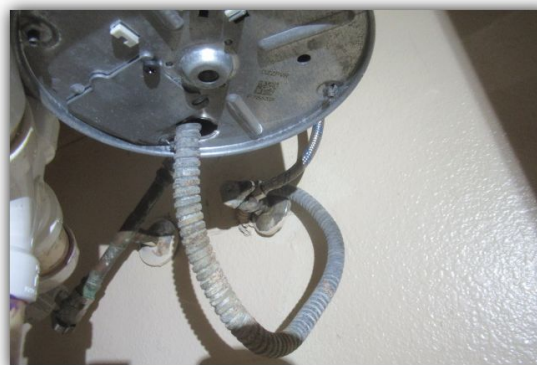
**Comments:** The garbage disposal electrical supply is not secured to the bottom of the unit. This condition can cause the insulation on the wires to wear through from the vibration of the unit when it is in use, resulting in an electrical short in the system.

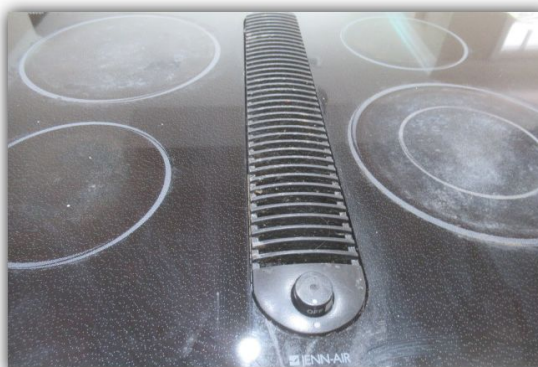
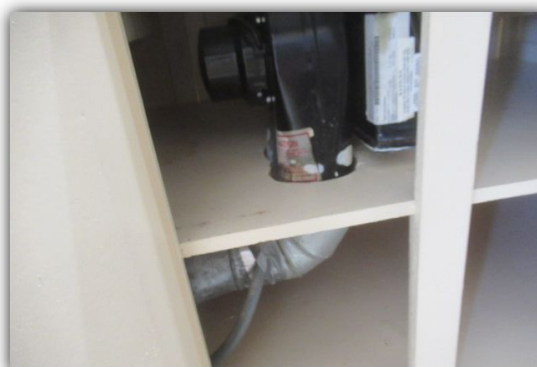
**Comments:** The vent hood was not drawing air as intended.

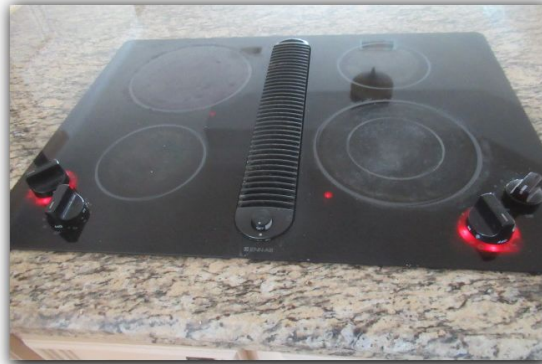
**Comments:** The knobs are defective and the burner elements did not operate as intended.

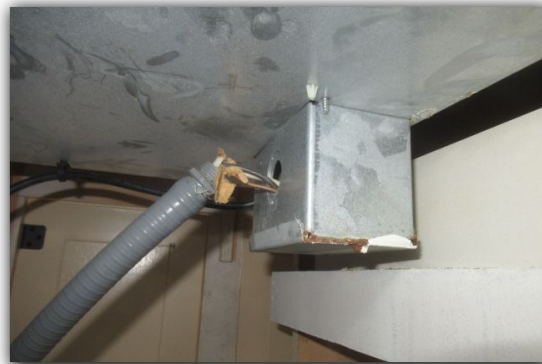
The electrical wiring is not fully protected by conduit as is required.

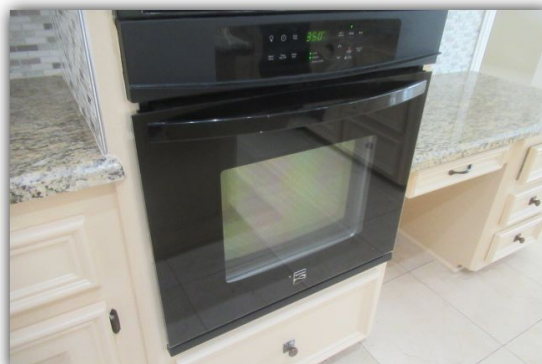
The oven appears to be operating properly.

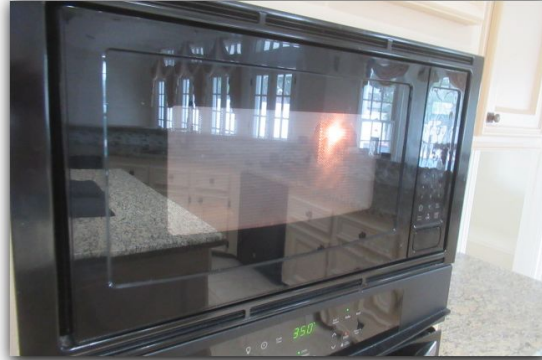
**Comments:** The microwave appears to be performing properly at this time.

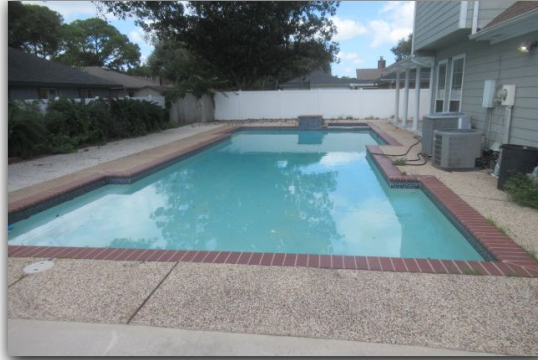
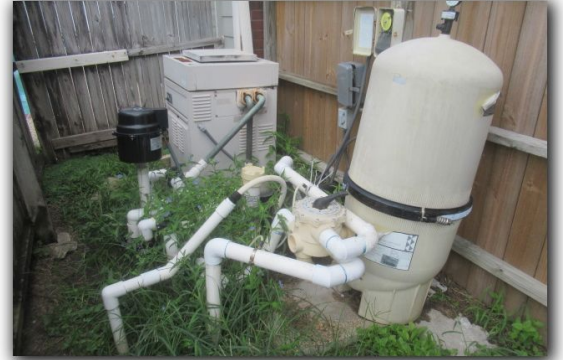
**Comments:** The pool equipment did not operate when tested.

A qualified pool contractor should be consulted these conditions as well as check the entire pool and equipment for any other defects.

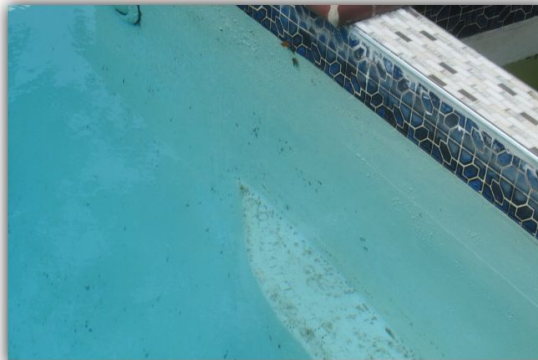
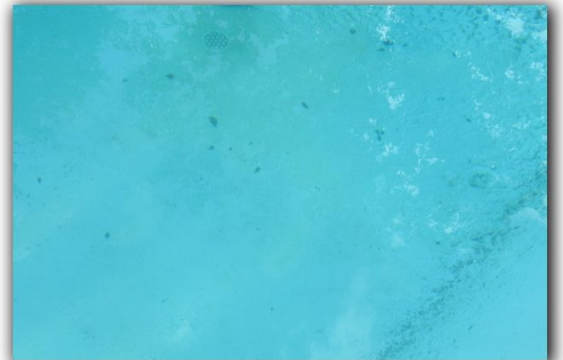
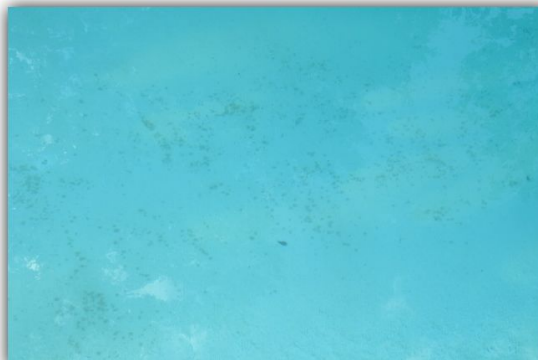
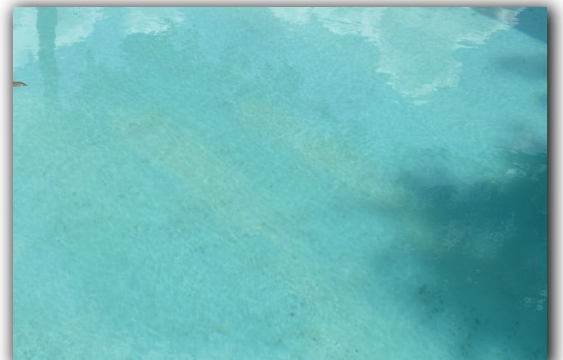
There was etching on the pool surface.

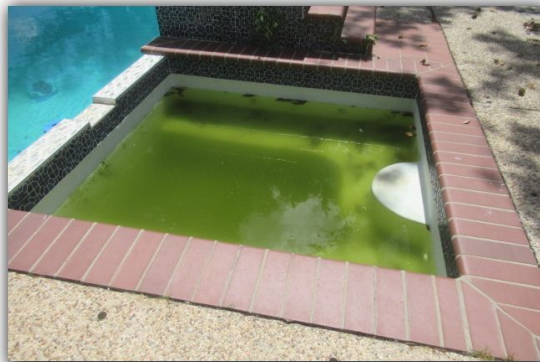
The gap between the perimeter coping tiles and the surrounding decking should be sealed.
