**SAMPLE INSPECTION REPORT**

# **Foundation Pre-Pour**

Pearland, Texas

## **Pre-Pour Foundation Inspection**

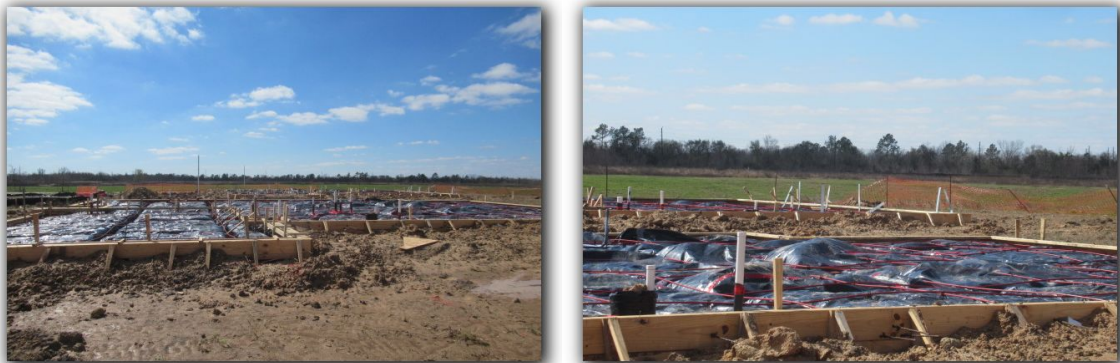
The windstorm tie down straps were not installed at the time of this inspection.

It is recommended that the builder be consulted regarding the above issues for correction prior to the concrete being poured.
