SAMPLE INSPECTION REPORT

# Seller Pre-Sale Inspection

Pasadena, Texas

Inspection performed October 3, 2026

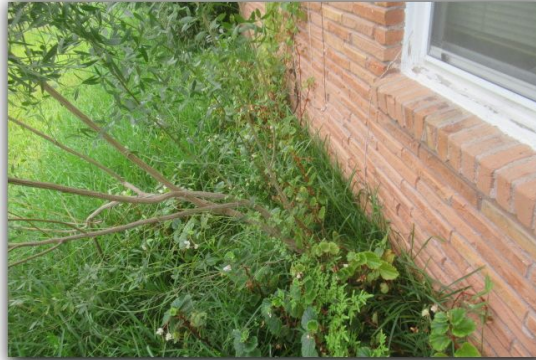
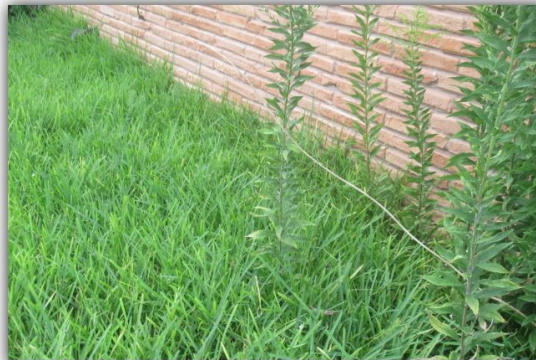
**Comments:** The soil levels are high in relationship with the interior of the home at the front, back and east side of the home. When soil levels are high against the face of the foundation it promotes water penetration of the structure and insect infestation. This item should be corrected so there is some exposure of the foundation face without creating reverse drainage. It is generally accepted that in an ideal situation, a brick veneer house should have about 4-6 inches of clearance. Wood siding houses should have more clearance.

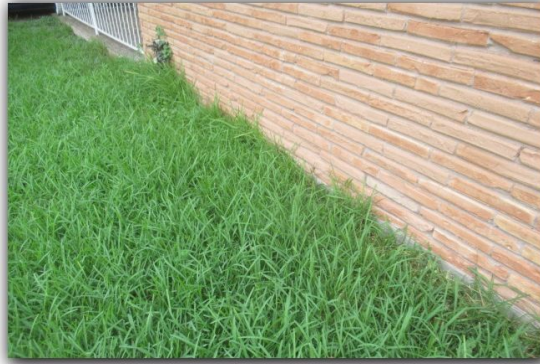
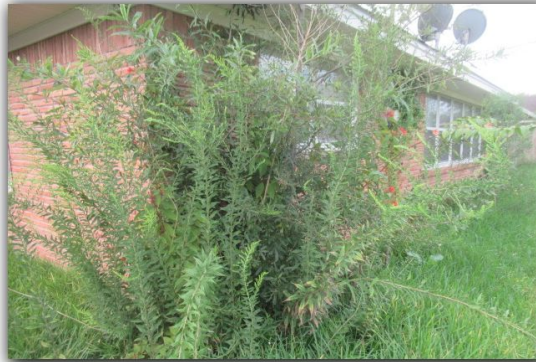
There was heavy foliage at the back of the home, therefore the face of the foundation and the brick walls in these areas were not visible. This condition will also hold moisture in these areas and may be conducive for insect activity. Cutting back the foliage in these areas is recommended.

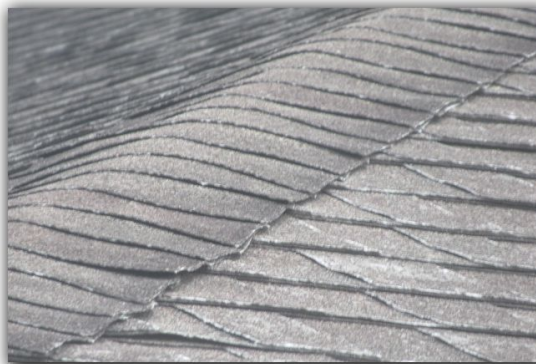
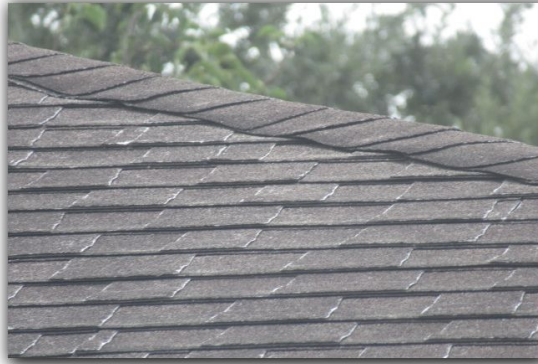
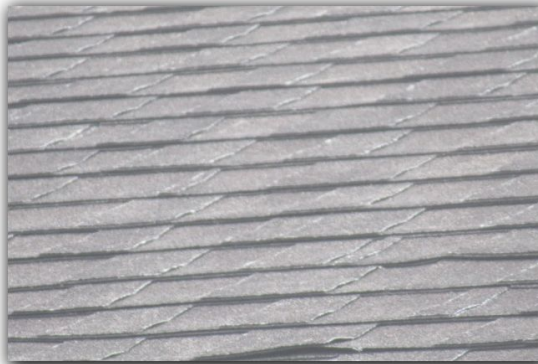
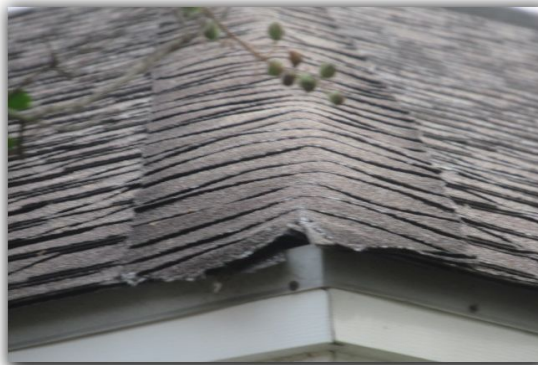
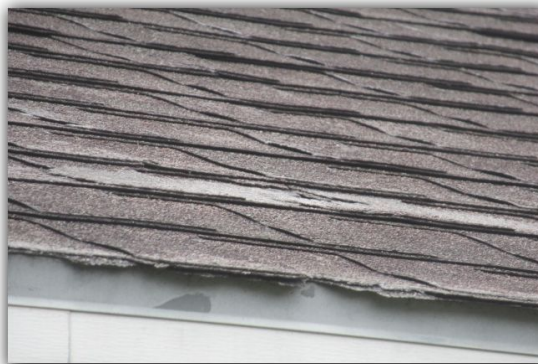
**Comments:** The surface of the roof is heavily worn/loss of aggregate and there are damaged shingles in some areas which is an indication that the shingles should be replaced in the near future.

There are several lifted shingles that may be caused by nails backing out. A qualified roofing

A qualified roofing contractor should be consulted regarding the above items and the need for replacing this roof covering.

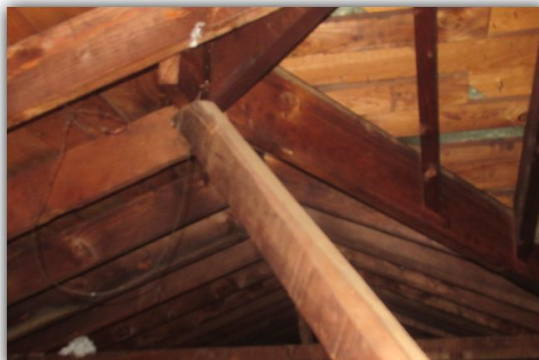
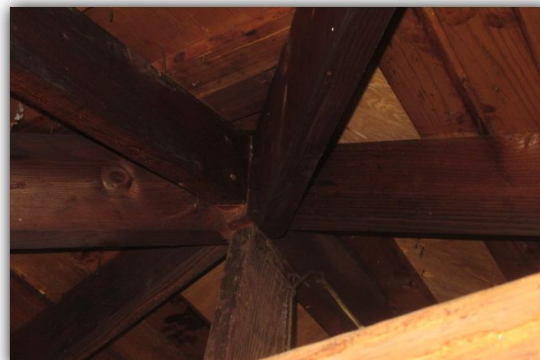
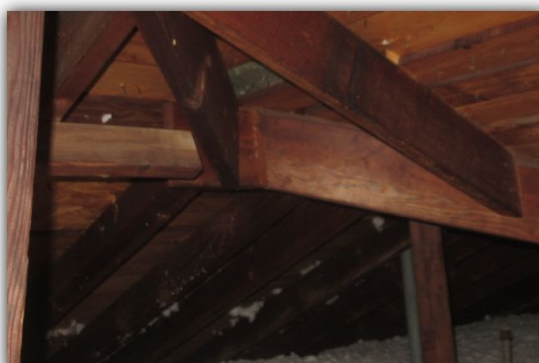
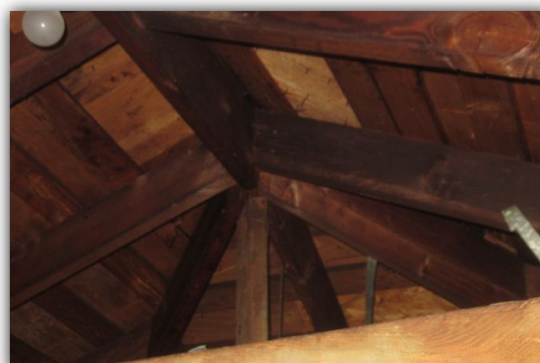
The mid span rafter supports have not been installed for the roof structure every four feet and are undersized in relationship with the rafters.

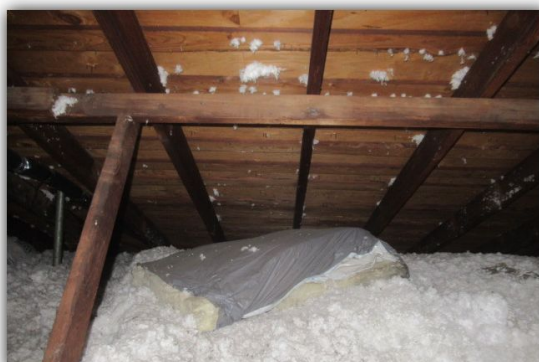
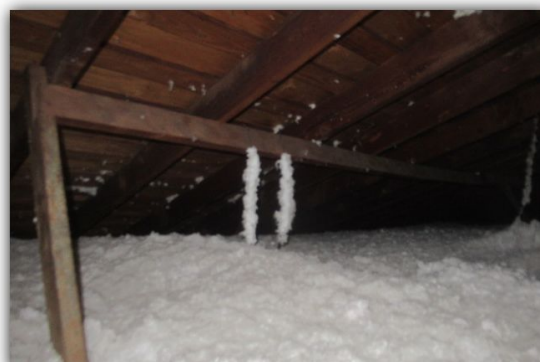
The insulation on the attic floor was thin to meet minimum current standards (R-30) and not complete in some areas. It is recommended that additional insulation be added for energy efficiency.

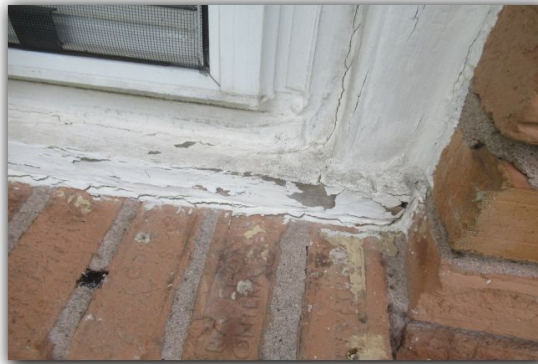
**Comments:** The exterior paint was peeling at several of the windows. Exposed or weathered wood is considered a conducive condition for wood decay and water penetration. It is recommend consulting a painting contractor so a course of corrective action can be further evaluated.

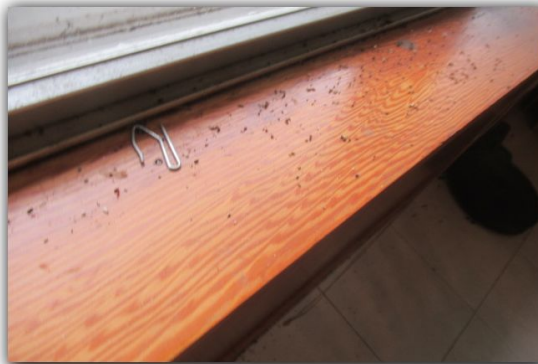
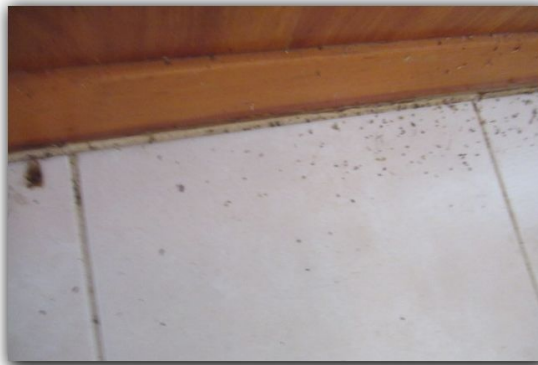
Evidence of insect infestation was observed at the back wall of the dining room. A licensed pest control company should be consulted so a corrective course of action can be evaluated. This inspection will only reveal visible structural damage. Hidden damage is a possibility. All damaged material should be repaired or replaced.

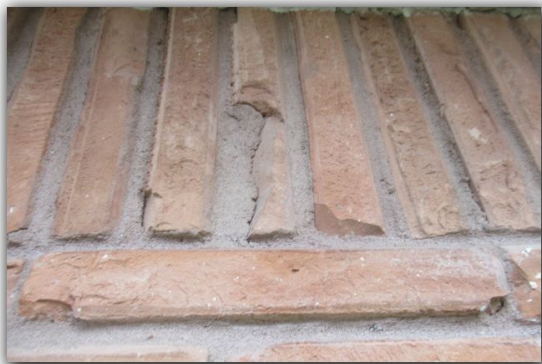
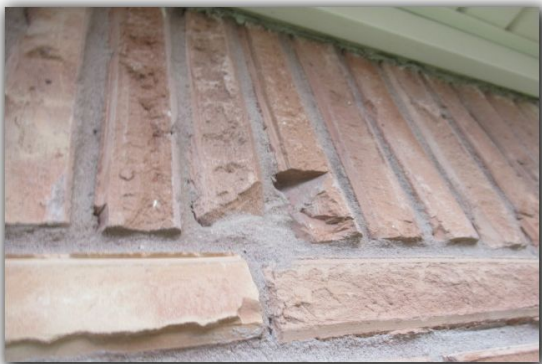
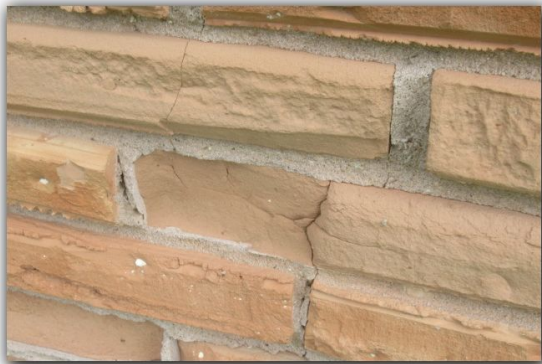
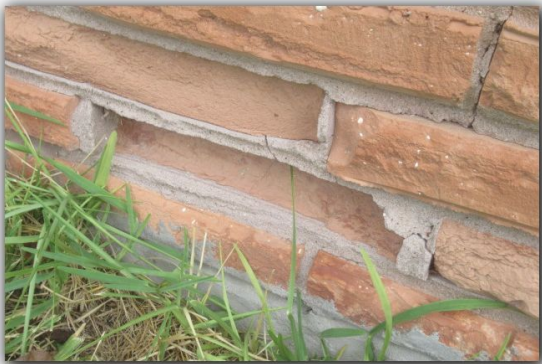
There are several incomplete bricks around the home.

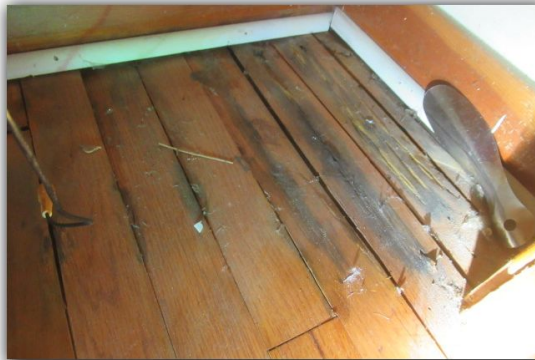
**Comments:** There is water damage to the hardwood flooring in the middle bedroom closet that is behind the master bathroom shower. This condition is an indication that the master bathroom shower leaks or has leaked in the past. Hidden damage is a possibility. All damaged material should be repaired and or replaced. A qualified contractor should be consulted regarding this condition.

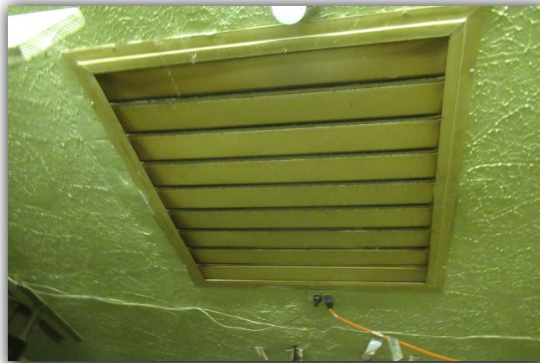
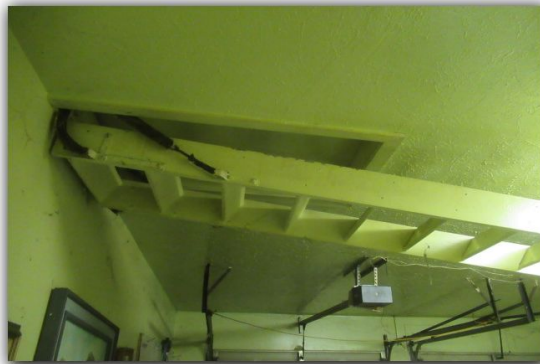
The garage access ladder assembly is not fire rated. A fire rated ladder assembly can help contain a fire in the garage for roughly twenty minutes. The garage is the second most likely place for a house fire to originate in a home. The presence of a carbon monoxide sensing smoke detector is also highly recommended.

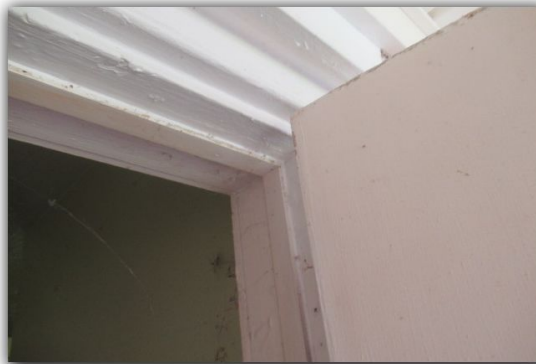
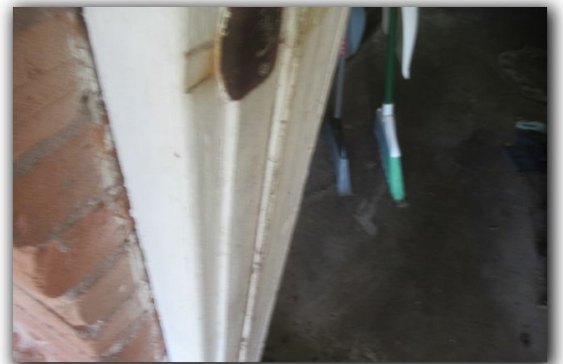
The back door off the garage is not weather stripped.

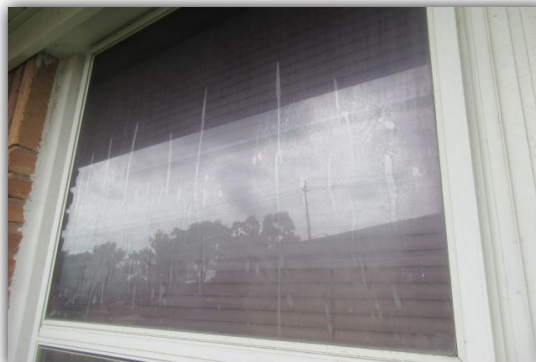
**Comments:** Thermo pane windows appear to have lost their seal as there is discoloration and moisture stains between some of the glass panes where visible.

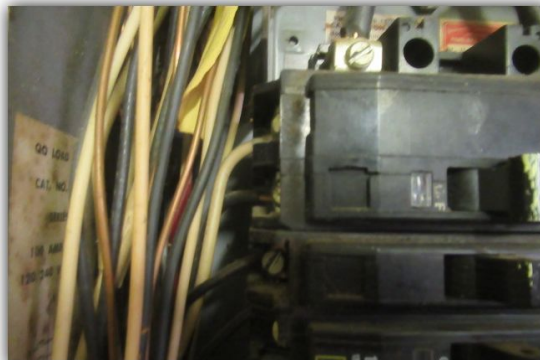
Arc fault breakers have not been installed for all the outlet and lighting branch circuits as would now be required. Arc fault breaker protection is now required for kitchens, family rooms, dining room, living rooms, parlors, libraries, dens, bedrooms, sunroom, recreation rooms, closets, hallways and the laundry areas.

A licensed electrician should be consulted regarding the above items as well as check the entire electrical system for any other possible defects.

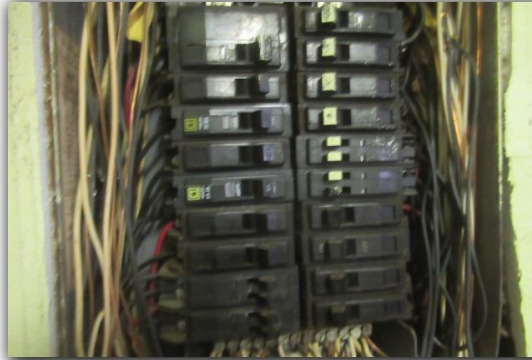
Service entrance barriers have not been installed over the main electric cables inside of the breaker box.

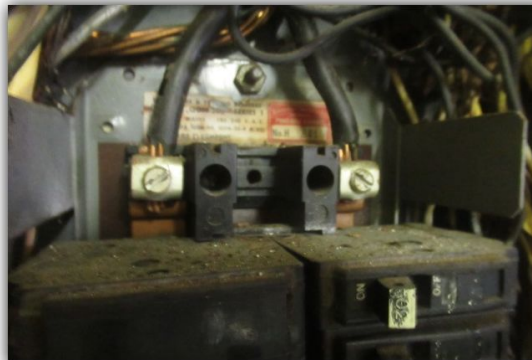
Whole house surge protectors are now required to be installed for all breaker boxes.

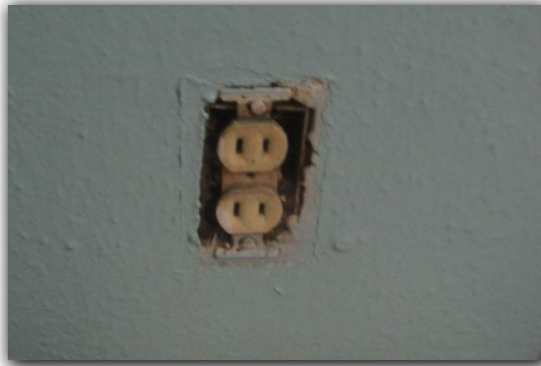
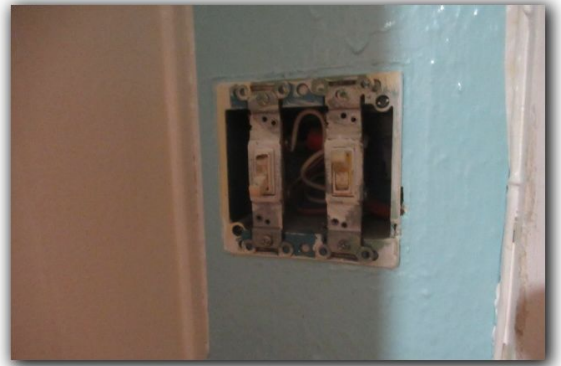
Most all of the outlets in the home are not grounded. I recommend having this corrected/serviced by a licensed electrician.

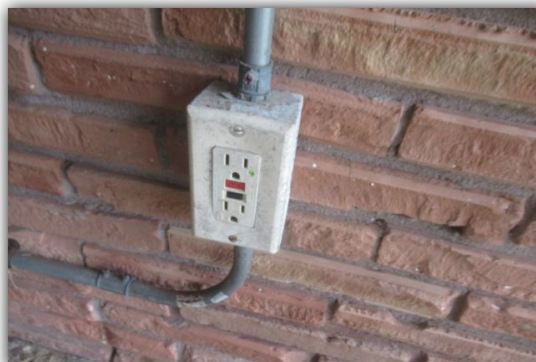
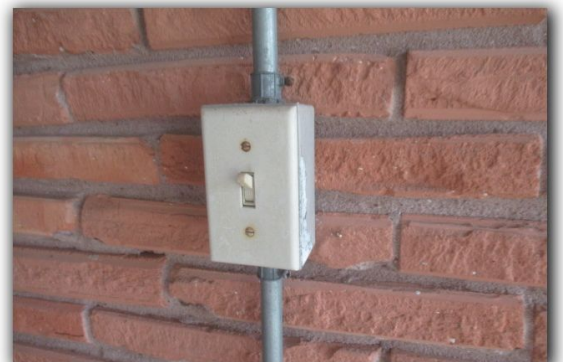
The exterior outlets and switches should have weather guard cover plates installed to protect them from water penetration and possible electric shorts.

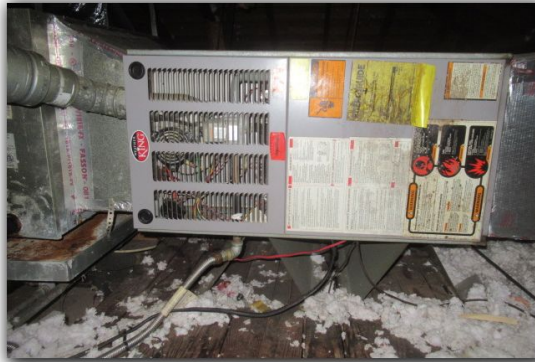
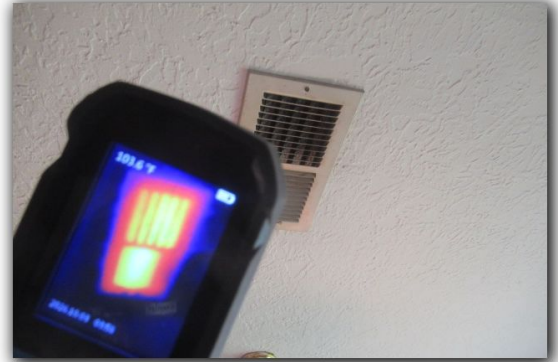
**Comments:** There is no condensate drip leg/sediment trap installed on the furnace gas supply line as is now required.

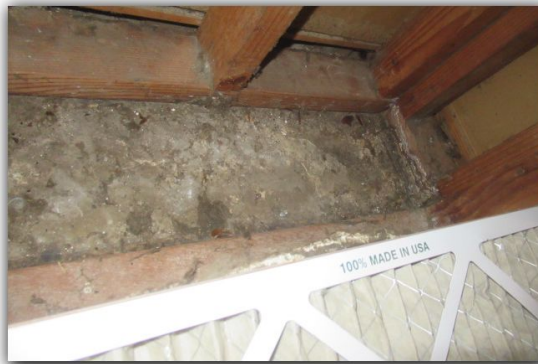
The frame for the return air chase filter housing is not secured to the wall.

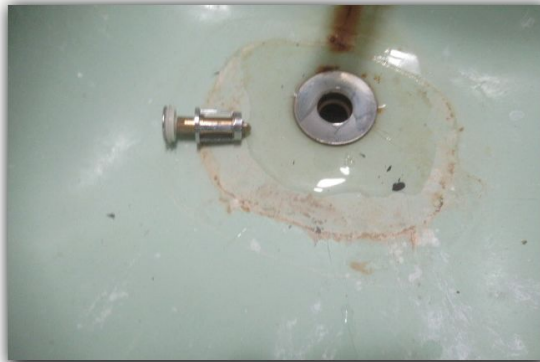
**Comments:** The master bathroom sink drain stop is not installed and operating properly. Sometimes a drain stop can be adjusted or it may need to be replaced.

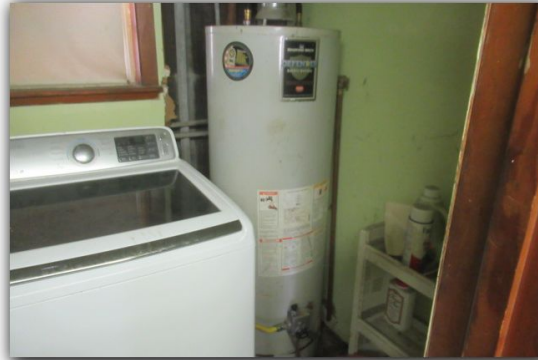
**Comments:** The water heater was not elevated above the floor. It is required that the water heater be elevated 18" above the floor. The combustible gases from a possible gas leak and even some solvents are heavier than air. Proximity of an ignition source poses a definite fire concern.

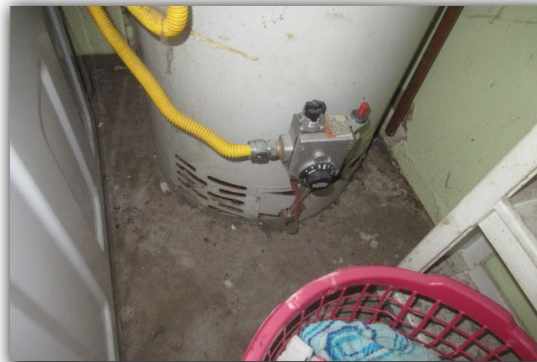
There was corrosion at the water supply lines/valve of the water heater. It is recommended that these fittings be replaced whenever possible to prevent future leaks.

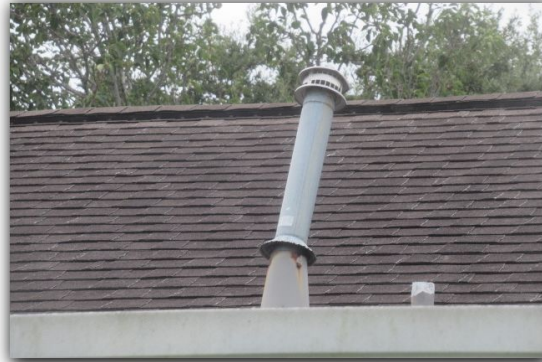
The water heater flue pipe is notably not straight which is an indication this it is not well secured.

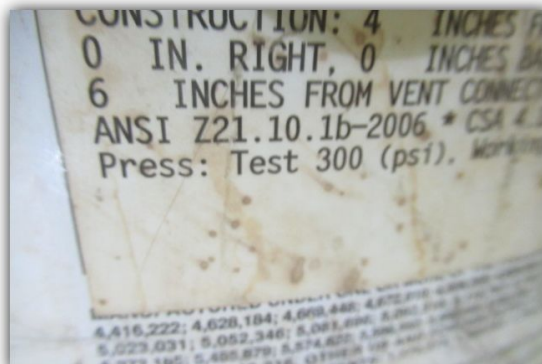
The 2006 model water heater is near or at the end of it's useful life. It is generally accepted that the average life of a water heater is 10 to 15 years.

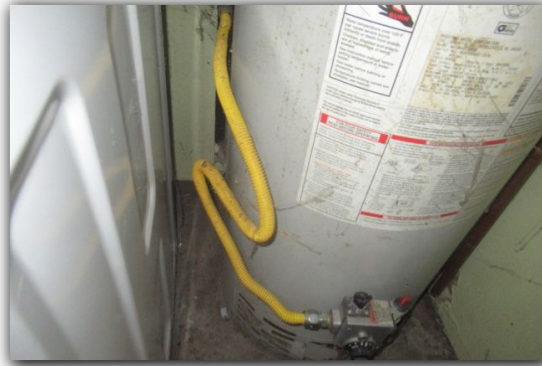
**Note:** The Temperature and Pressure Relief (TPR) valve was not manually operated. Operating the valve during an inspection may cause it to fail to reseal, resulting in a continuous leak, which is a risk of damage to the interior of the home. Recommend a qualified licensed plumbing contractor evaluate and test the TPR valve as part of routine annual maintenance to ensure proper safety function.

A qualified plumber should be consulted regarding the above items and the need for replacing this water heater.

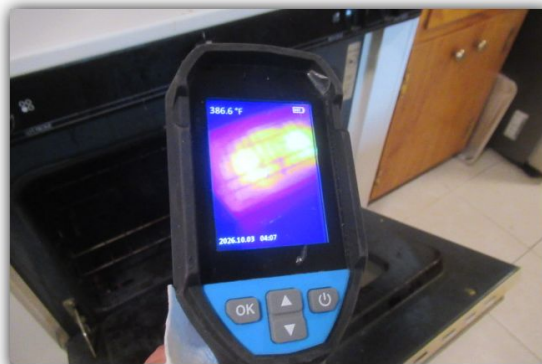
The range is not secured to the surrounding cabinet or wall and the anti tip device is not securing

the range as intended. Children can tip the oven over if the door is used as a stepping stool. All ovens are now required to be secured in some fashion. An anti-tip device should be installed.

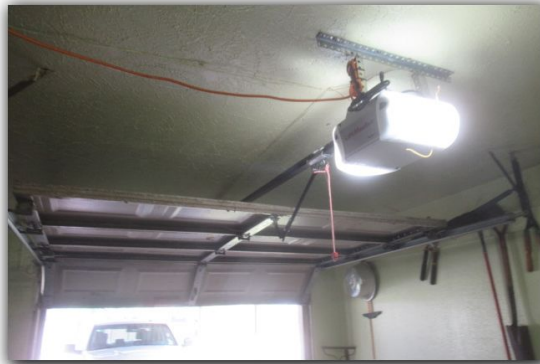
The east side garage door operator is disengaged from the overhead garage door. Therefore it could not be operated.

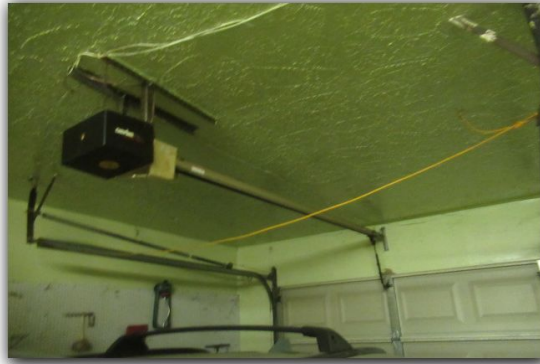
The laser reversing eyes for the west side overhead garage door are higher than 6 inches from the garage floor which could cause injury or damage to property.
