SAMPLE INSPECTION REPORT

# Waterfront Elevated Home

Hitchcock, Texas

Original inspection: August 28, 2026

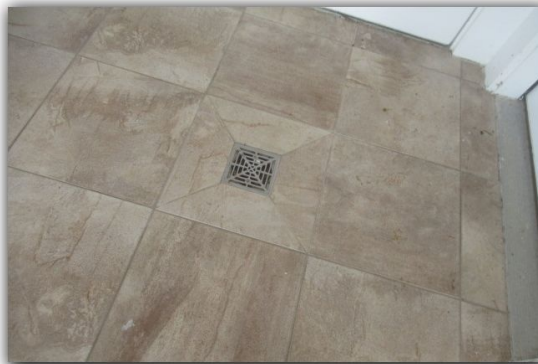
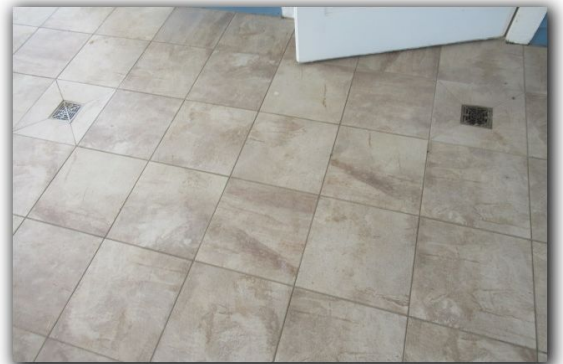
There is a sub surface drain system. This drain system should assist in diverting rain water to the street or storm sewer. The overall effectiveness of this system was not determined. Underground drains can become clogged or obstructed.

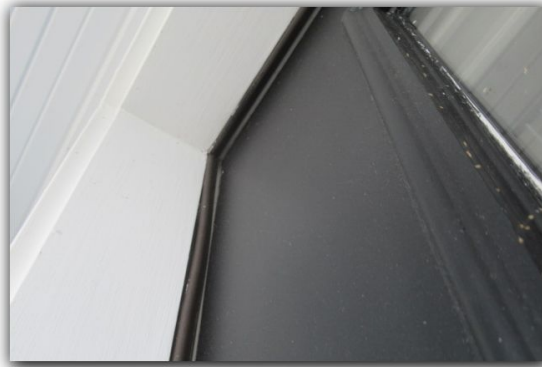
**Comments:** The front door does not seal completely at the top when shut.

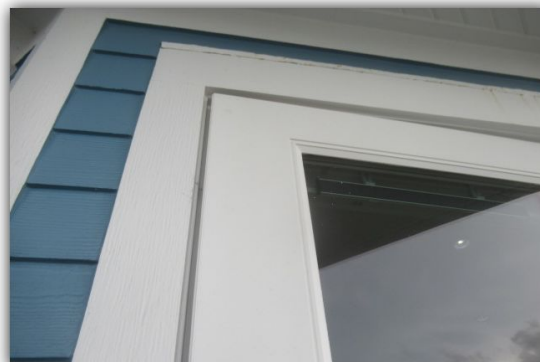
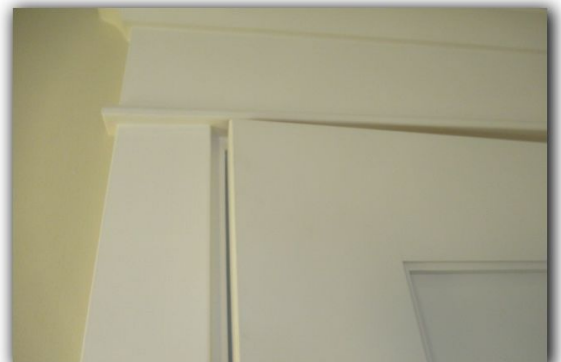
The exterior door off the master bedroom and the third level south side bathroom door stick when operated. All doors should be present and in working order. Doors that stick or do not latch properly can usually be adjusted. In most cases, doors that stick or do not latch properly are an indication of past movement in the structure.

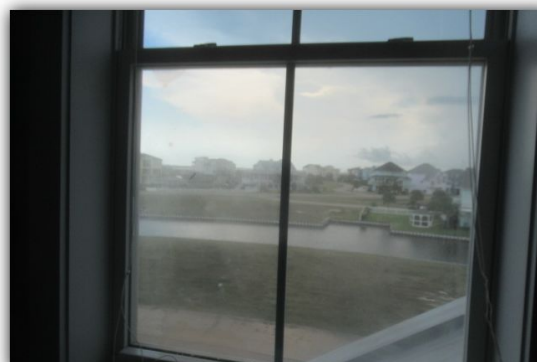
**Comments:** Double pane windows at the third level bedrooms and one of the fourth level windows appear to have lost their seal which is causing discoloration between the glass panes.

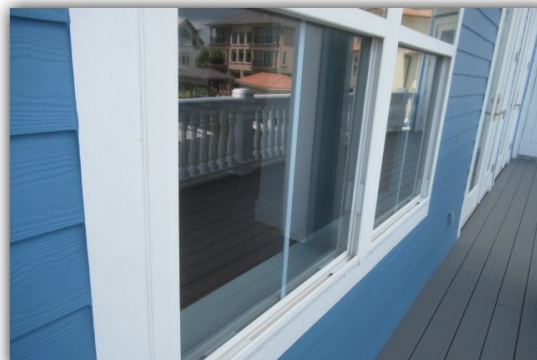
Window screens were missing. Screens are mentioned in this part of the report as they are a specific item in the T.R.E.C. Guidelines. All windows that have channels for screens should have them installed.

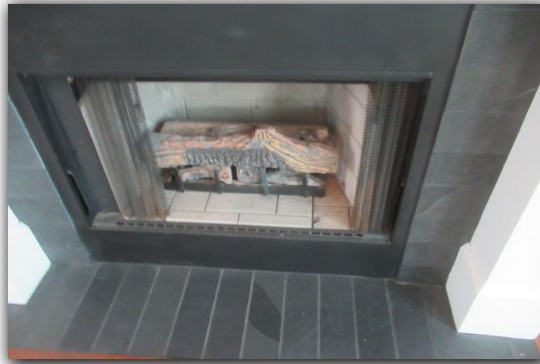
**Comments:** The gas feature in the fireplace did not ignite when tested.

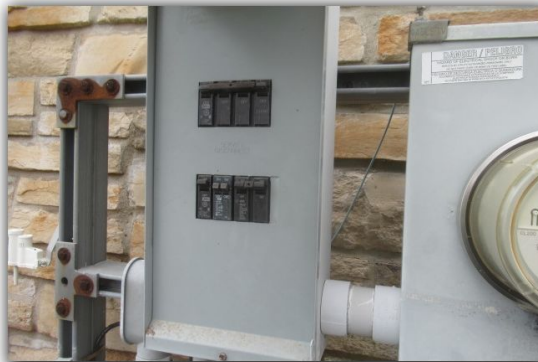
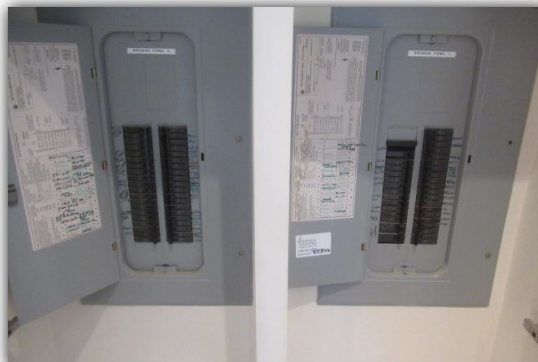
**Location of Breaker Box:** Main breaker box on the north side of the home with two sub panel boxes on the third level north hallway

**Comments:** Dead front securing screws were missing at the sub panels.

A licensed electrician should be consulted regarding the repair of the above items as well as check the entire electrical system for any other possible defects.

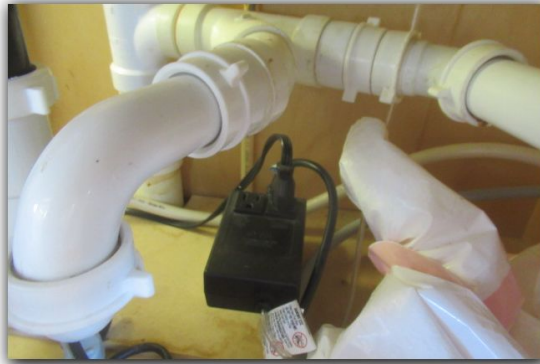
The electrical outlet/switch box for the main kitchen sink garbage disposal should not be located below the plumbing pipes.

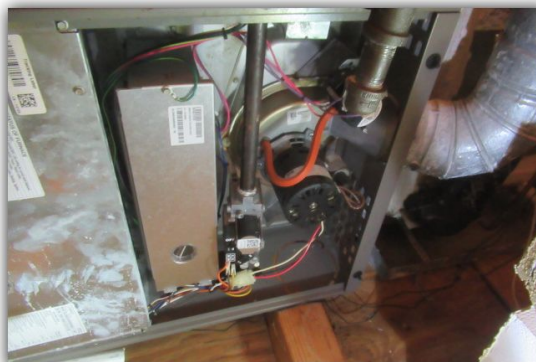
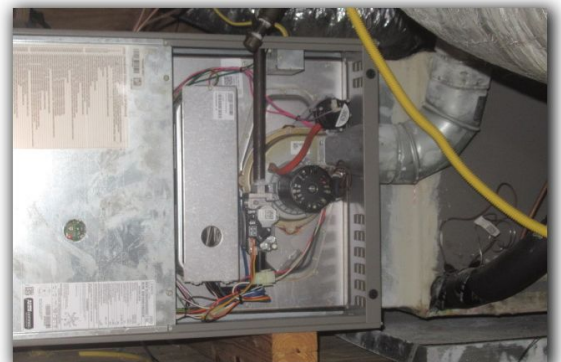
**Comments:** The cover panels for the heating equipment were not installed at the time of this inspection.

A qualified HVAC technician should be consulted regarding the above items as well as check the entire heating system for any other possible defects.

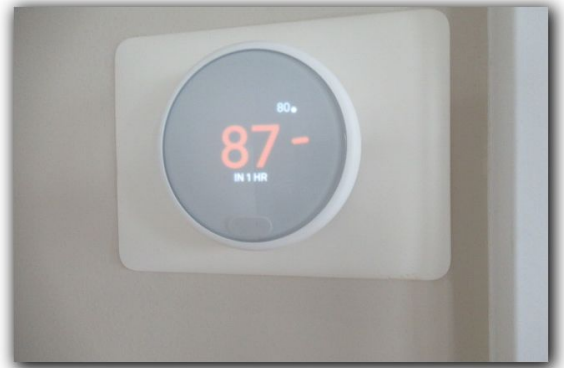
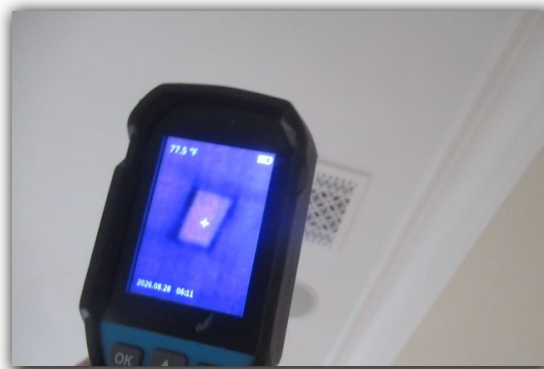
The heating equipment did not respond to the thermostats when tested.

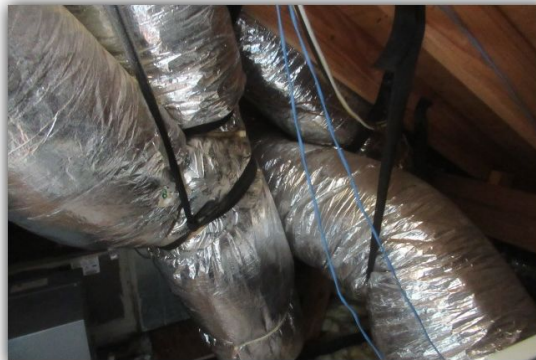
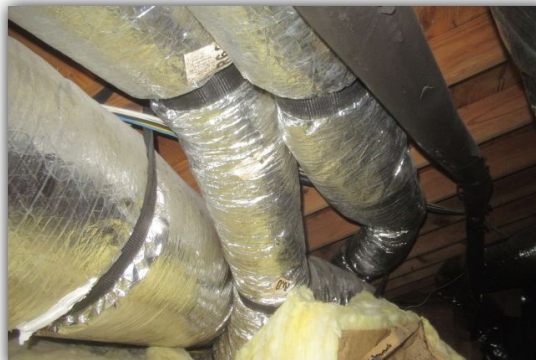
**Comments:** Ducts in the attic area are in contact with each other which may cause condensation and damage to the outer coating. These ducts should be separated a minimum of one inch or unfaced insulation placed between them.

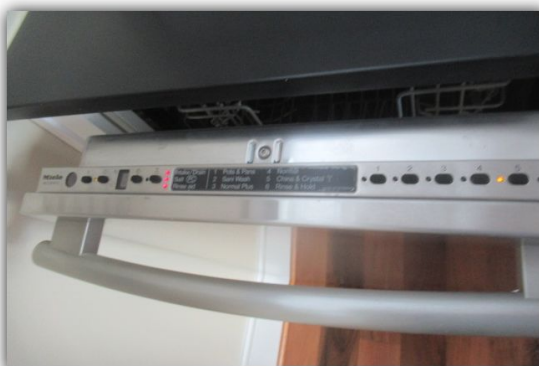
The dishwasher at the 4th level bar area did not operate when tested.

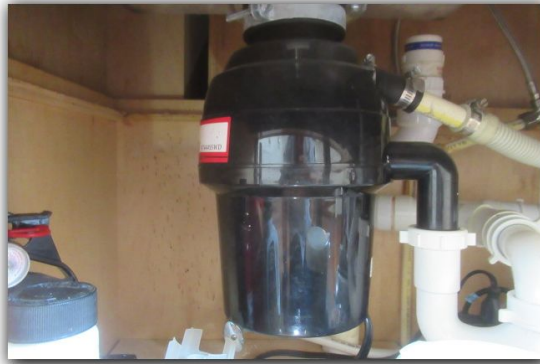
There is debris in the main kitchen sink garbage disposal that should be removed before operation.

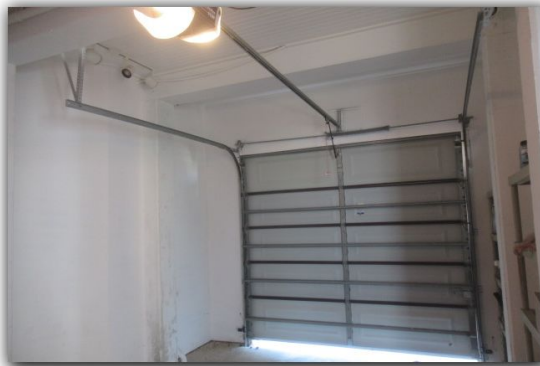
The south side garage door did not open and close as intended.

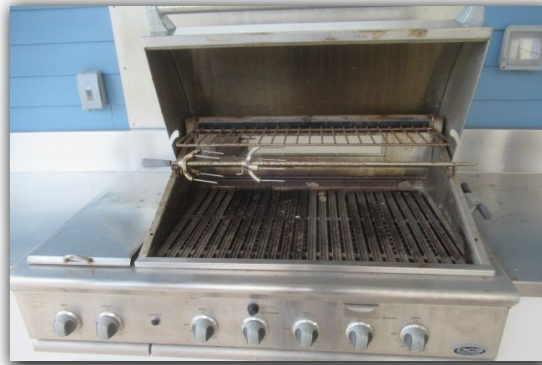
**Comments:** The outdoor grill on the 1st level did not operate when tested.

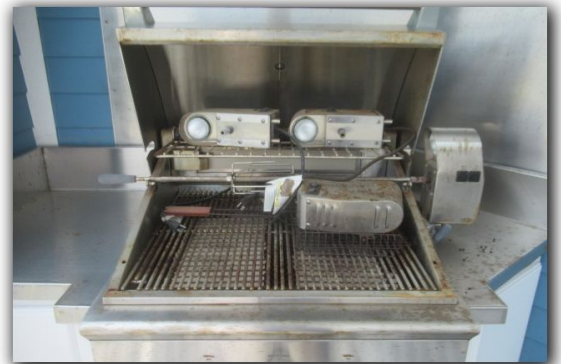
The gas was turned off to the outdoor grill on the 2nd level therefore it was not performance tested.

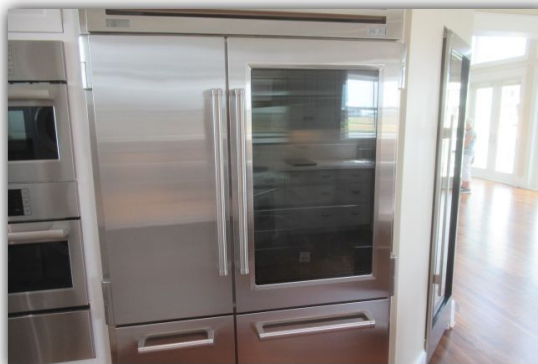
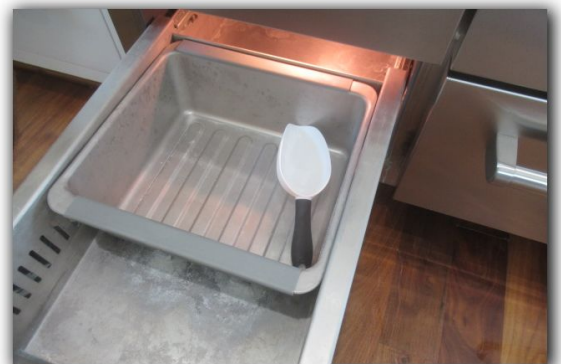
The refrigerator/freezer in the kitchen was not making ice at the time of this inspection.

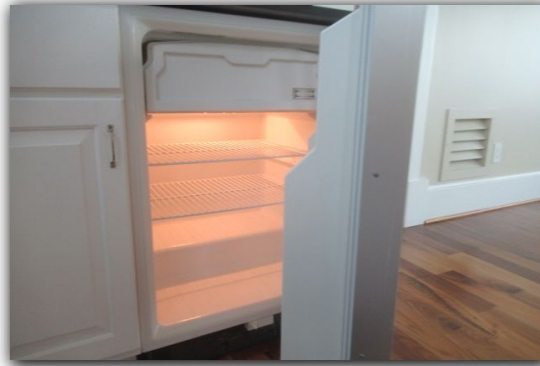
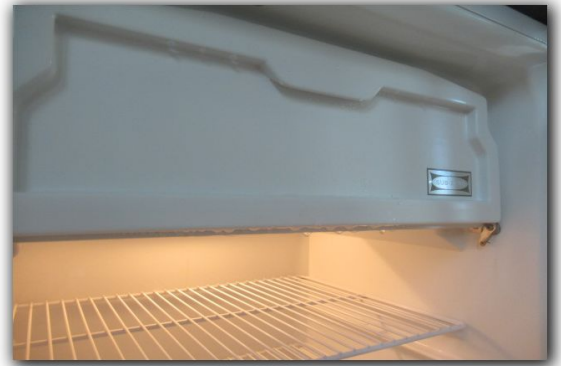
Water was dripping from the freezer compartment of the mini refrigerator in the fourth level bar area.

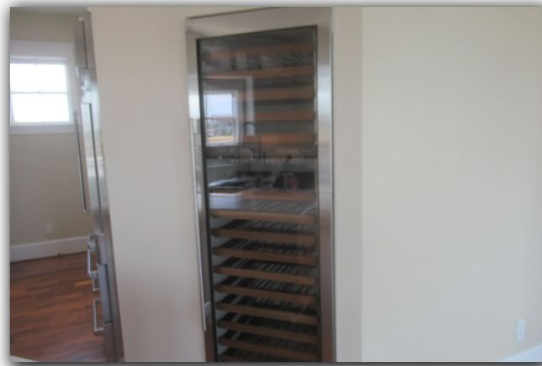
The wine cooler was operating/cooling at the time of the inspection.

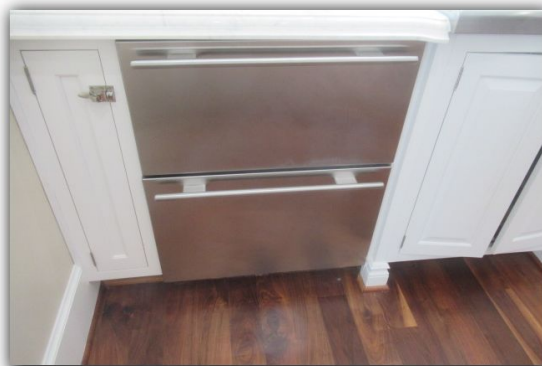
The drawer refrigerator was operating properly.
